EXCAVATIONS AT THE CAPPADOCIA GATE

KERKENES FINAL REPORTS 1

GEOFFREY D. SUMMERS

ORIENTAL INSTITUTE PUBLICATIONS • VOLUME 145
THE ORIENTAL INSTITUTE OF THE UNIVERSITY OF CHICAGO
CHICAGO • ILLINOIS

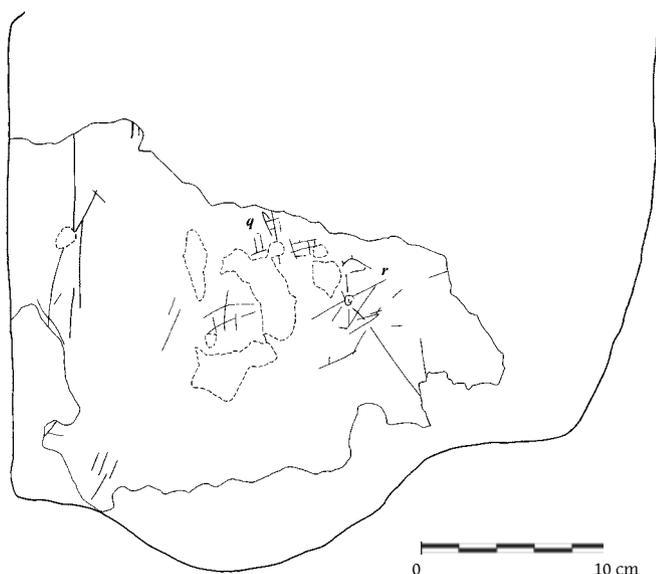
FIGURE 3. Lower graffiti block glacis face with recognizable individual figures indicated by letters (drawing by Susanne Berndt)

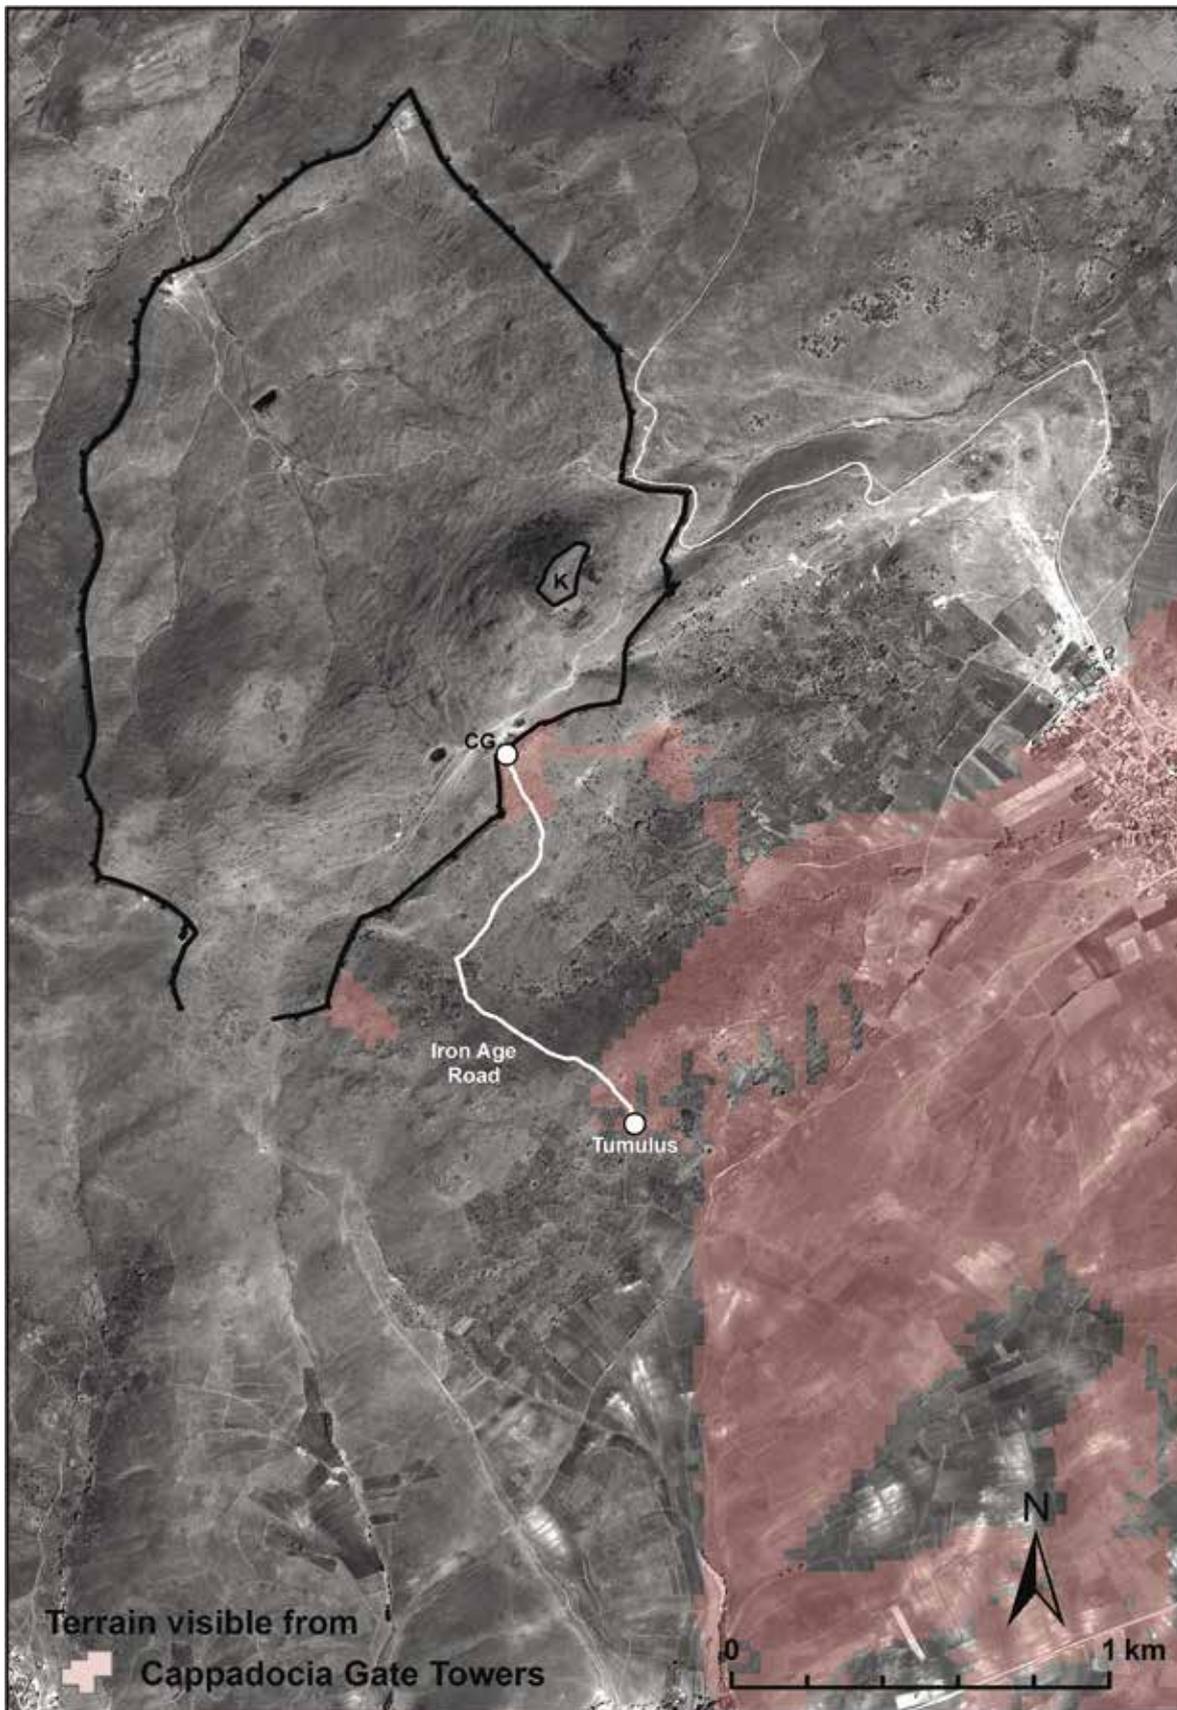
PLATE 12 | VIEWSHED OF THE THREE TOWERS

Viewshed of the three towers along the front of the Cappadocia Gate, showing the visible terrain in a pink semitransparent tone. Only the upper portion of the Iron Age road could be observed from the Cappadocia Gate. "CG" = Cappadocia Gate; "K" = Kale.

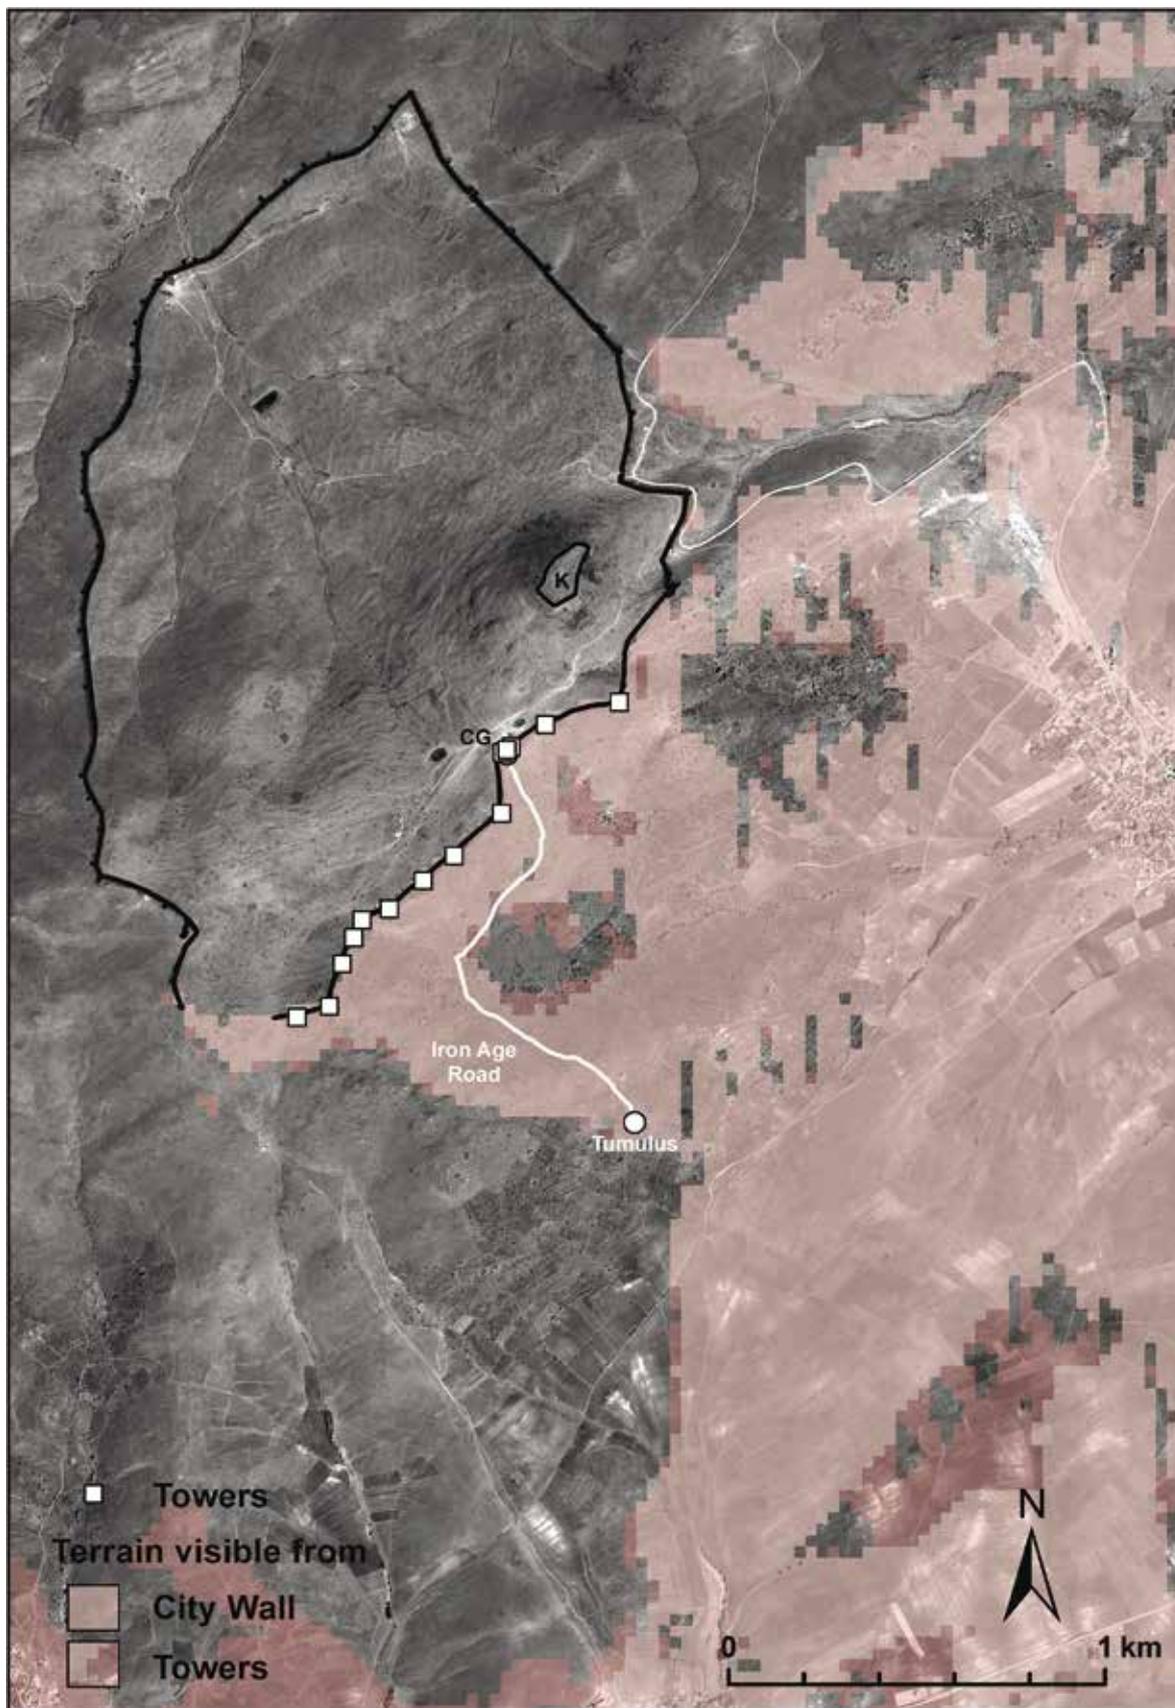
Viewshed showing the terrain visible from the city wall and the towers along the southeastern stretch of the defenses over ca. 2 km. Not surprisingly, the viewshed of the towers is slightly larger than that of the wall top and covers the area visible from the wall top. "CG" = Cappadocia Gate; "K" = Kale.

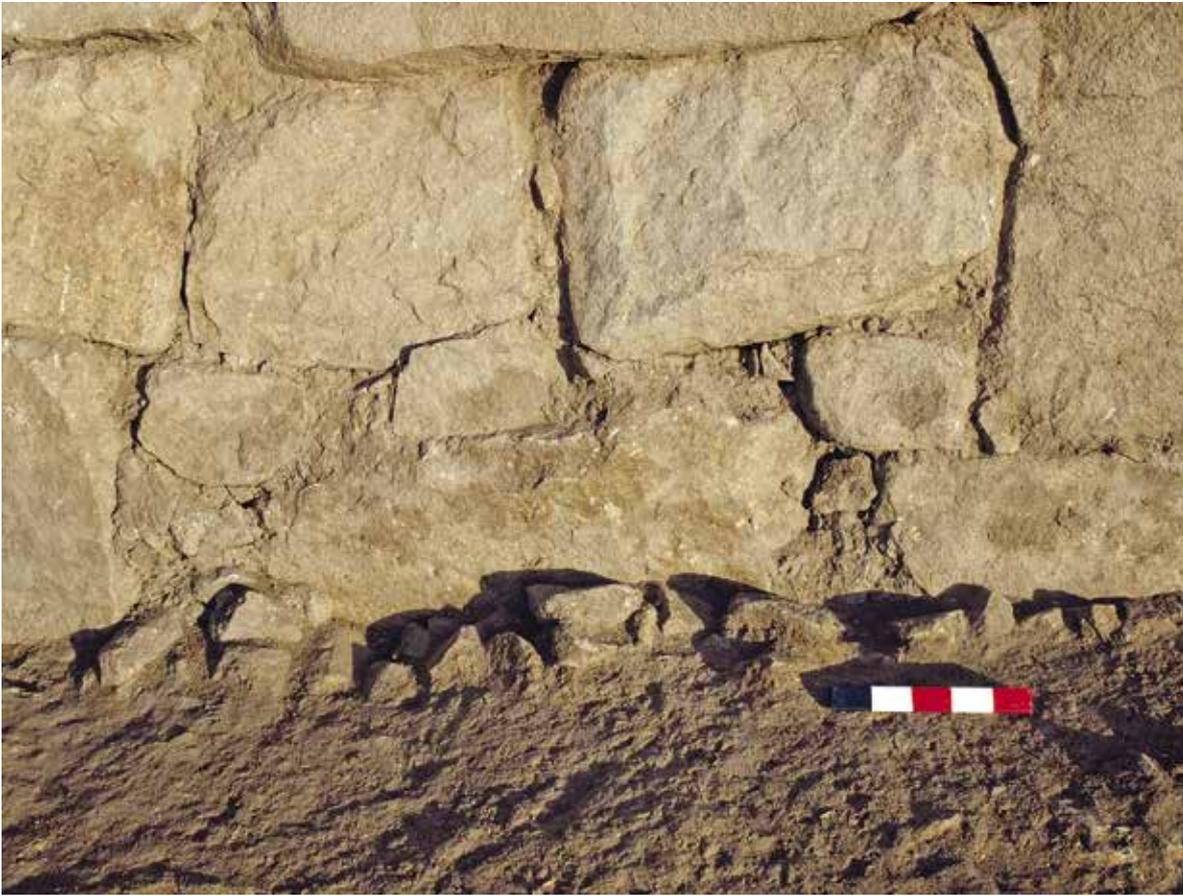
PLATE 18 | BASE OF THE TRENCH AND GLACIS FACE

| (a) Small stones filling the shallow foundation trench in front of the glacis against the stretch of city wall to the northeast of the gate

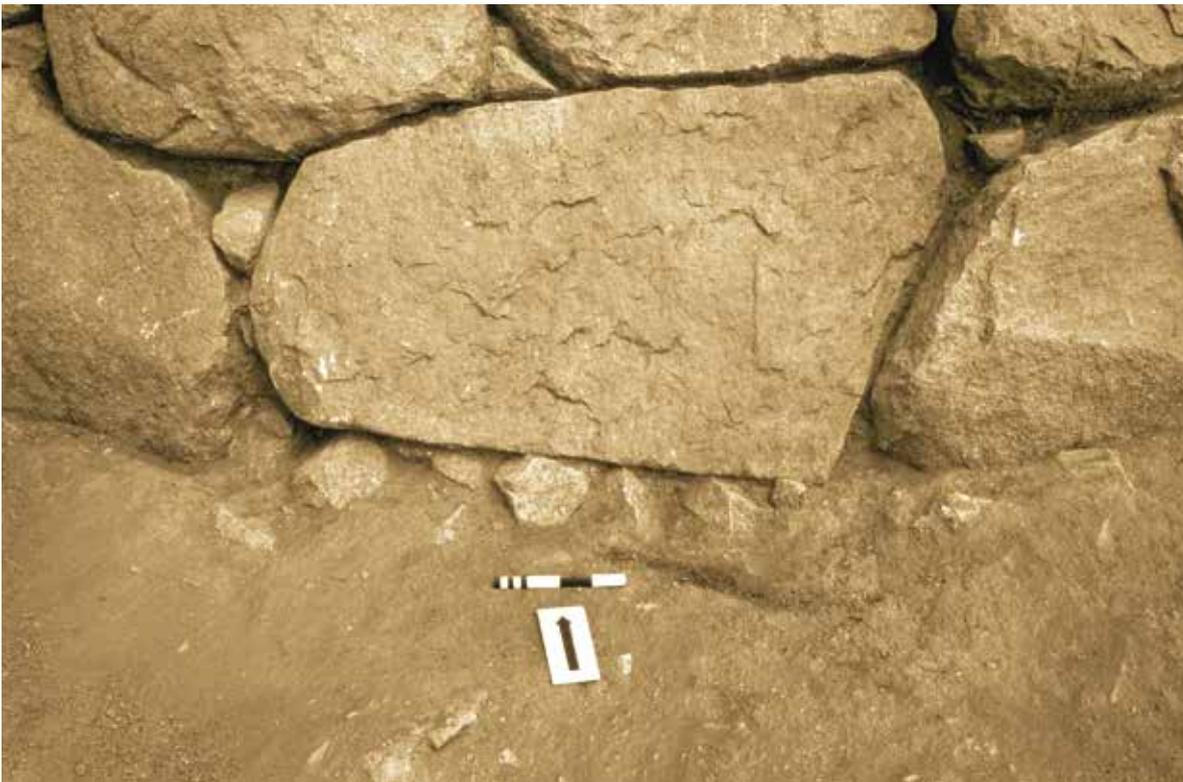
| (b) Small stones propping the glacis face at the required incline in front of the West Tower

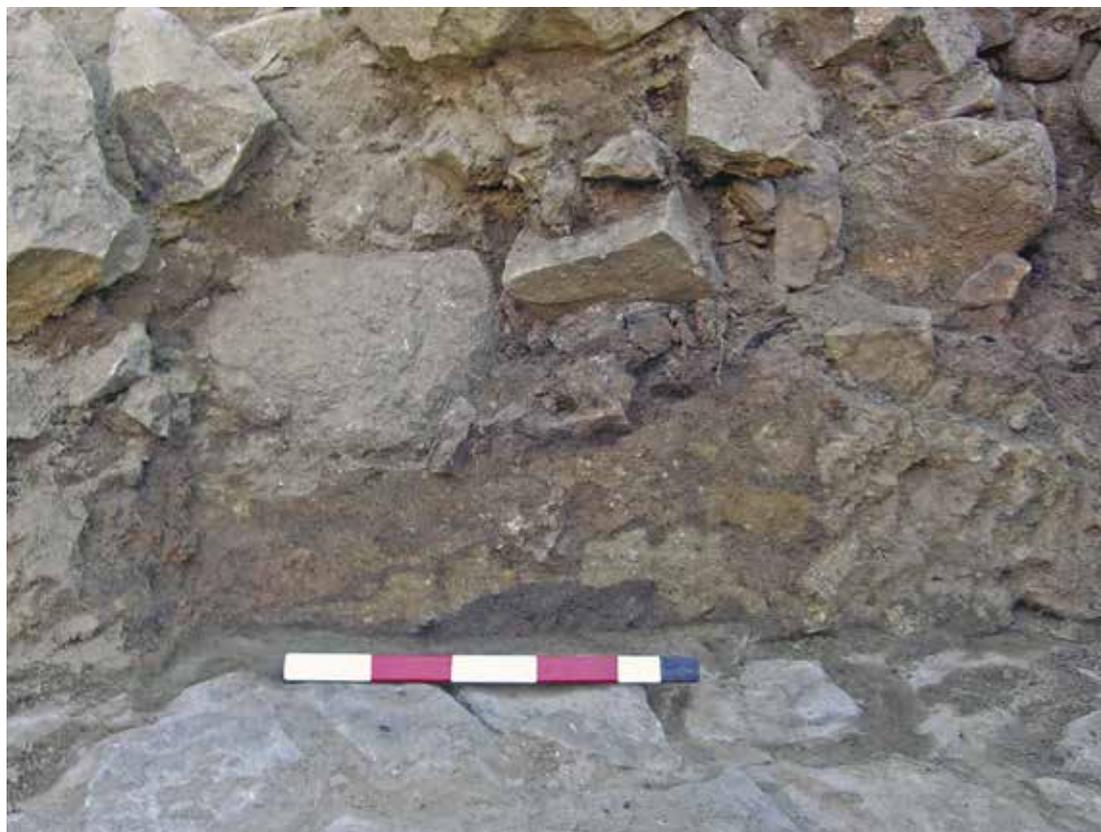
PLATE 24 | EVIDENCE OF THE USE OF MUDBRICK AND MUD PLASTER

(a) A portion of the section through the court behind the Middle Tower. Light-colored silt lies on the pavement, with burning above. A pile of mudbrick-like debris fell immediately before the stone walling.

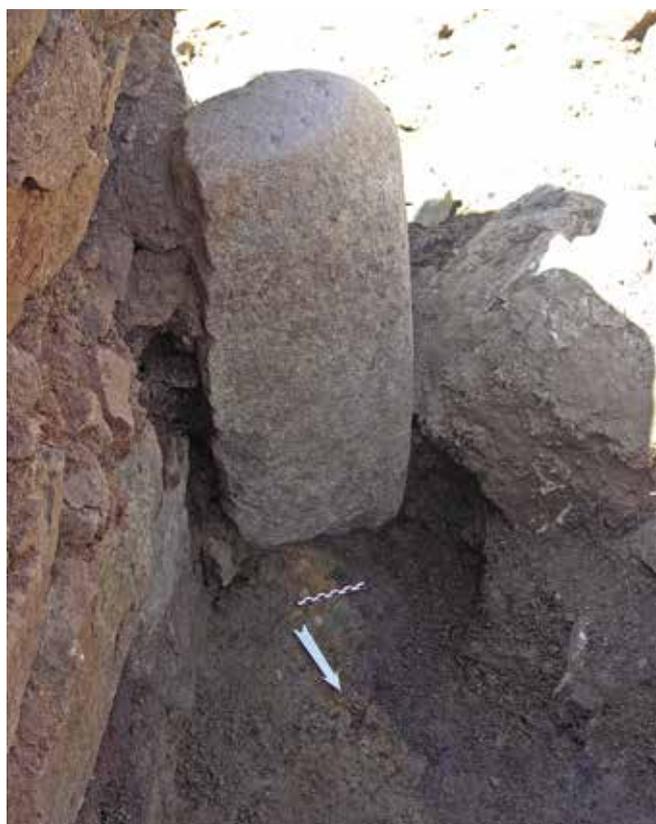
(b) The aniconic stela with the burned surface of the silt and a fallen sandstone block against the inner face

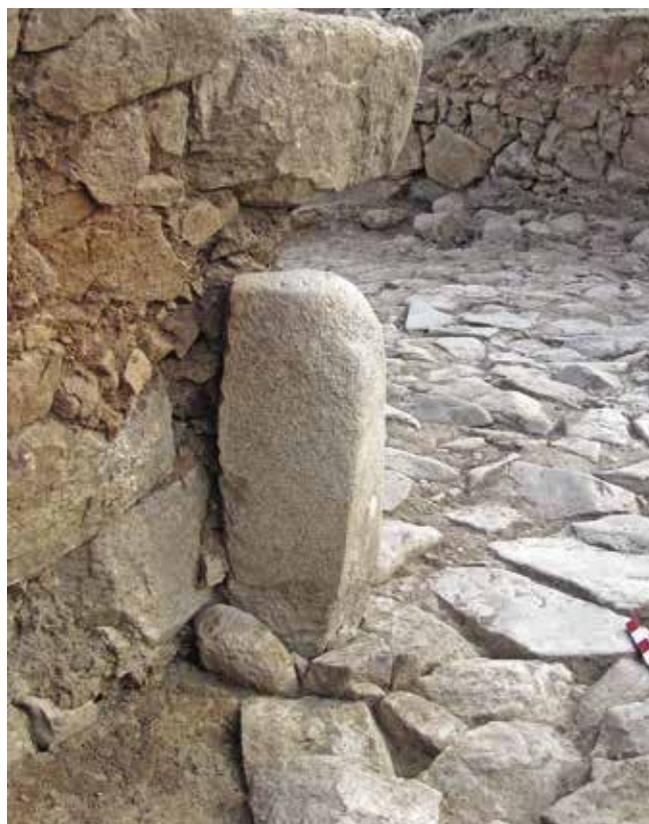
(c) The aniconic stela with silt removed to reveal the packing stones

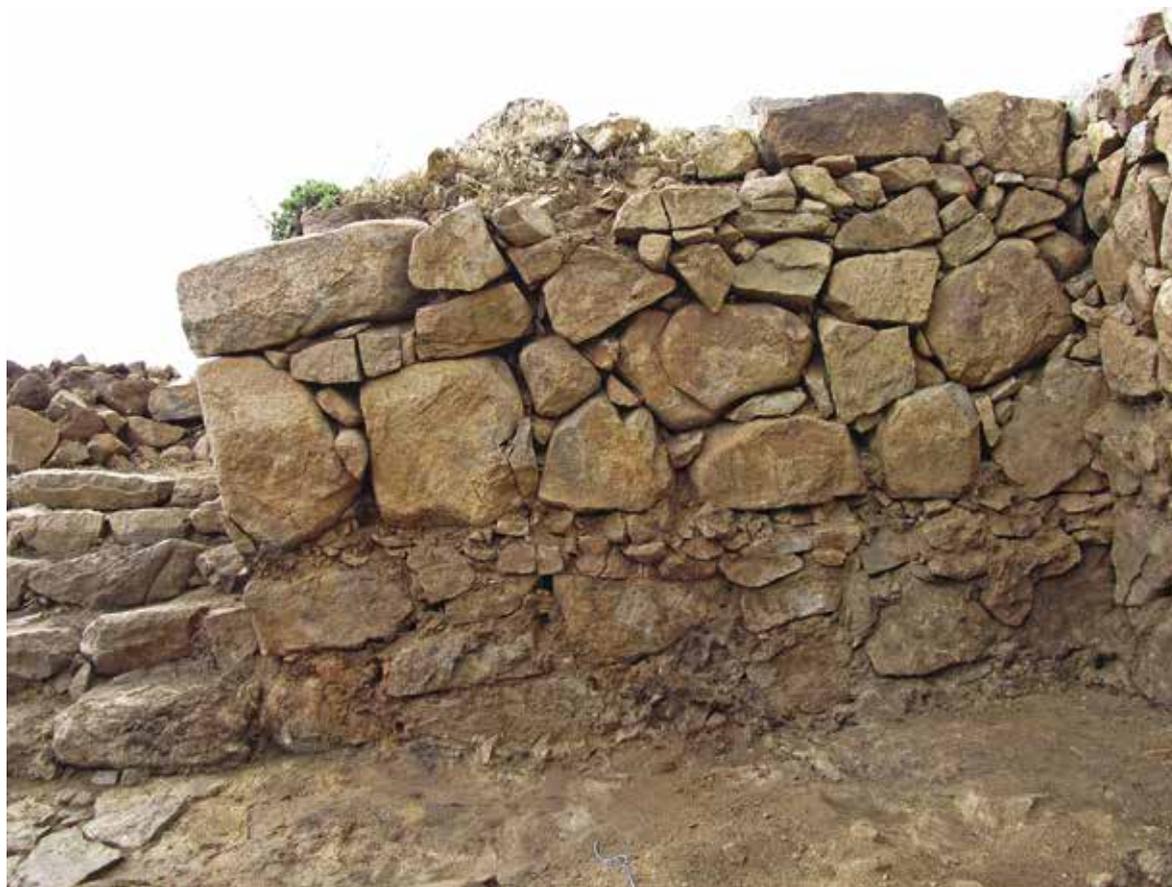
PLATE 28 | DISPLACEMENT OF FACE STONES IN THE NORTH TOWER

(a) The southeastern face of the North Tower, showing the extent to which the corner was leaning. The stones at upper right are not in their original positions.

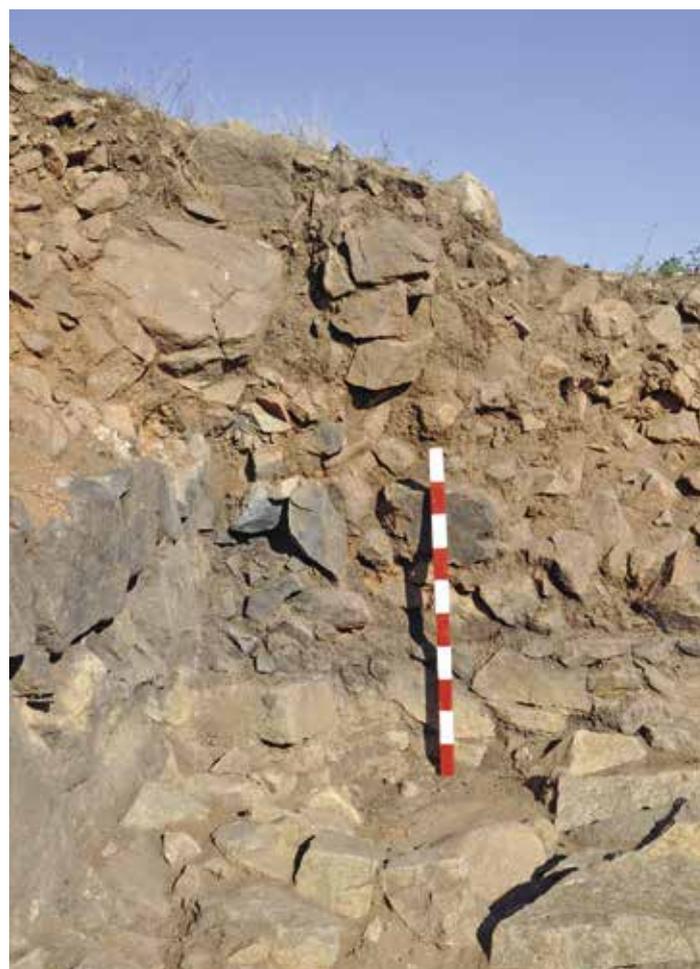
(b) The western corner of Room 2 with the West Tower wall at left, the face of the rear façade behind the scale, and the stone leveling and drain below the floor exposed. The large rectangular stone in the corner supported a vertical timber in the façade. When the façade frame and the horizontal beams in the tower face burned away, the uppermost two stones in the tower slid into the void, while the façade wall face slipped forward.

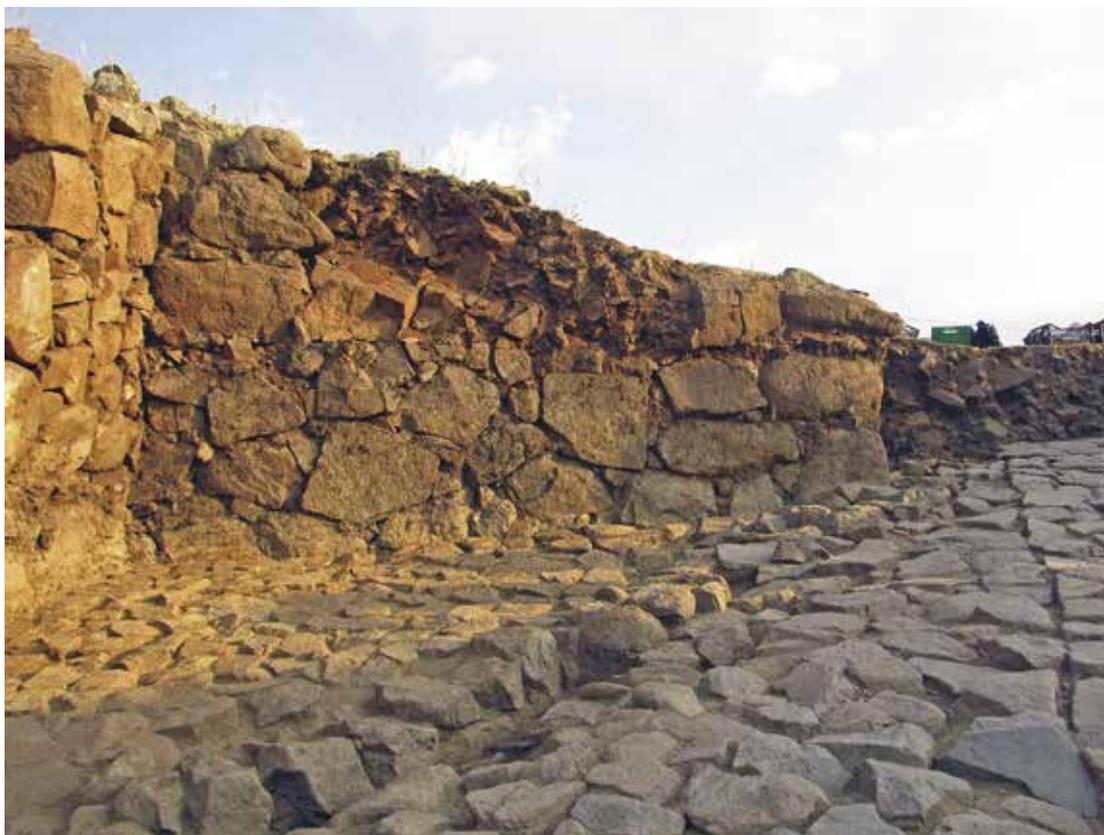
PLATE 30 | THE WEST TOWER AND PASSAGE WALL

| (a) The southeastern face of the West Tower with the passage wall. Displaced stones were removed before the walling could be revealed.

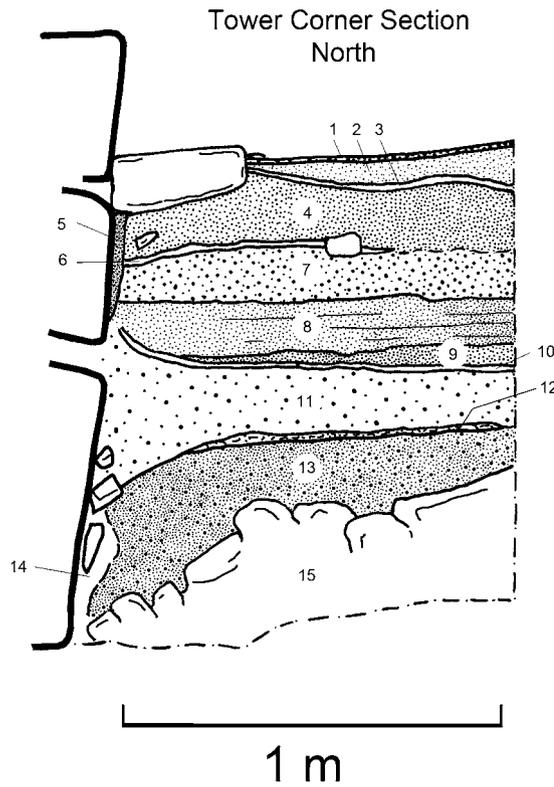
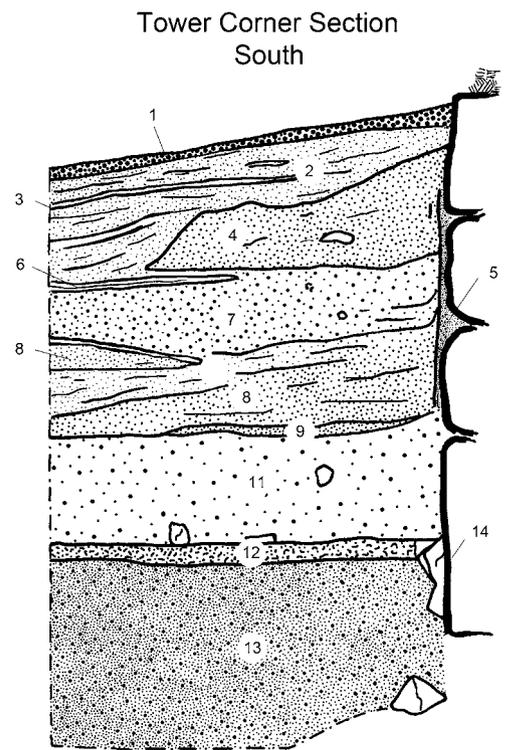
Strata below the burned surface in the sondage against the northeastern face of the Middle Tower. (See pl. 17 for a photograph and pl. 61 for location.)

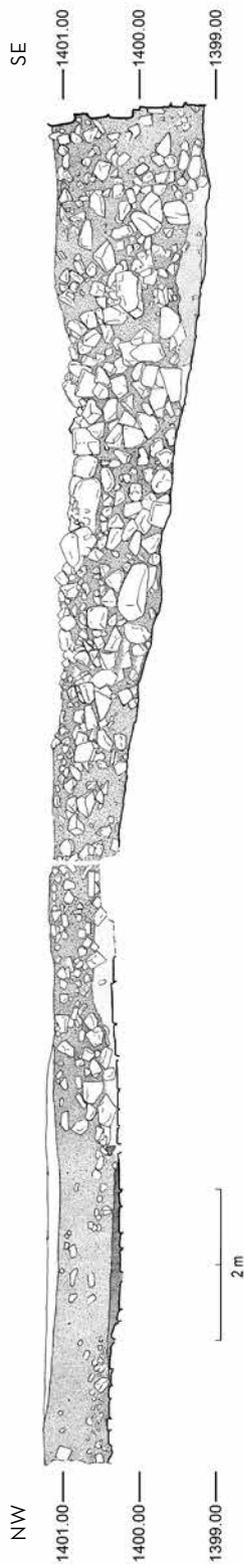
Section 4a
Through the center of the rear part of the gate and court at 1:100. (See pl. 61 for location.)

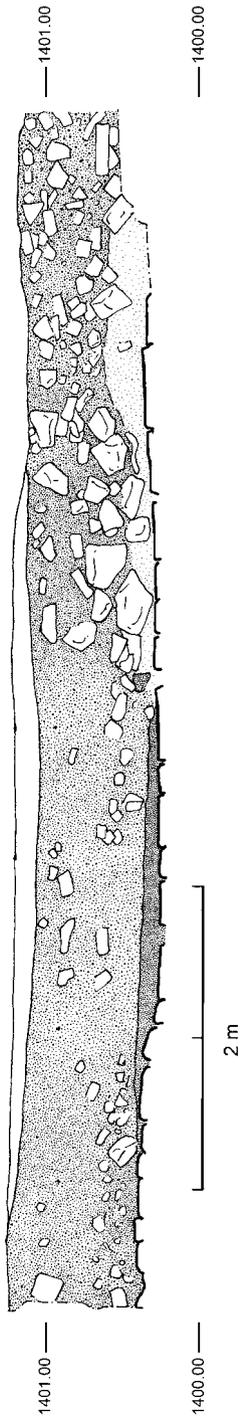
Section 4b
Northwestern portion of section 4a (above), through the center of the rear of the gate. Burned debris from the rear façade and debris from the front façade lie directly on the pavement, beneath postdestruction accumulation. (See pl. 61 for location.)

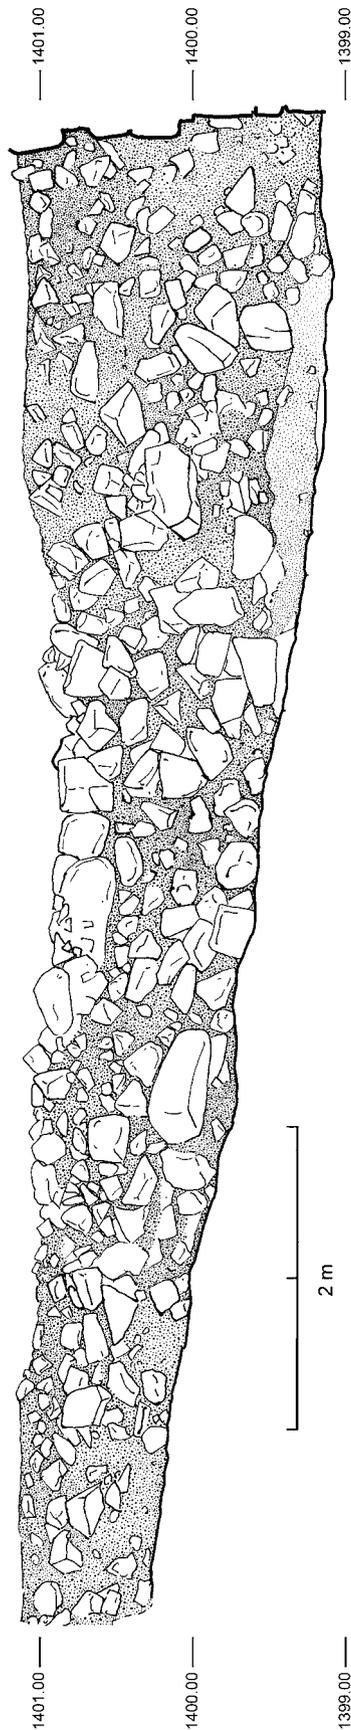
Section 4c
Southeastern portion of section 4a (above), through the court. Toward the south end the putative mudbrick collapse above silt on the pavement is shown. The section was only cut through the lower part of the very loose stone collapse. (See pl. 61 for location.)

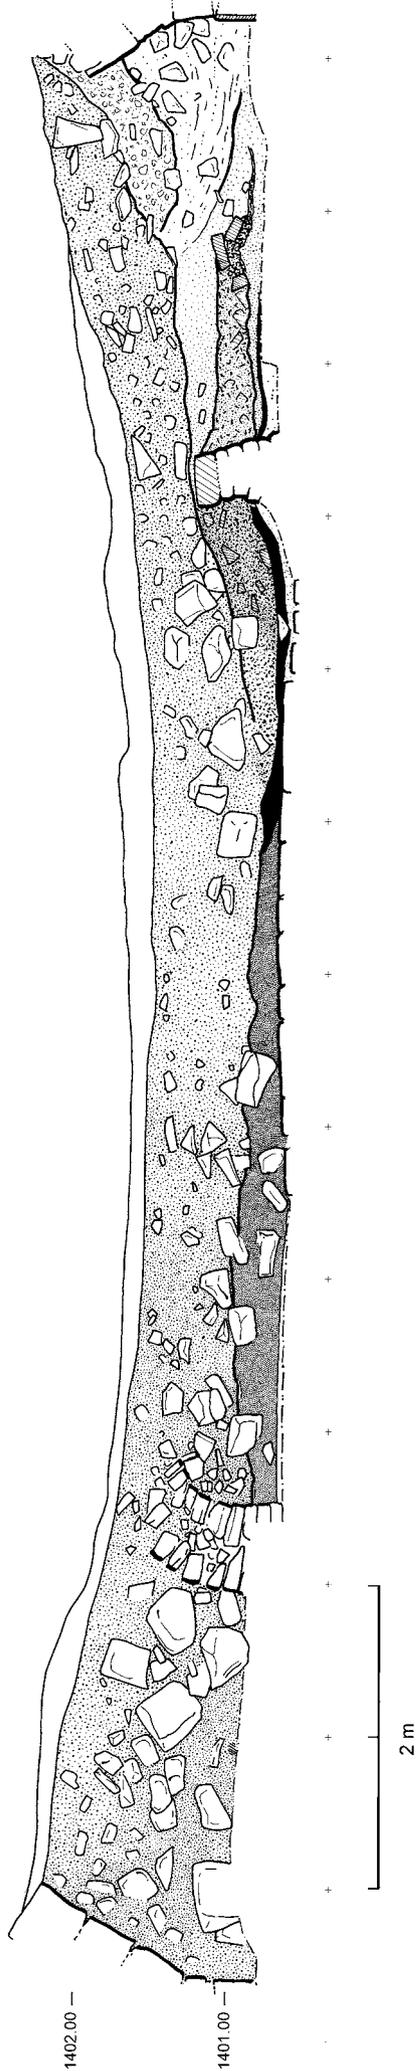
Section 5
Across the rear section. In Room 2, at left the floor was not drawn because the precarious face of the West Tower collapsed before it could be reached. At right the burned mudbrick collapse from the wall of Room 3 is shown above the burned surface. There was a thick accumulation of burned debris above the central passage. (See pl. 61 for location.)

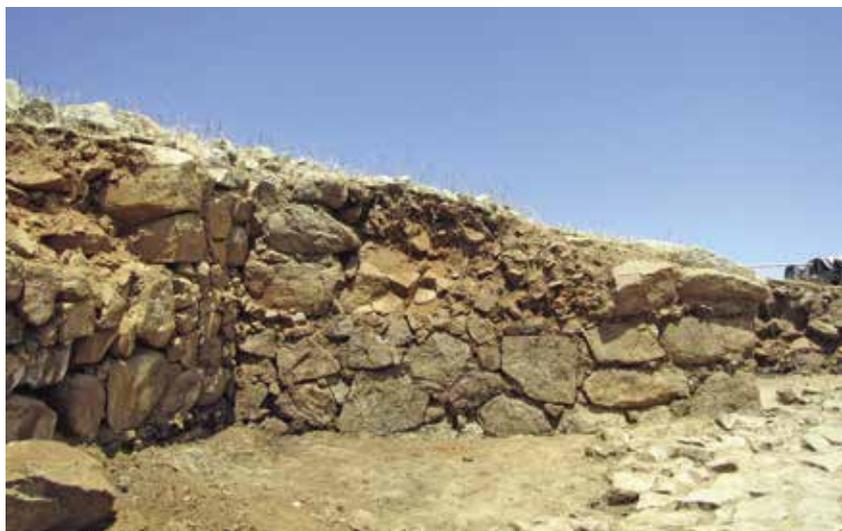
(b) Once fully recorded, the upper courses of stones from the northeastern wall of the Middle Tower were moved back before the remaining fill was removed.

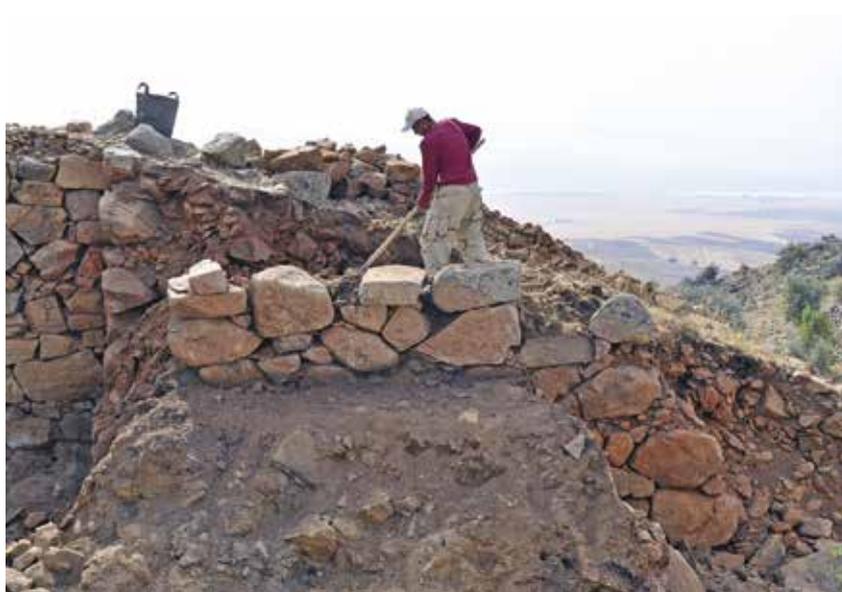
(c) Restoration of the glacis was essential if the very loose fill of rubble and soil was to be stopped from washing down.

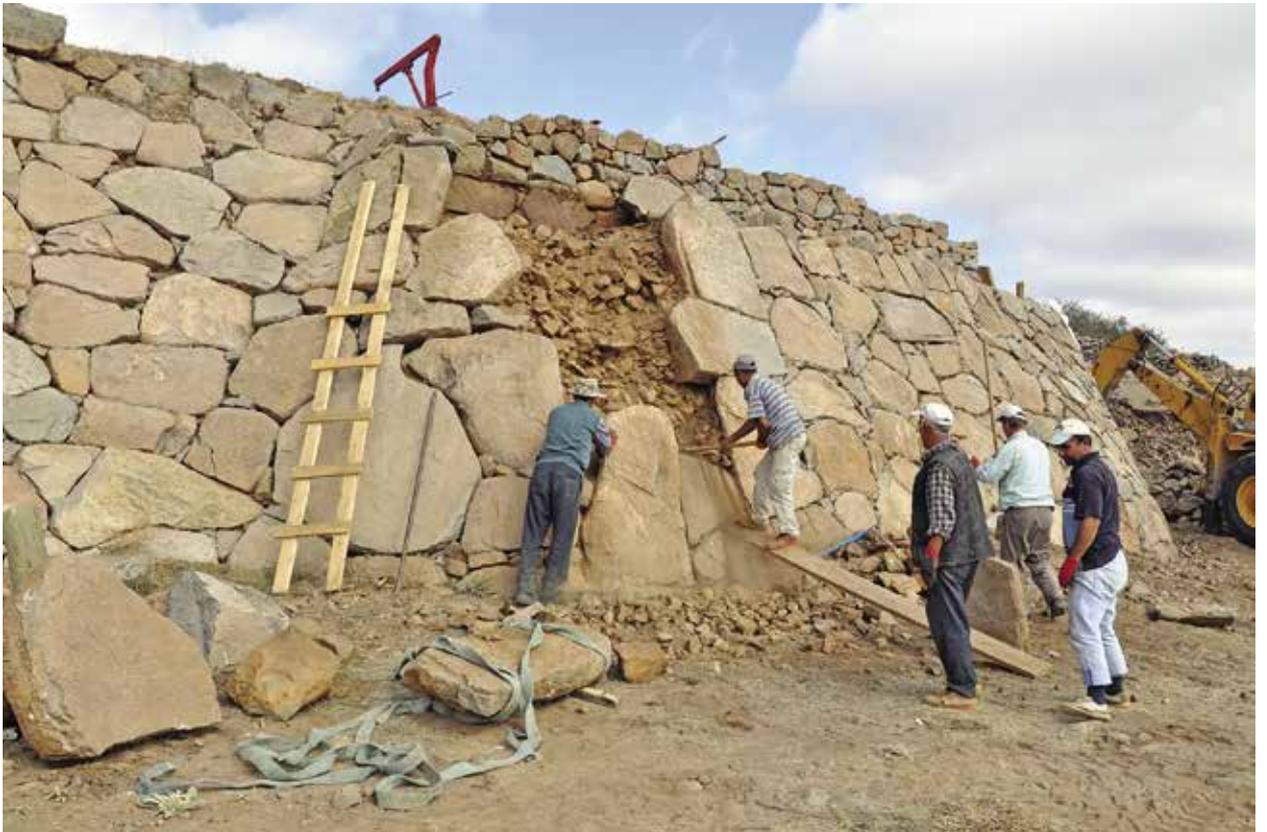
(a) The southeastern corner of the East Tower was rebuilt with comparatively smaller stones that can be distinguished from original work.

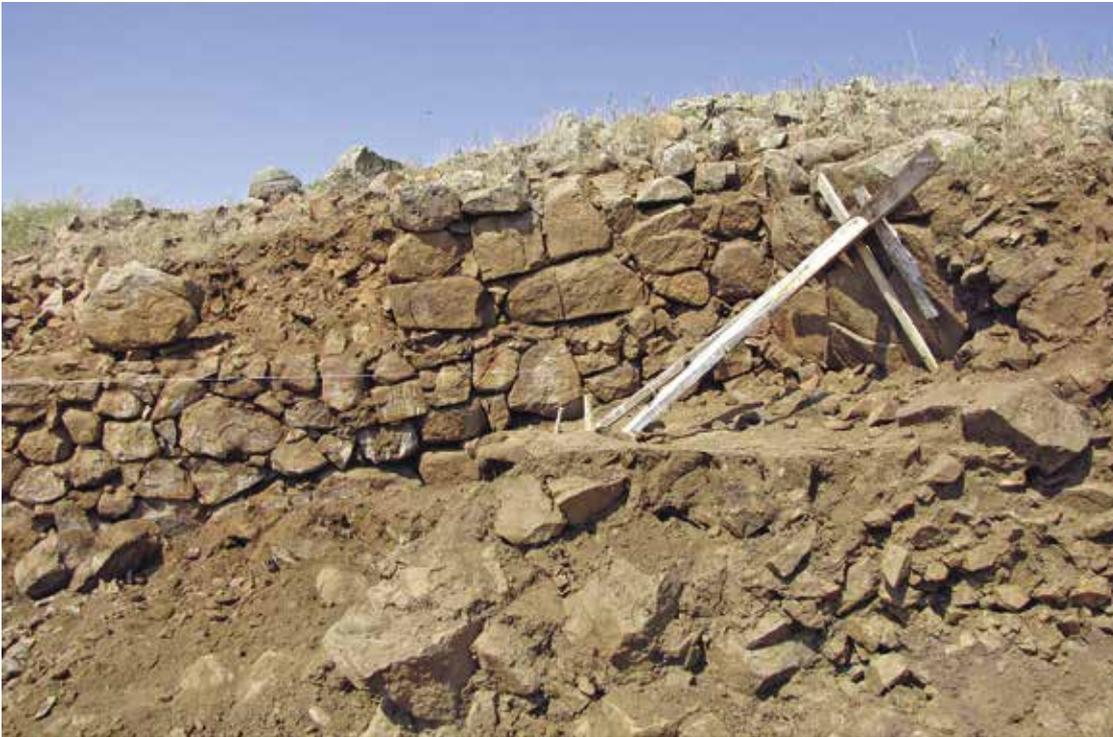
PLATE 98 | ARCHITECTURAL RESTORATION

(a) The loss of horizontal timber beams due to fire or deterioration has led to the dislocation of the face stones and created wall surfaces that incline outward.

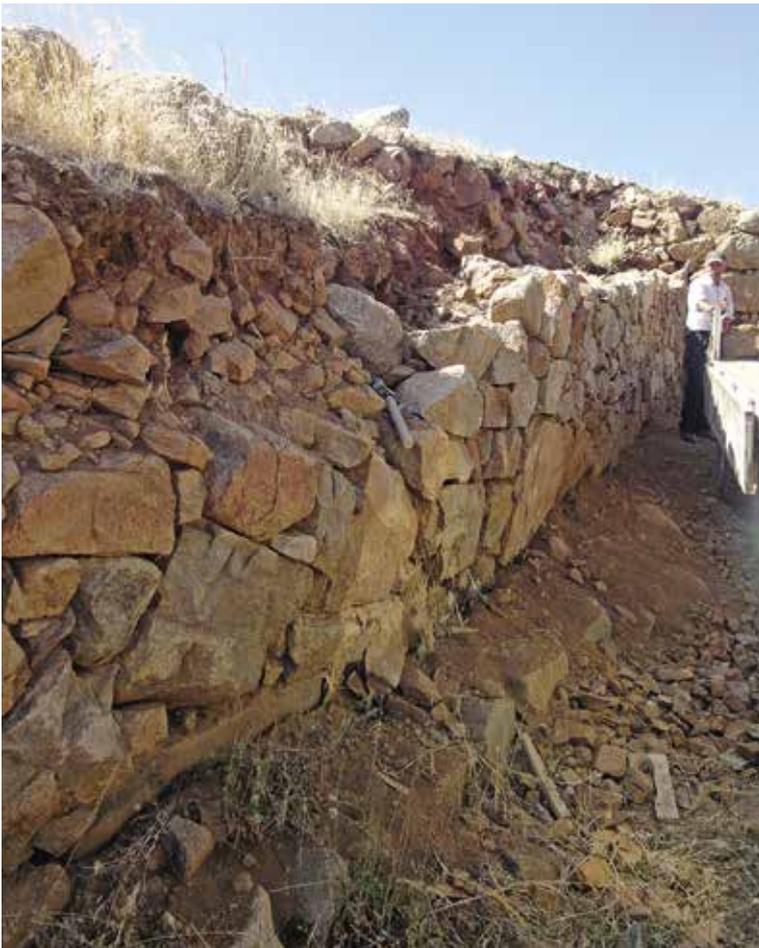
(b) The western side of the front passage adjoining the southern face of the West Tower was rebuilt to function as a temporary retaining wall against the infill that was likely to have washed down on to the gate court pavement otherwise.

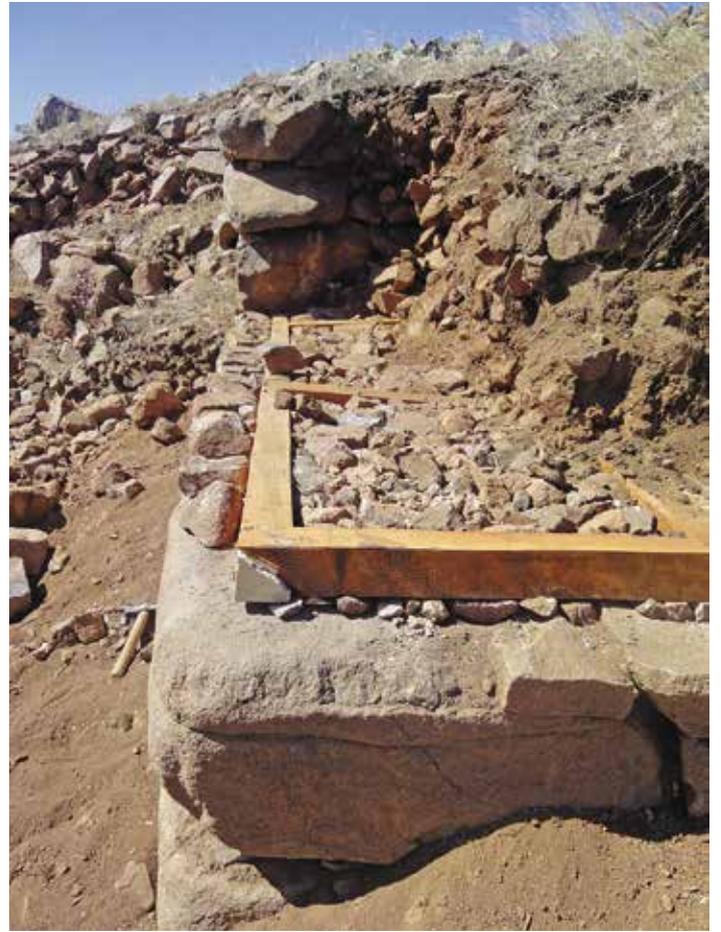
(a) The horizontal timber beams were located ca. 5–10 cm inside the wall faces, as they were in the original masonry, so that they would not be visible from the surface and prone to rapid deterioration.

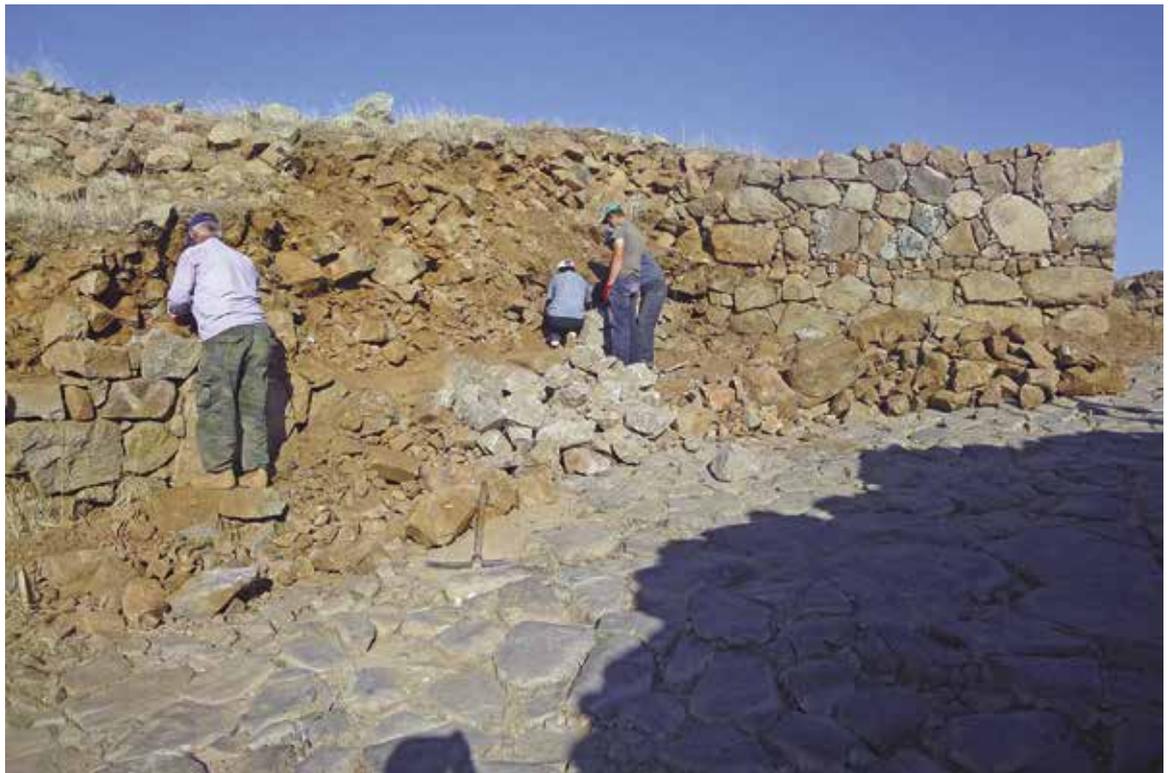
(b) The southern face of the West Tower completed and the western wall of the front gate passage being cleared of fallen debris before the building of a temporary retaining wall

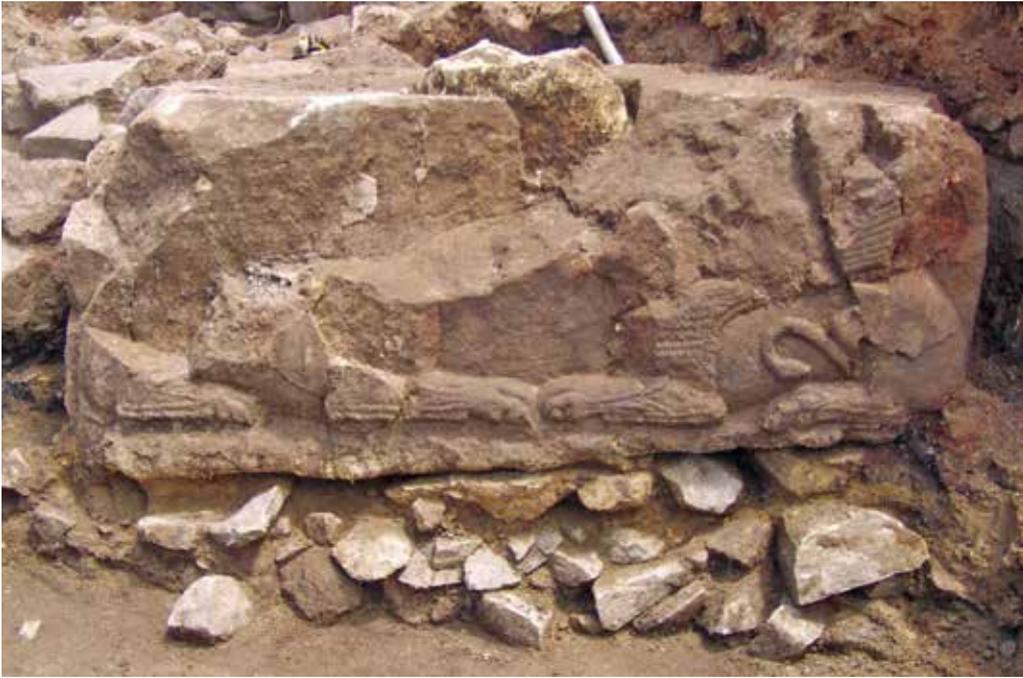
(a) Sphinx block K11.249 on the granite rubble makeup with pieces of sandstone, probably waste from trimming the back corners, used to level the base before it was carved.

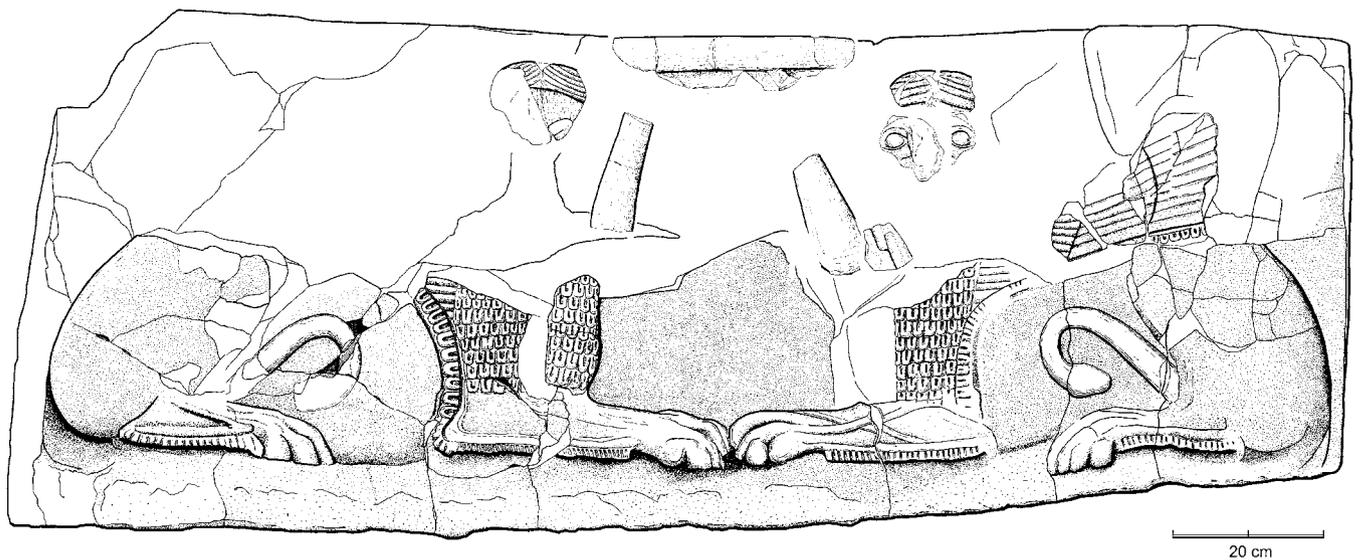
(b) Reconstruction of the sphinx block K11.249

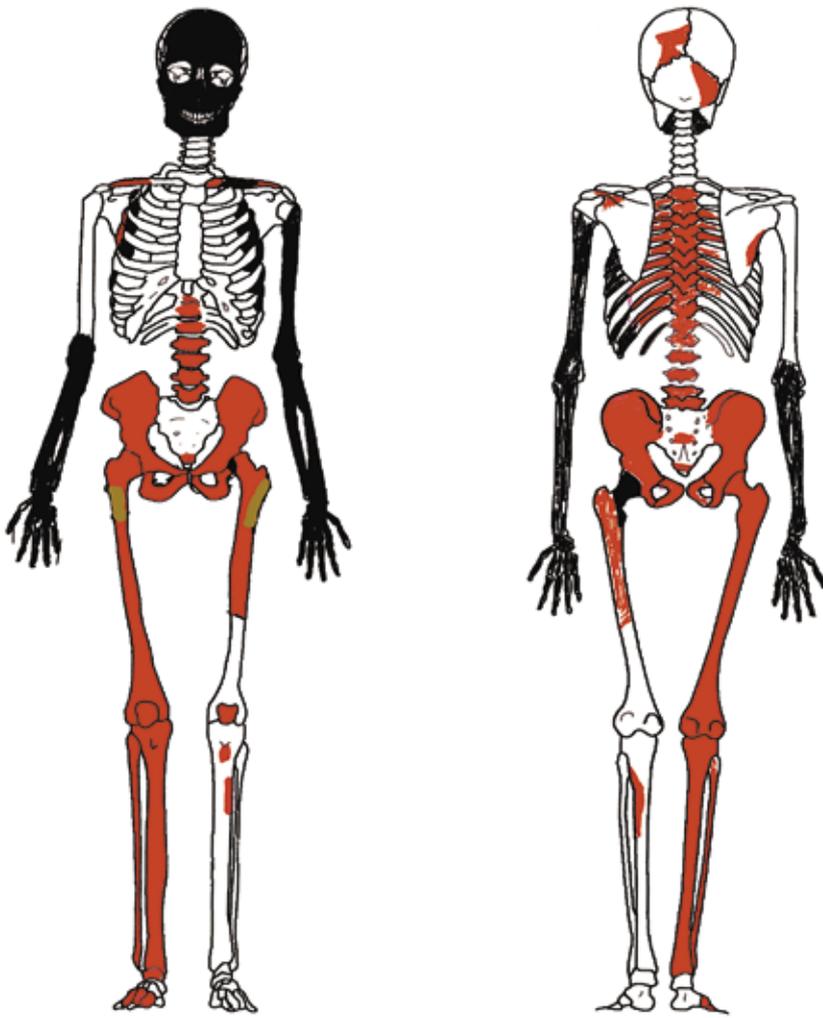
(b) Diagram of burned and unburned parts of skeleton SK2. Red = burned; black = unburned; white = absent.
