KERKENES FINAL REPORTS 2

# Excavations *at the* Palatial Complex

# EXCAVATIONS AT THE PALATIAL COMPLEX

ORIENTAL INSTITUTE PUBLICATIONS • VOLUME 148  
THE ORIENTAL INSTITUTE OF THE UNIVERSITY OF CHICAGO  
CHICAGO • ILLINOIS

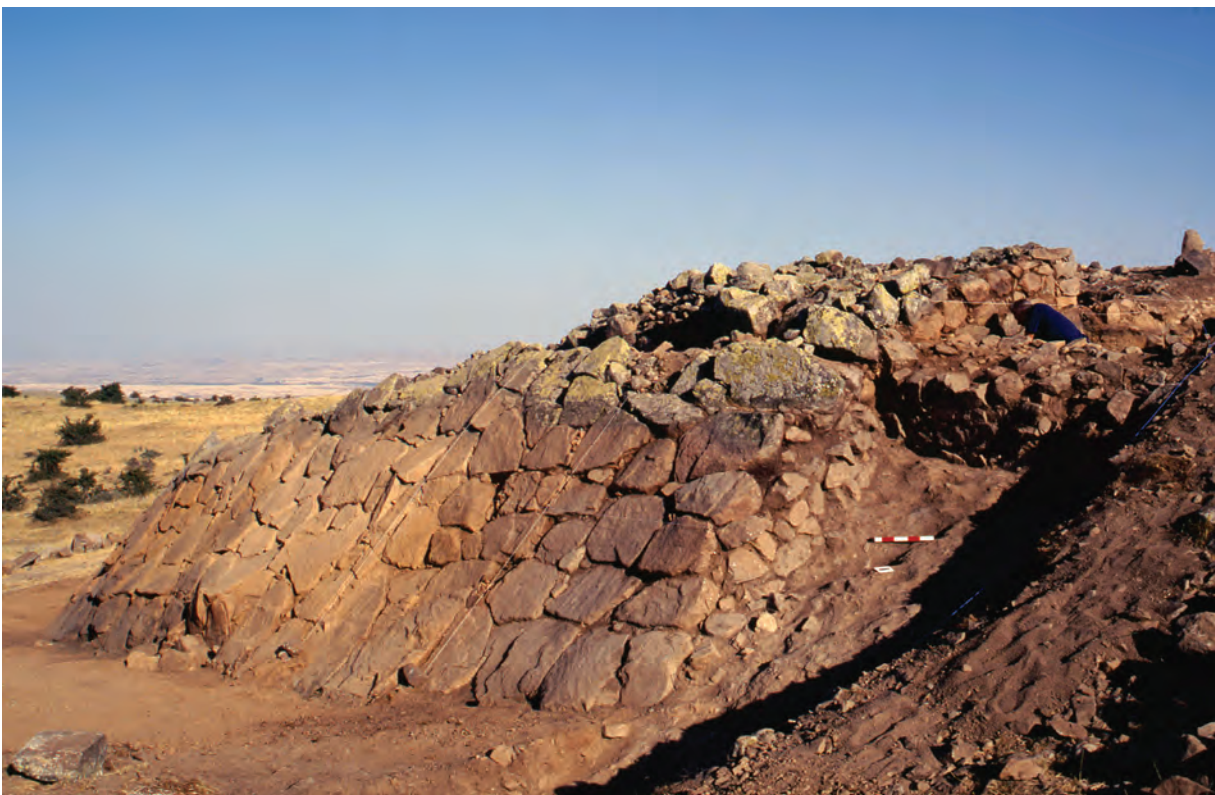
| (a) Structure A glacis around northeastern corner of North Tower

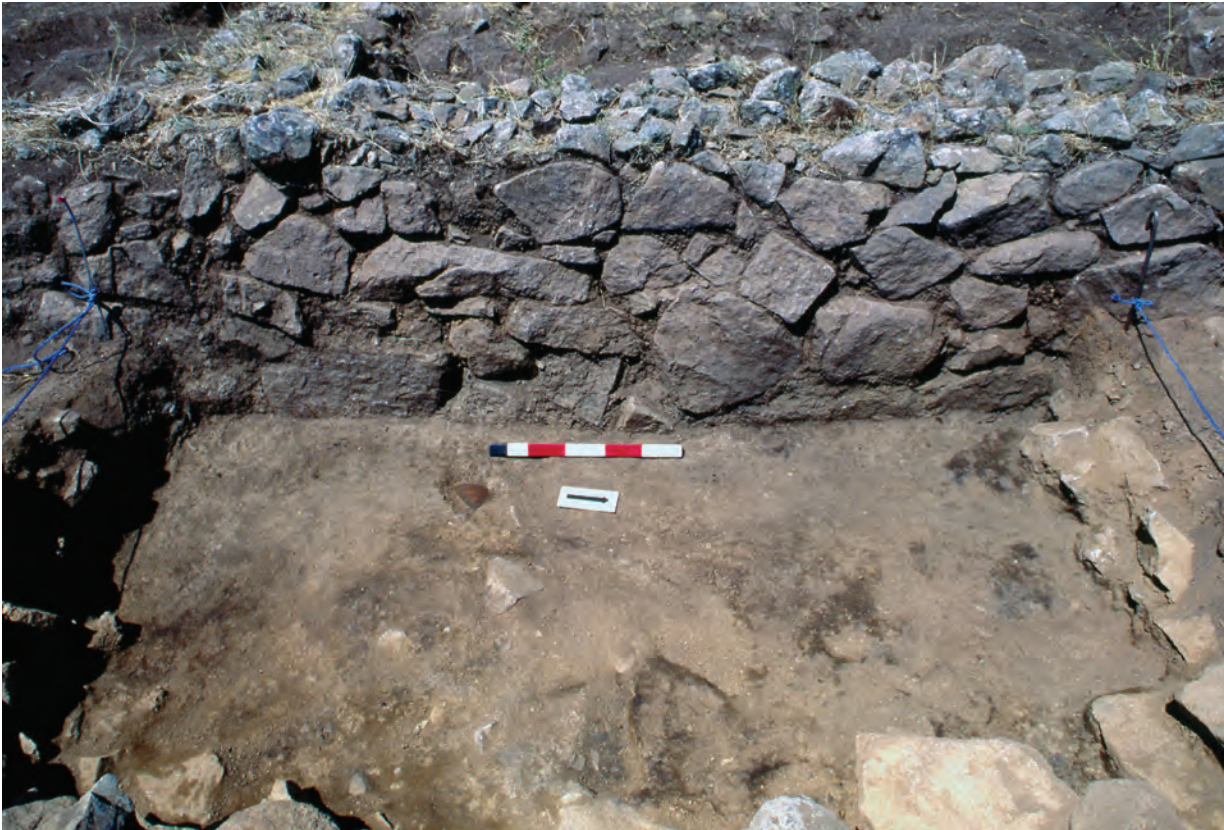
| (b) Elevation at southern end of CT16 between Structure C (Wall 3) and Structure A. A laid-clay surface at the base of the sounding ran beneath the wall of Structure C.

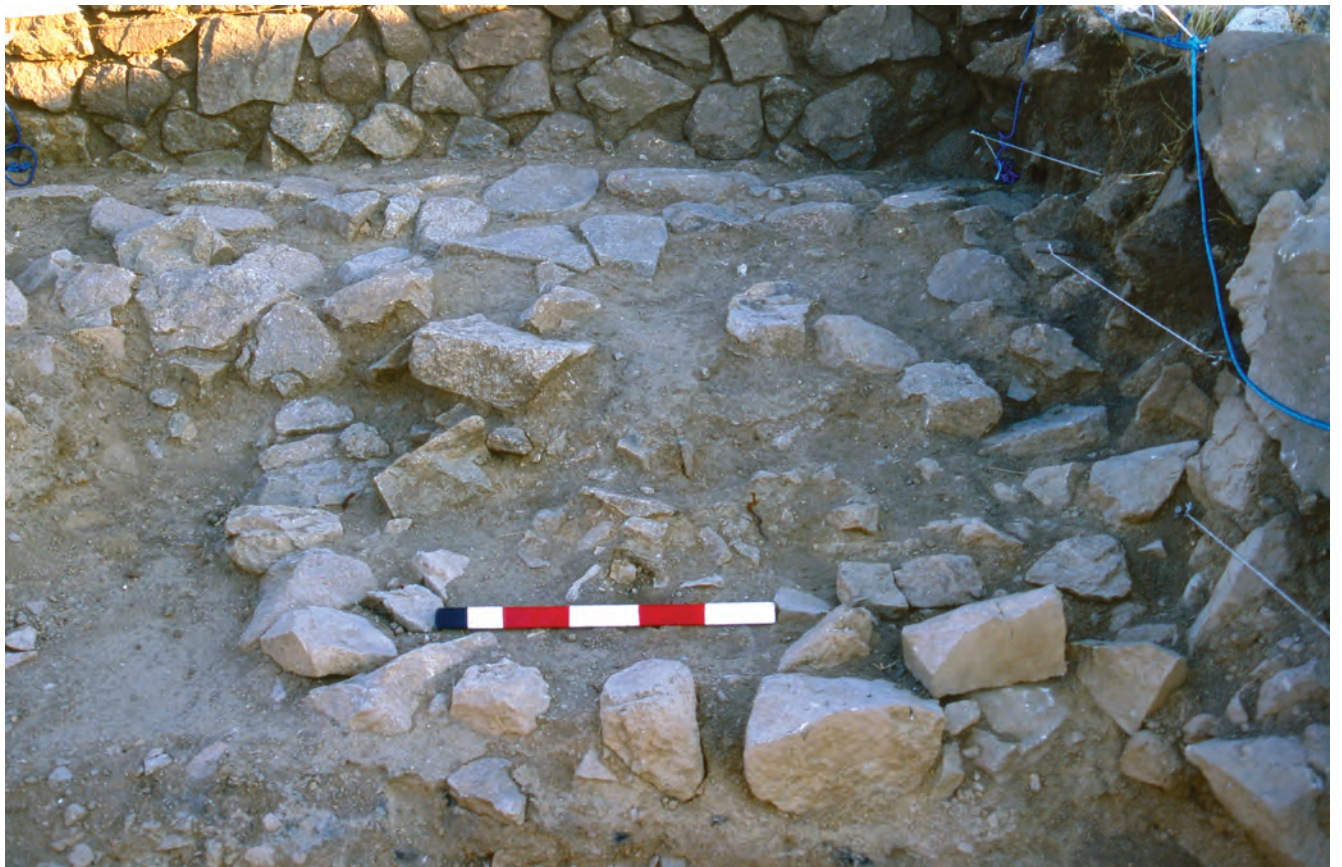
(a) Plan of paving, burned surface, and curved stone feature in CT13 |

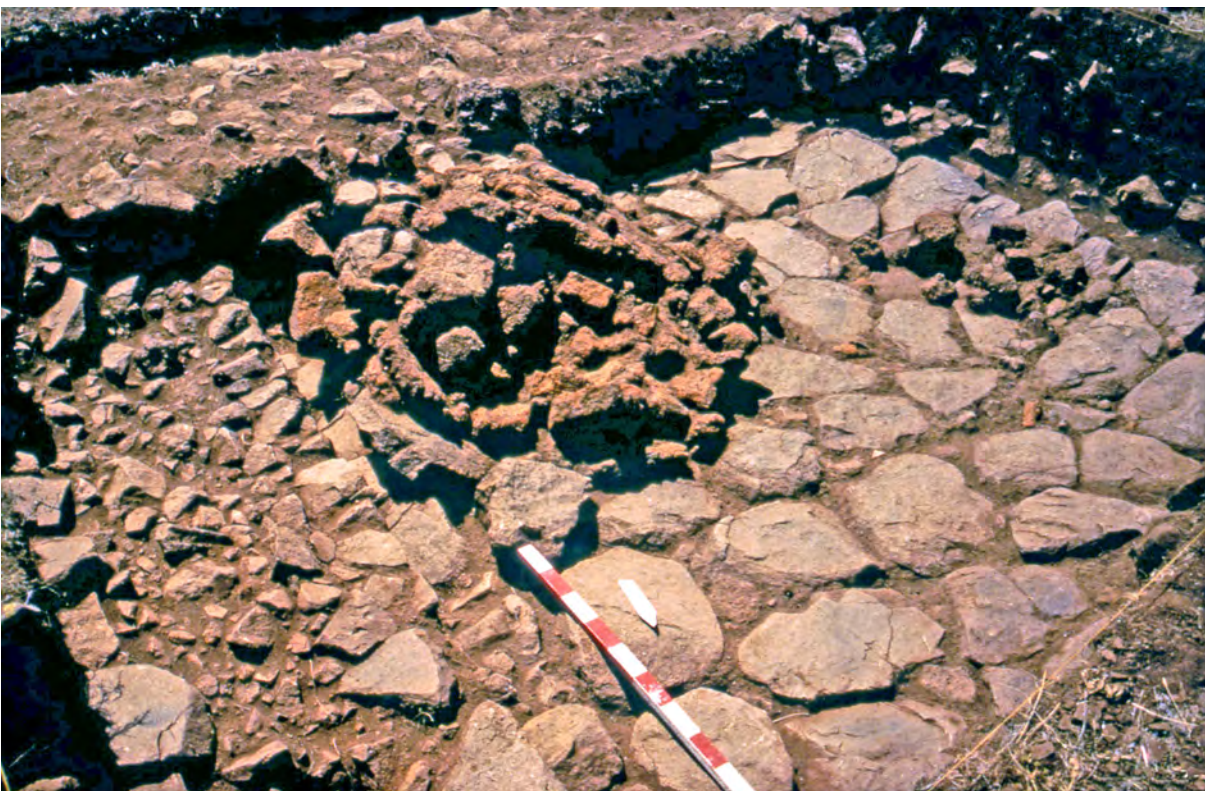
| (a) Structure E stone pavement, with inclined sides and drain along far side, looking southeast

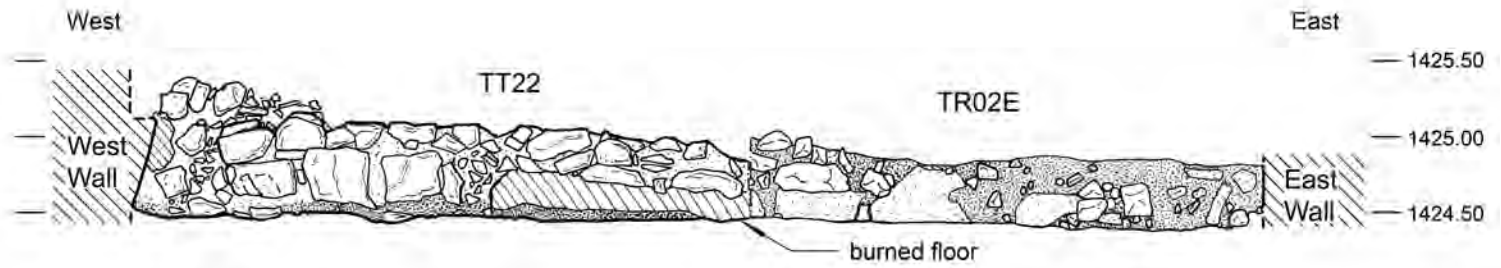
Elevation A

(a) TT22, eastern face of western wall of the anteroom, drawn down to level of burned floor, with top of the broader footings (at left)

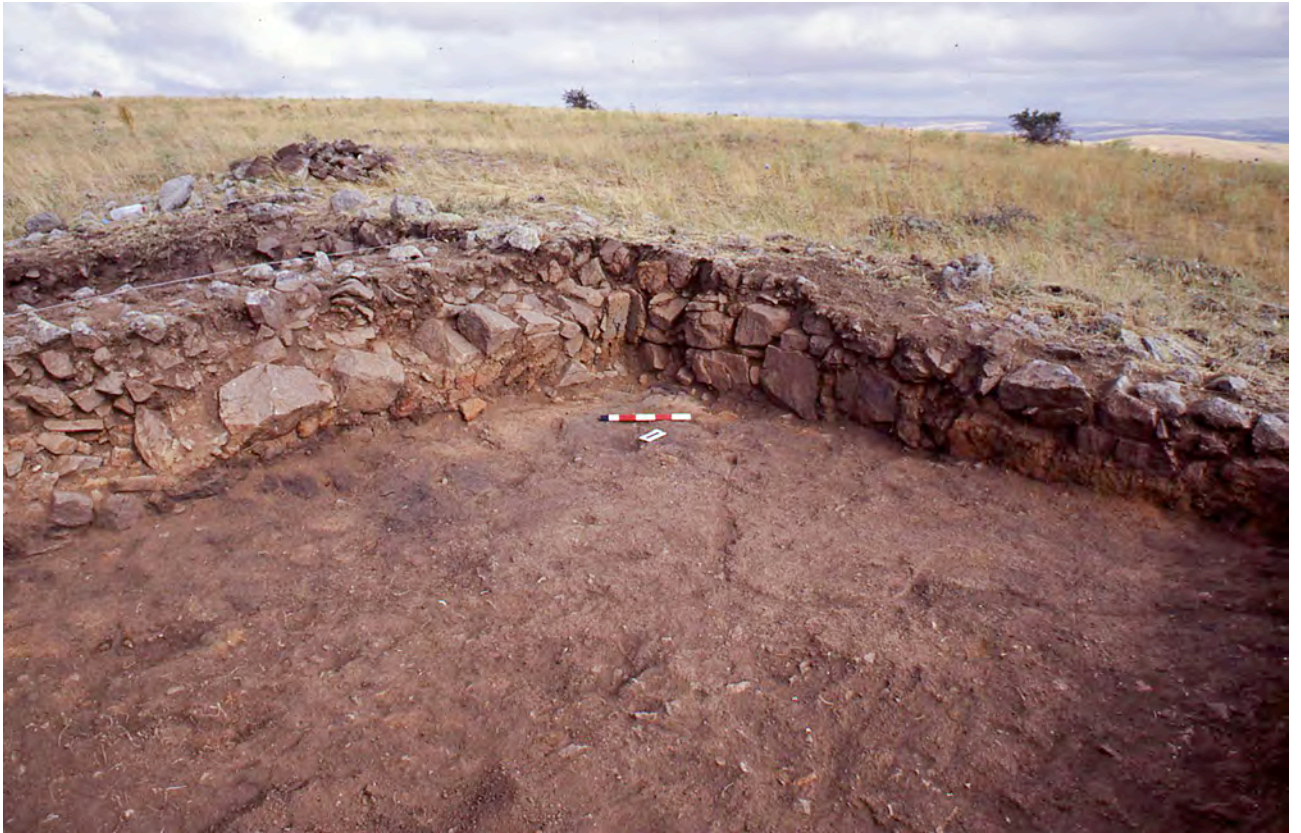
(c) Southern section of TR02 showing uniform stony layer above burned clay floor of the hall

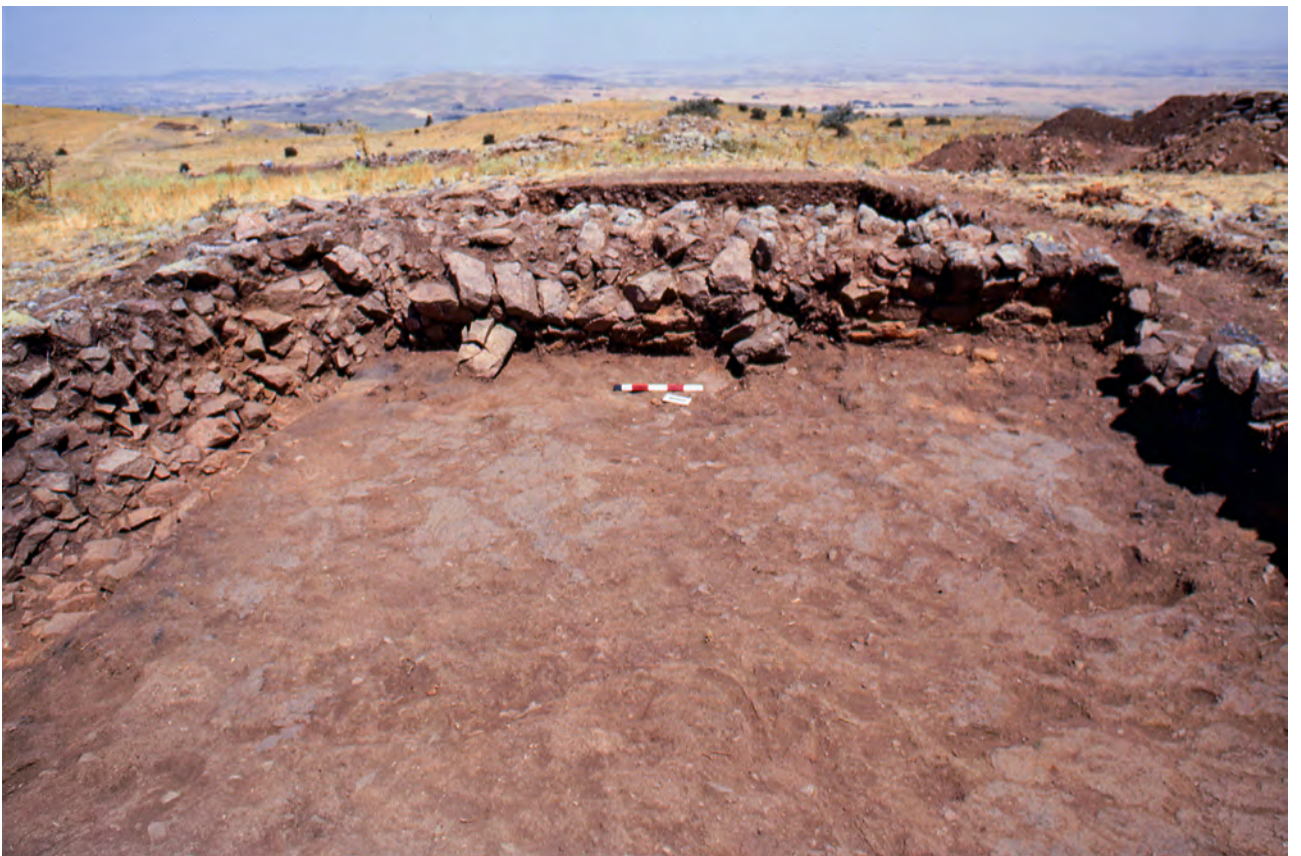
(a) Northeastern corner of the Audience Hall in TT22 showing poor condition of the walling |

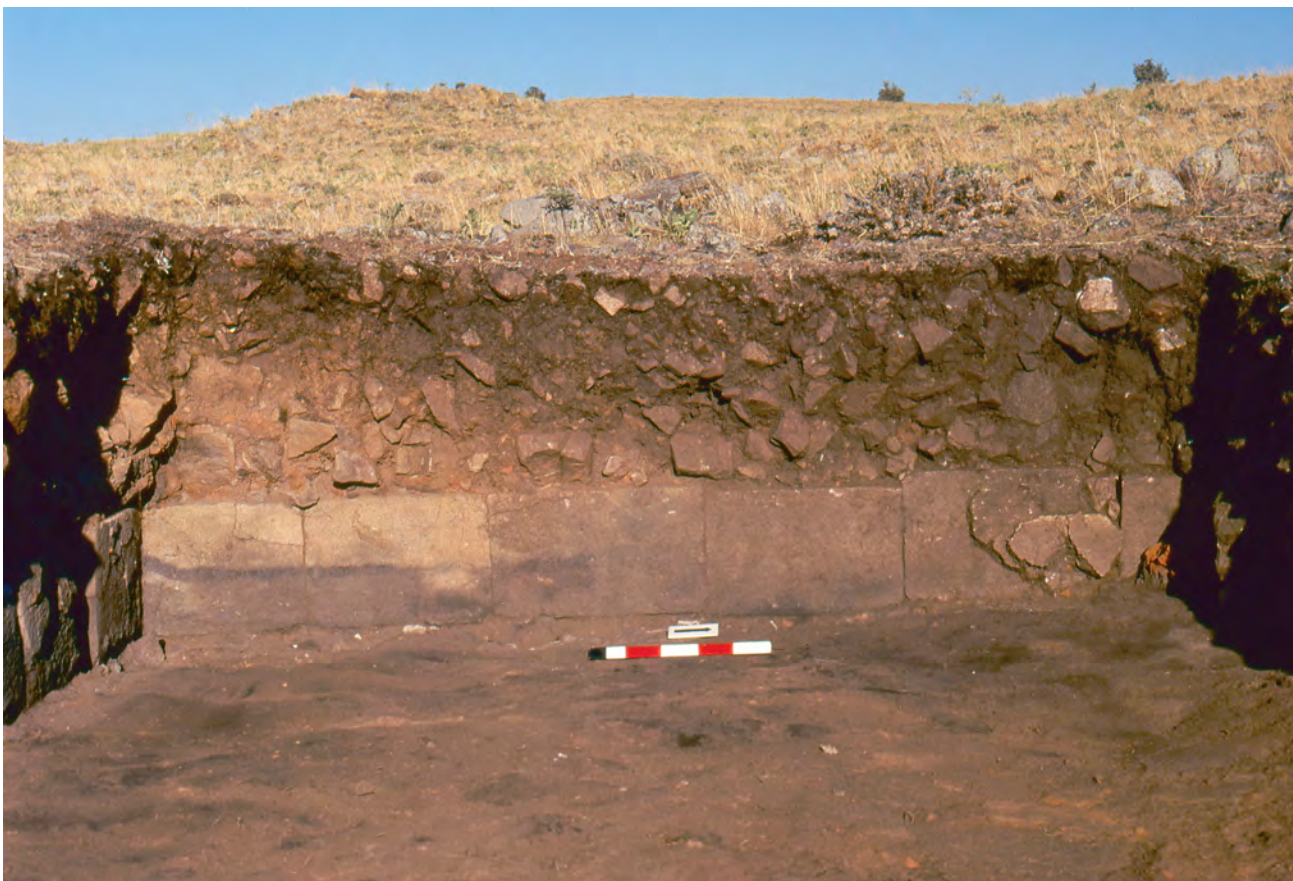
| (a) Extension of TR05 over southern wall of the Ashlar Building in Room 1, with western end of sandstone surround. The tops of the ashlars were trimmed to accommodate horizontal beams.

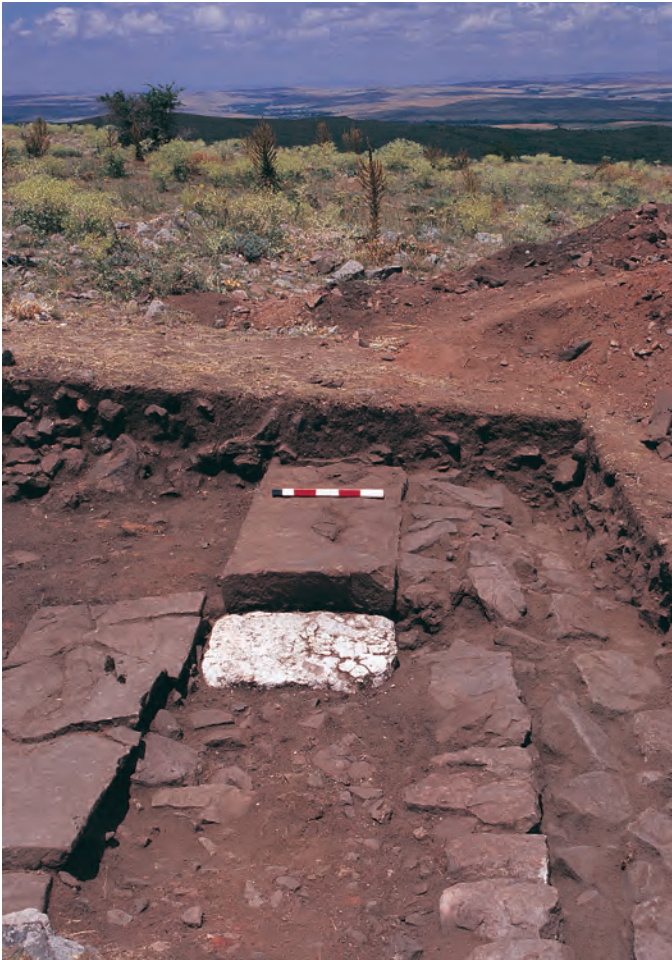
| (a) The limestone block in the foundations of the front wall was trimmed to fit, beneath the sandstone threshold stone

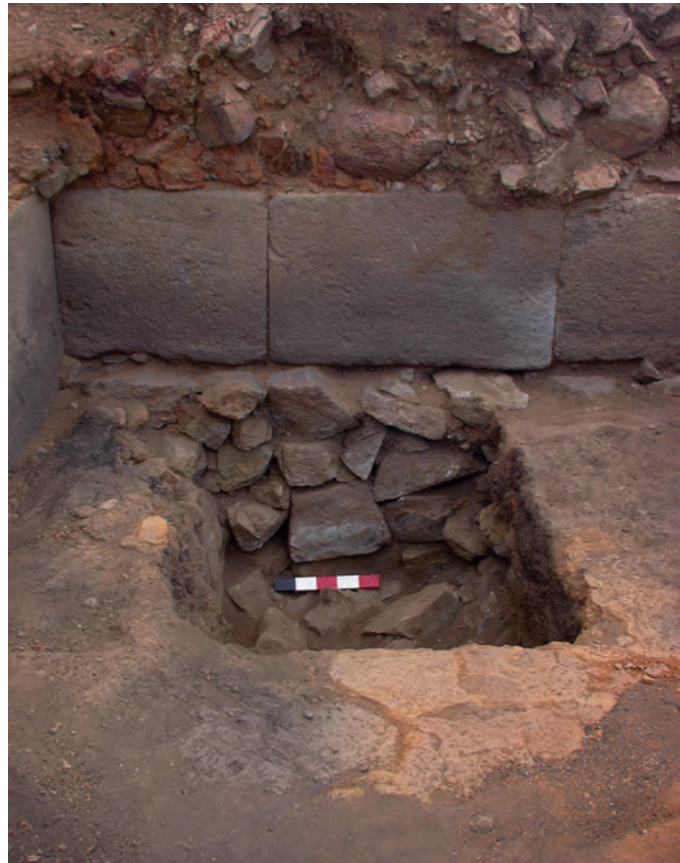
| (b) The sondage in Room 2 of the Ashlar Building revealed the stone footing on which the ashlar blocks were laid

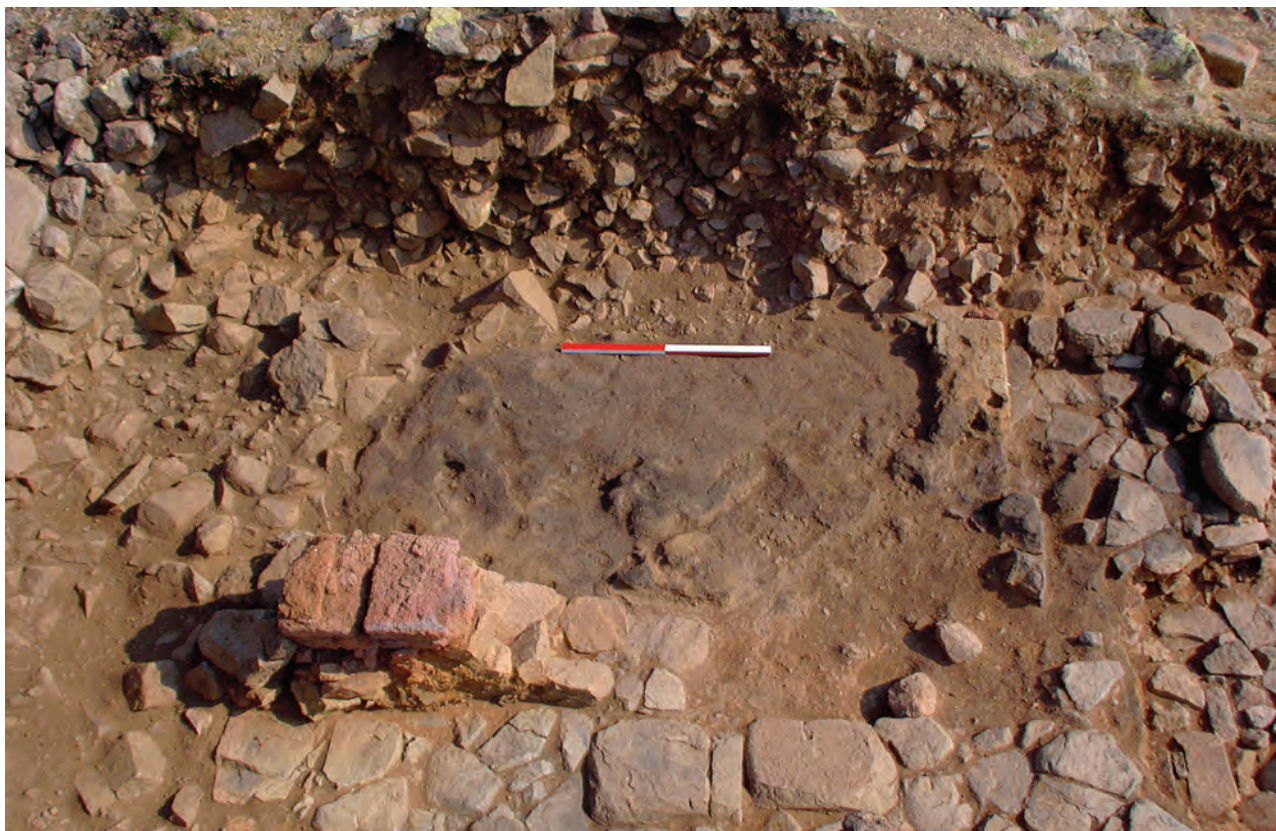
(a) Room on northern side of central section of the Monumental Entrance, between the two façades, with stone step at bottom and burned mudbricks on raised stone footing at left |

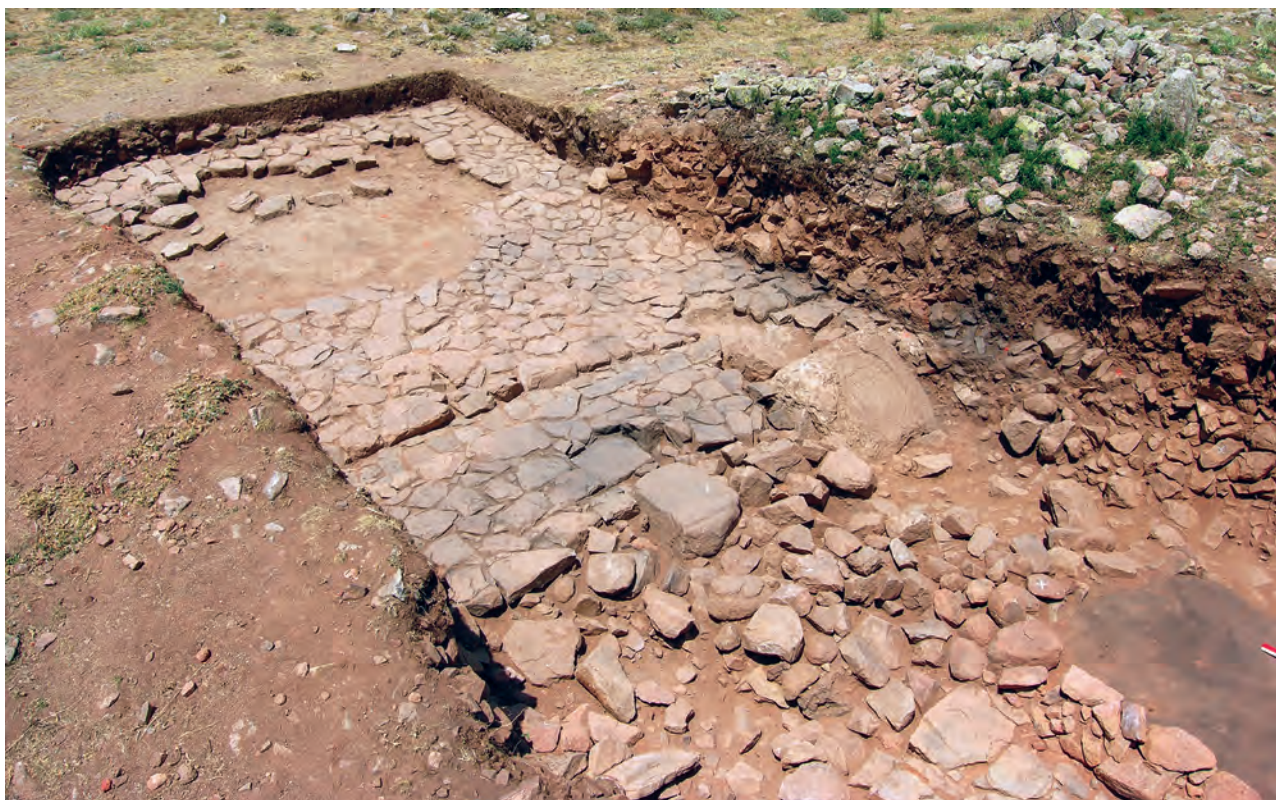
(b) Back of the Monumental Entrance looking northwest, with rubble fill of rear façade, fallen aniconic stele with displaced column base to the right, and drain in the paving |

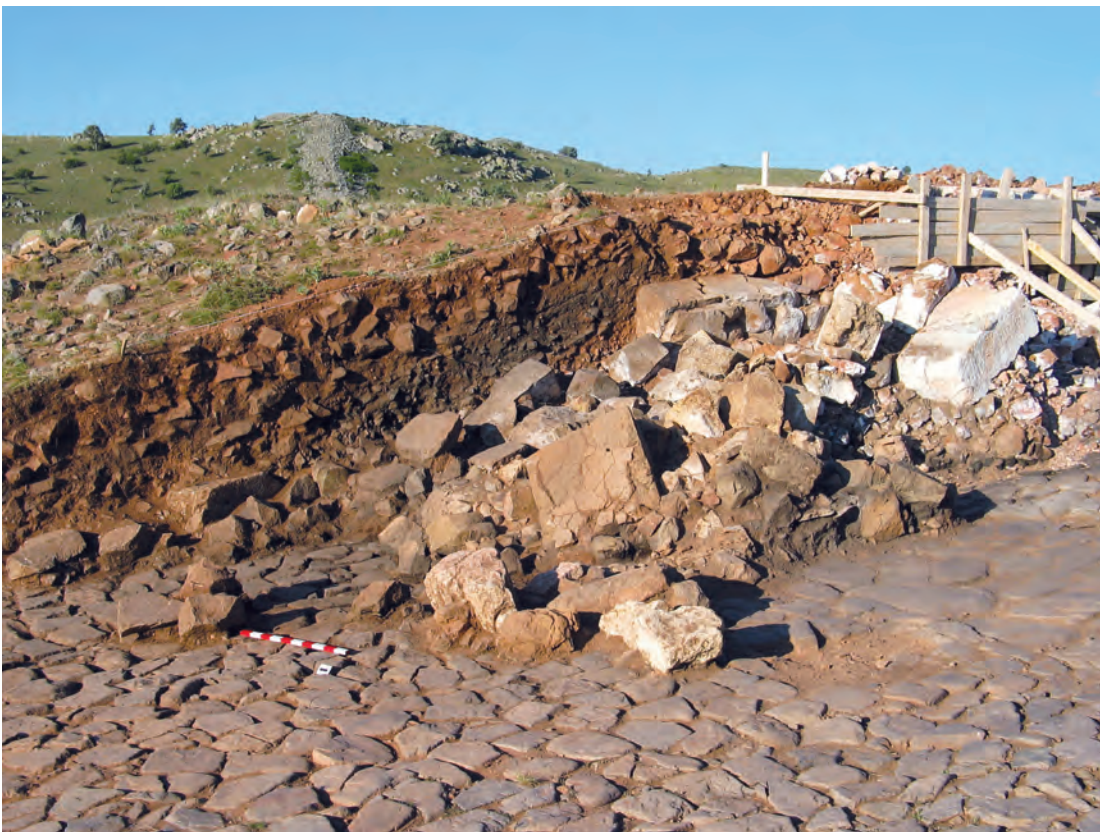
(a) View of collapse from northeastern corner of the South Platform. The face of the topmost preserved granite cornerstone with cuttings for mending clamps has been propped in place; the column base is not yet revealed, while the plinth can be seen at right.

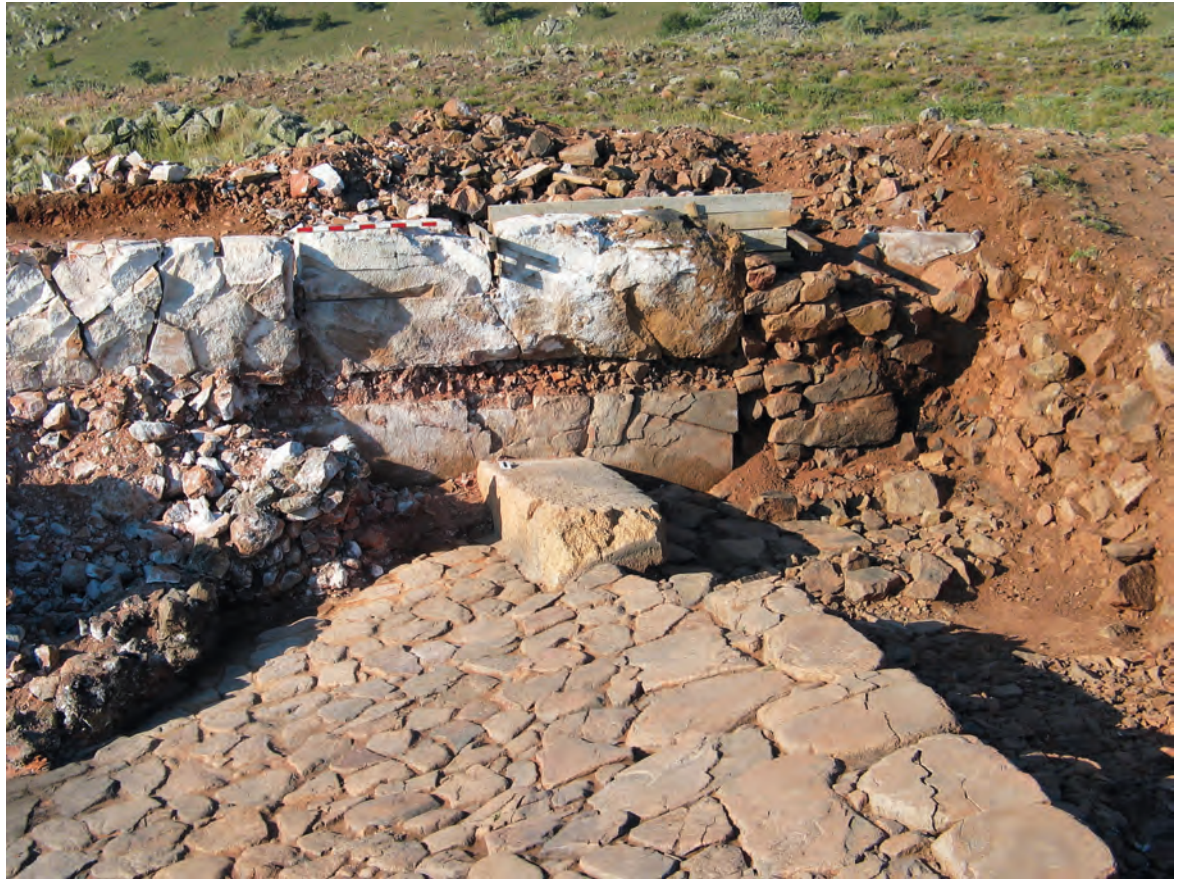
(b) Another view of the collapsed northeastern corner of the South Platform, with topmost preserved cornerstone visible at center. The white is caused by carbonates deposited since the destruction.

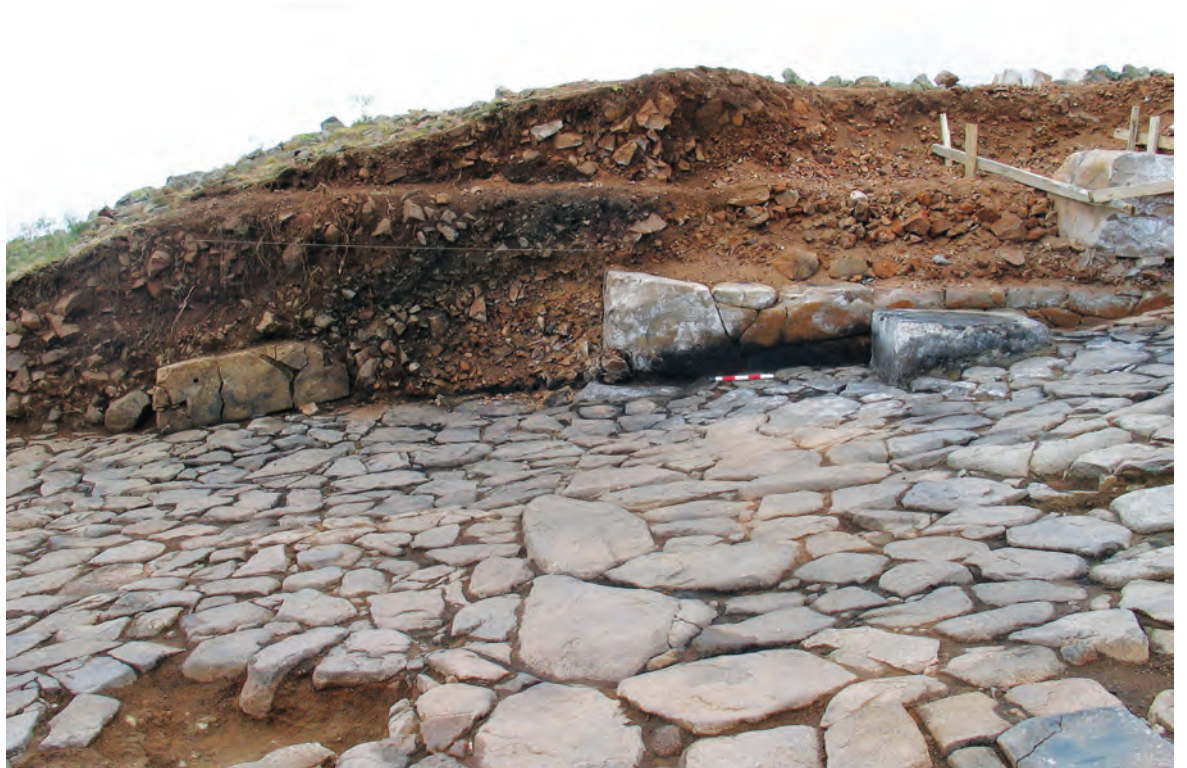
(a) Face of the South Platform, with sandstone plinth, part of foundation for front façade, five pavers indicating position and size of doors, and some of the undisturbed burned collapse. Lower blocks in the wall face are granite. Faces of the upper course of sandstone have fallen away and been removed.

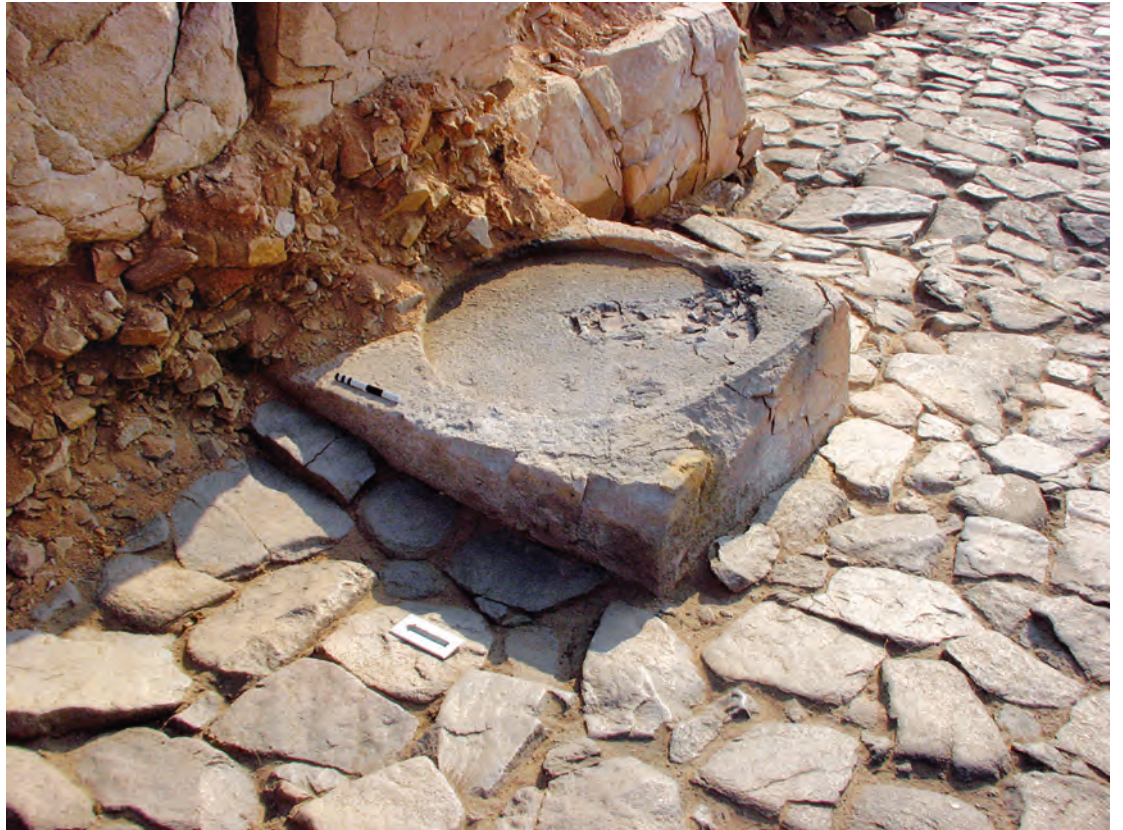
(α) Northern column base, before total removal of burned debris, showing very severe damage caused by fire. The scale is 20 cm. |

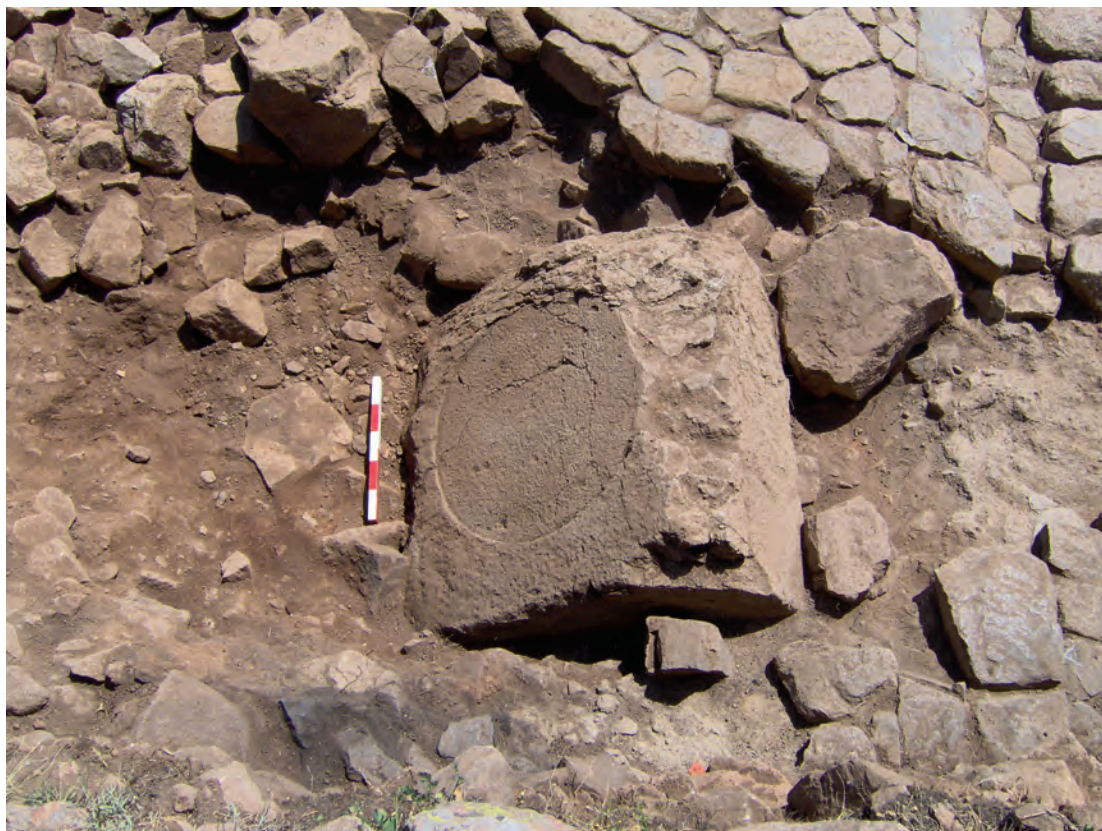
(a) Column base in rear section of the Monumental Entrance, tilted by treasure seekers who burrowed underneath it, with part of damaged drain at right

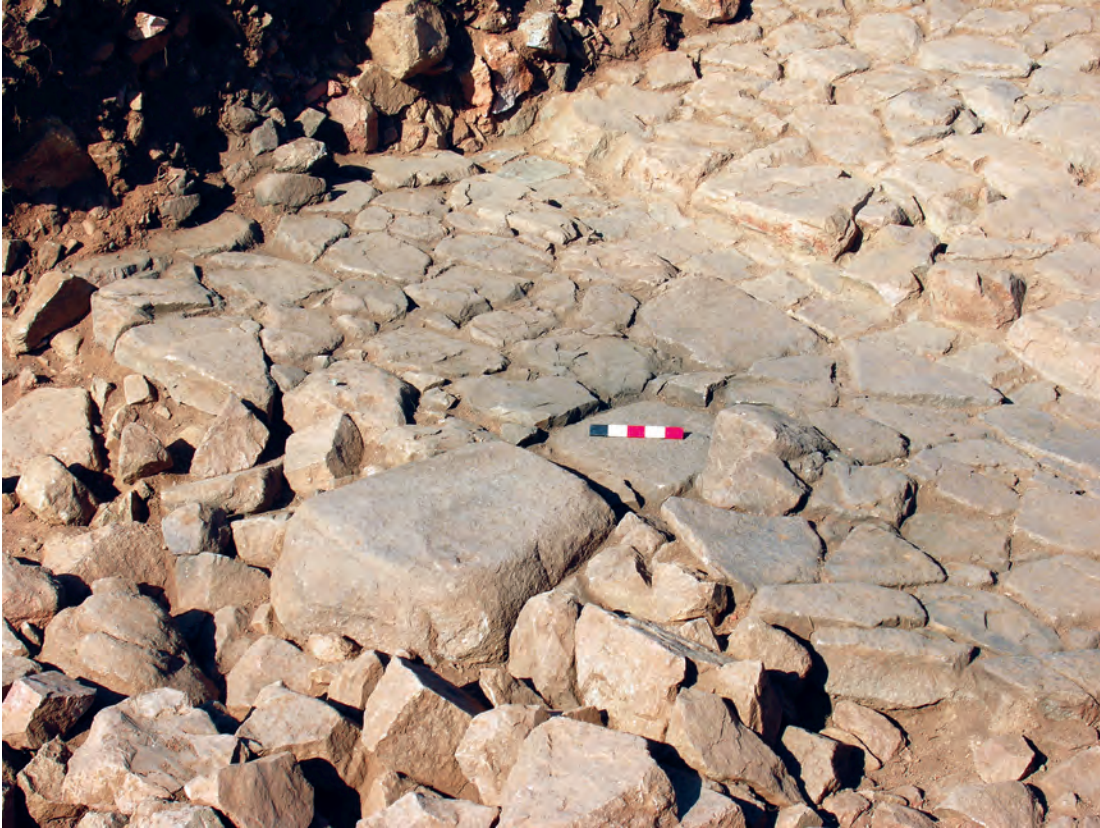
(a) Aniconic granite stele in the rear section of the Monumental Entrance fallen back into foundation of rear façade before complete removal of fallen rubble. The scale rests on the stone in front of the stele that was set below the level of the paving. The drain runs diagonally across the picture at upper right.

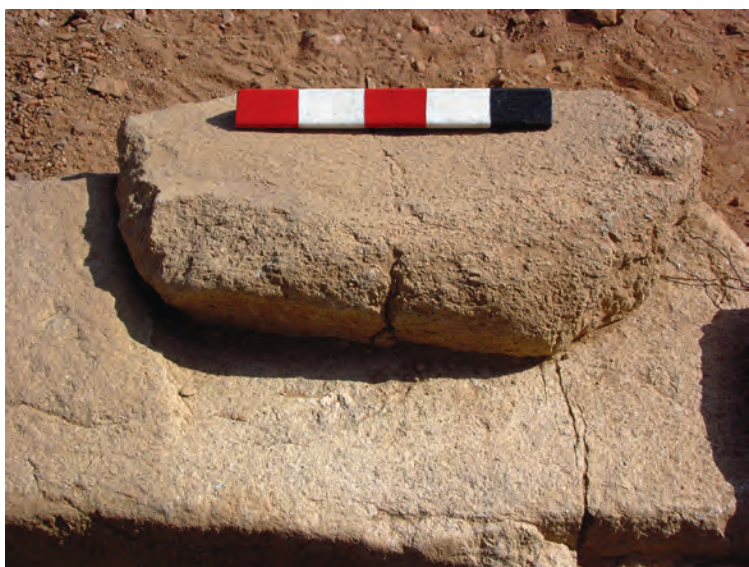
(b) Fitted granite in southern wall of the North Platform. The fronts of the stones had broken away as a result of fire. The 25 cm scale is placed where the timber beam would have been.

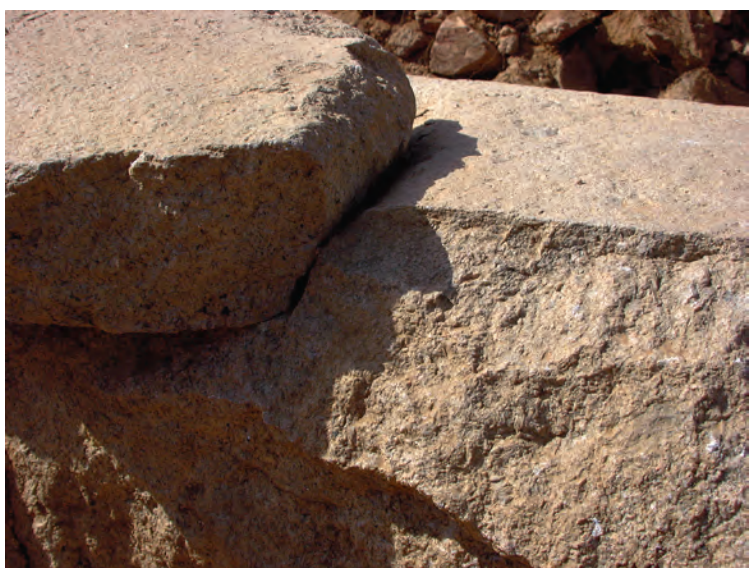
(c) Detail of fitted granite in southern wall of the North Platform where wall front has broken away

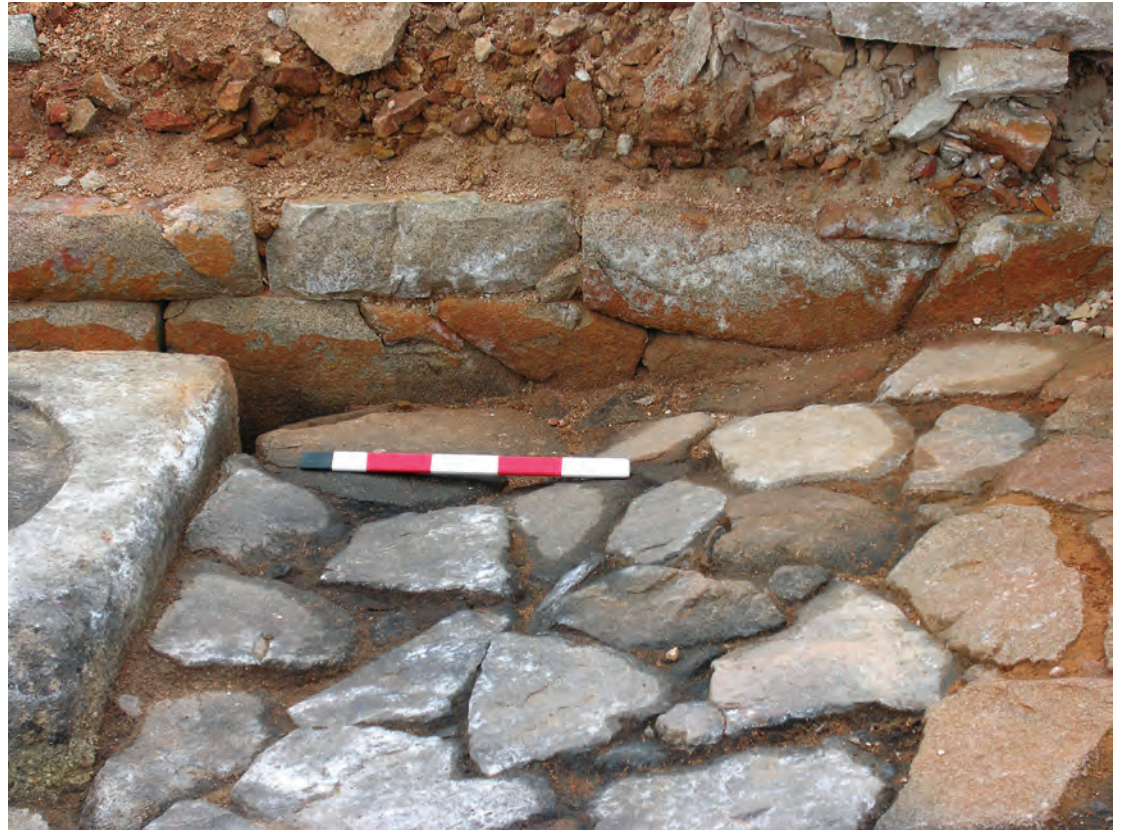
(a) Granite in northern wall of the South Platform, with row of narrow stones above larger, fire-cracked blocks, beam slot above, and part of sandstone column base at left |

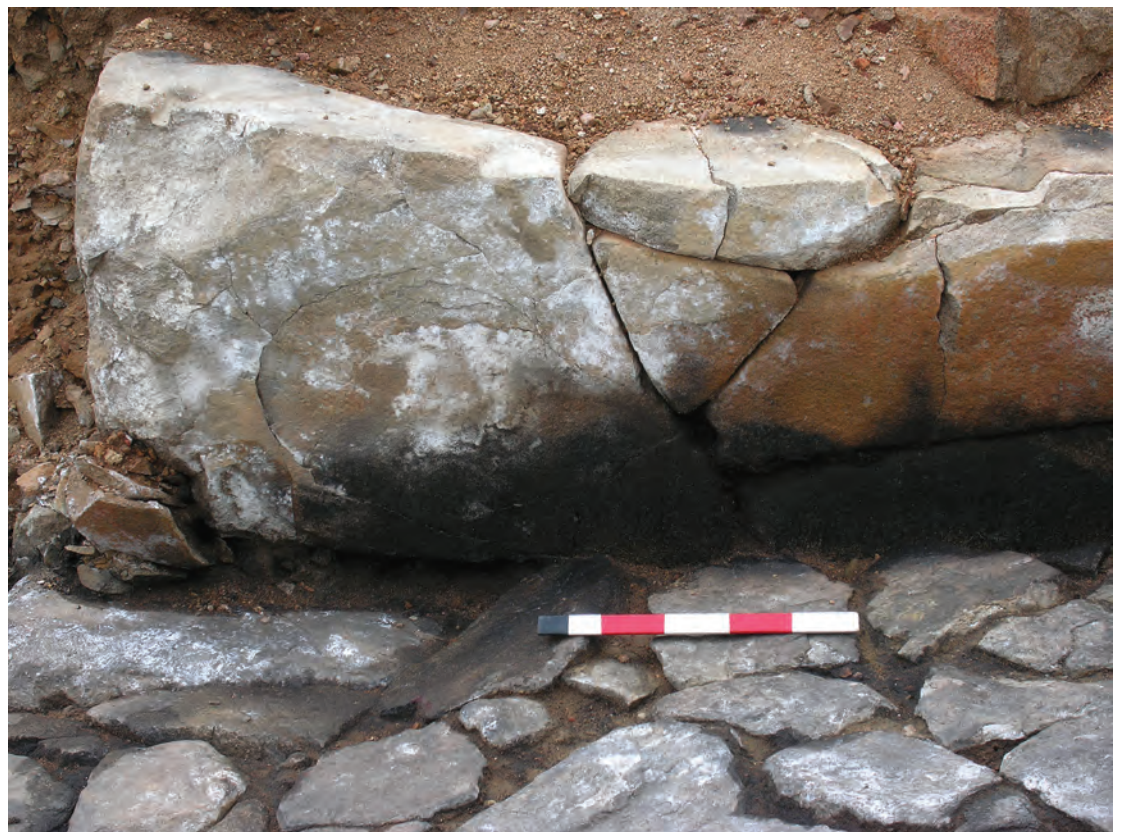
(b) Granite, shaped to fit tightly between two large blocks in northern wall of the South Platform, showing fire damage |

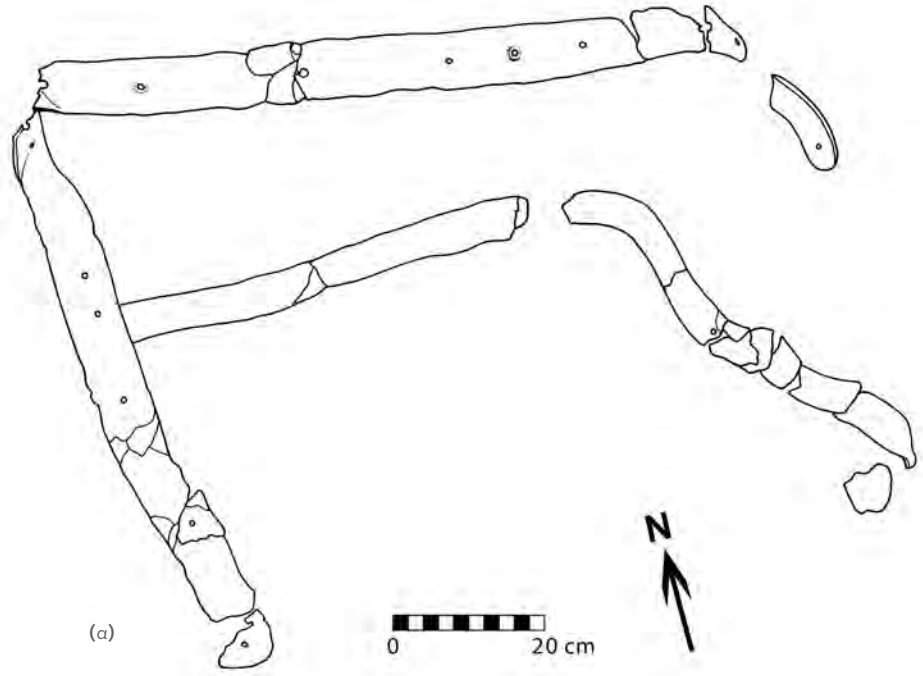
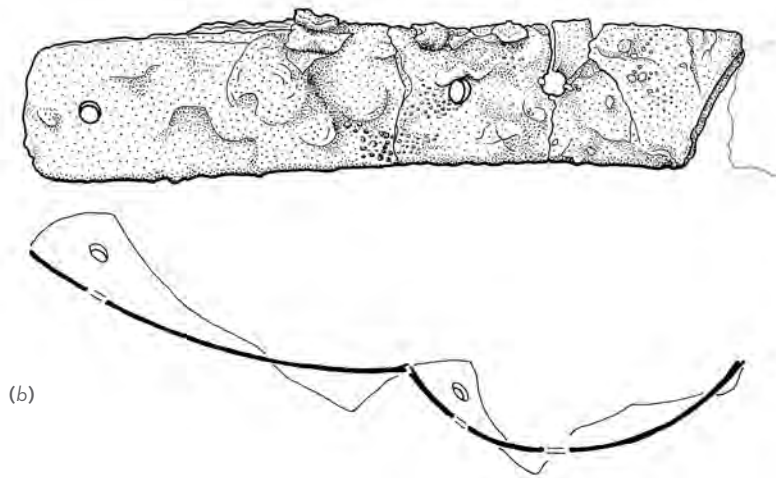
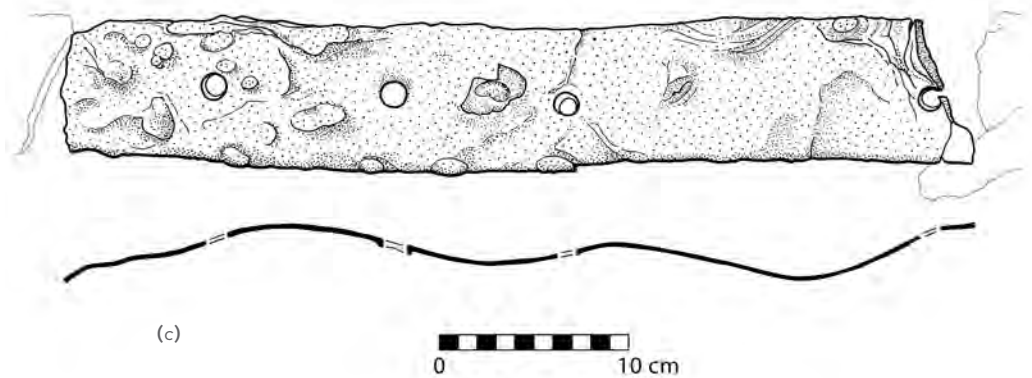
PLATE 142 | IRON BAND FROM THE MONUMENTAL ENTRANCE

Plan of two iron bands,  
03TR11U08meto1 (above) and  
03TR11U08meto2 (below), as  
found in TR11

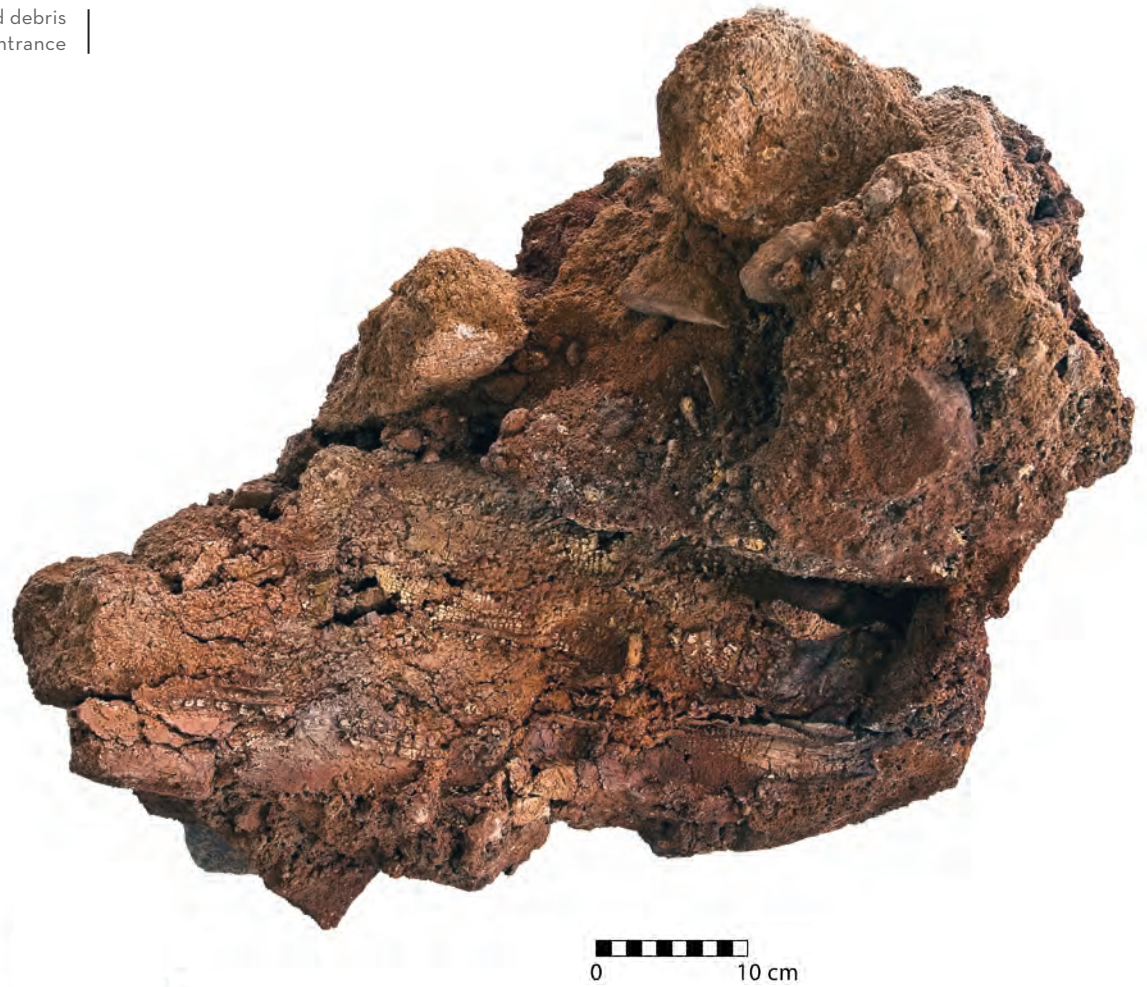
(a) Mass of burned and fused debris  
from the Monumental Entrance
