KERKENES FINAL REPORTS 2

# Excavations *at the* Palatial Complex

# EXCAVATIONS AT THE PALATIAL COMPLEX

ORIENTAL INSTITUTE PUBLICATIONS • VOLUME 148  
THE ORIENTAL INSTITUTE OF THE UNIVERSITY OF CHICAGO  
CHICAGO • ILLINOIS

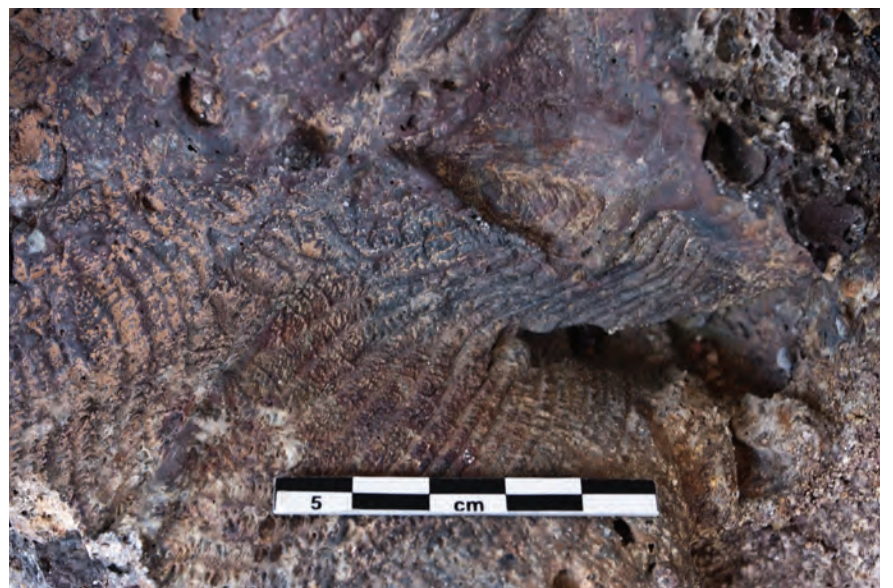
(b) Detail of plate 165a showing timber impressions  
in vitrified debris

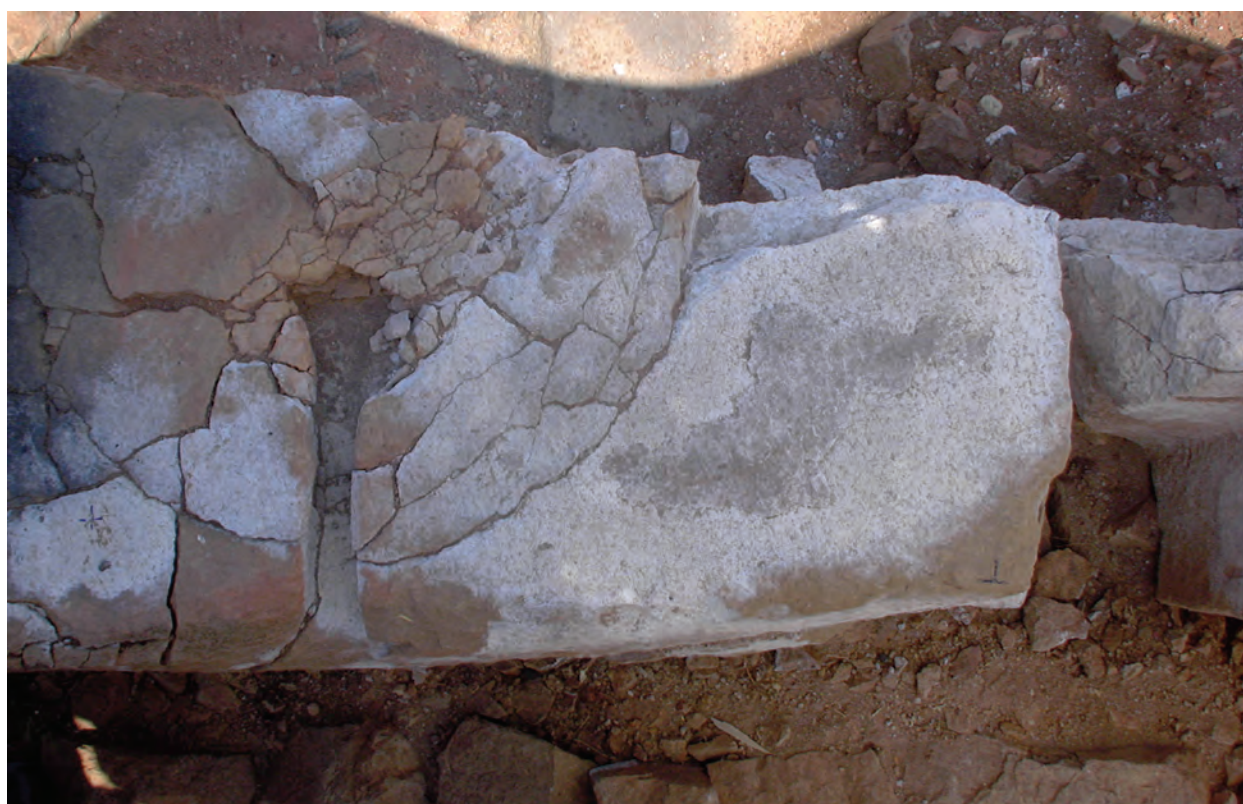
(b) Clamp cutting 13 in situ in TR15 on topmost preserved course of the South Platform. The edge of the platform core is at the bottom of the image. The front portion of the block was destroyed.

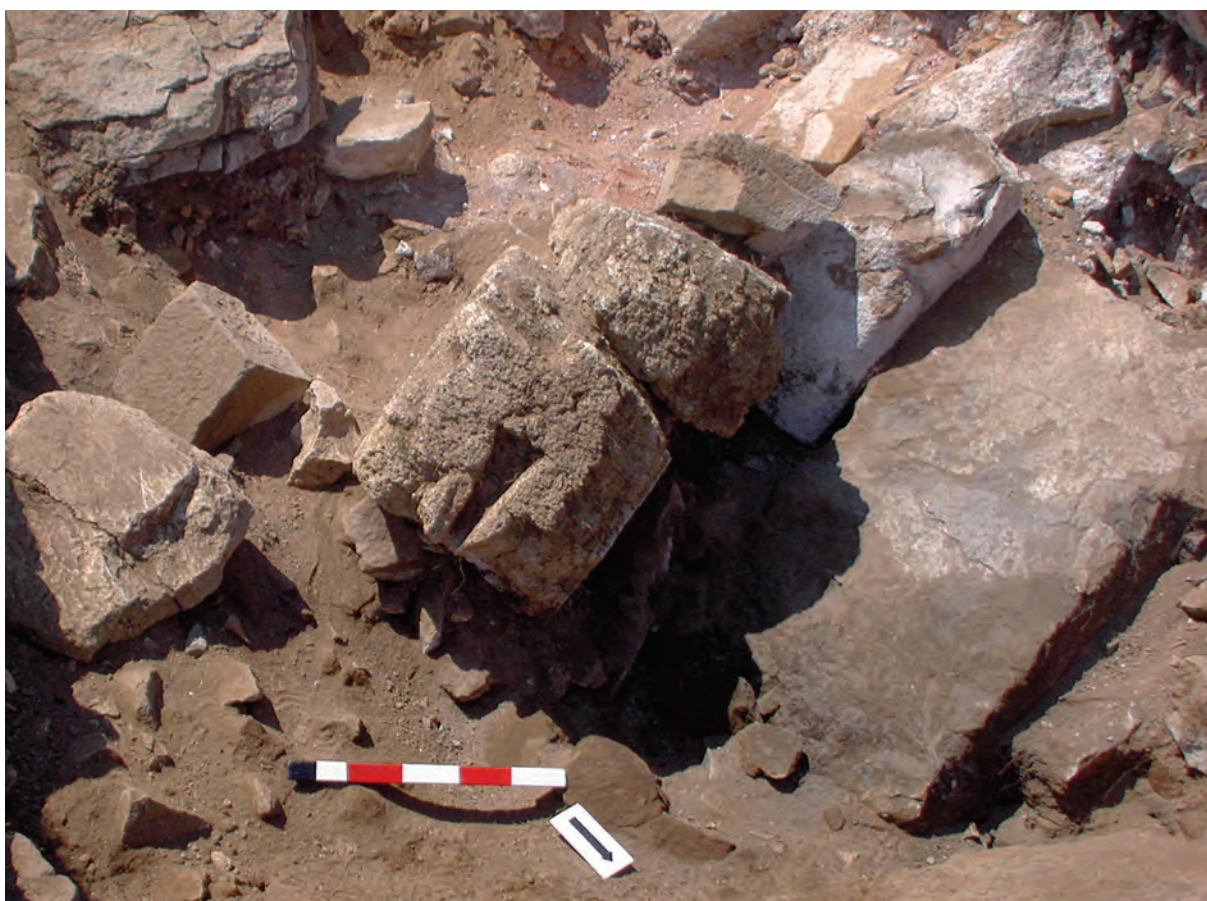
(b) Clamp cutting 15, as found in TR16U08. Idol block fragment O4TR16U08arco2, now part of the corner block of Idol Block 1, can be seen at upper right.
