KHORSABAD

EXCAVATIONS IN THE PALACE AND AT A CITY GATE

THE UNIVERSITY OF CHICAGO
ORIENTAL INSTITUTE PUBLICATIONS
VOLUME XXXVIII

GORDON LOUD

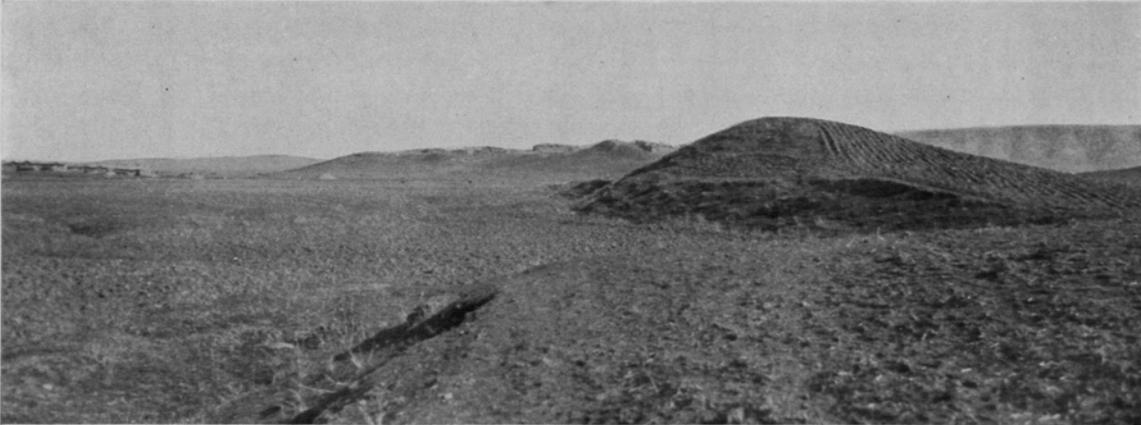
FIG. 2.—THE MOUND COVERING GATE 7, WITH THE PALACE MOUND IN CENTER BACKGROUND AND THE MODERN VILLAGE OF KHORSABAD AT LEFT

Figure 2 shows the mound which covered the ruins of the gate before we started work. The palace mound, astride the town wall, can be seen in the background. The brook which now runs along the ruins of the town wall has cut into the pavement of large rough blocks which leads up to the gate from outside the town. It was these stones, from which the earth had been washed away, that gave us a basis from which to start work. The walls themselves were very much damaged, and we did not trace what was left of them. The portions adjoining the outer of the two portals of the gate were covered with whitewashed mud plaster (Fig. 3).

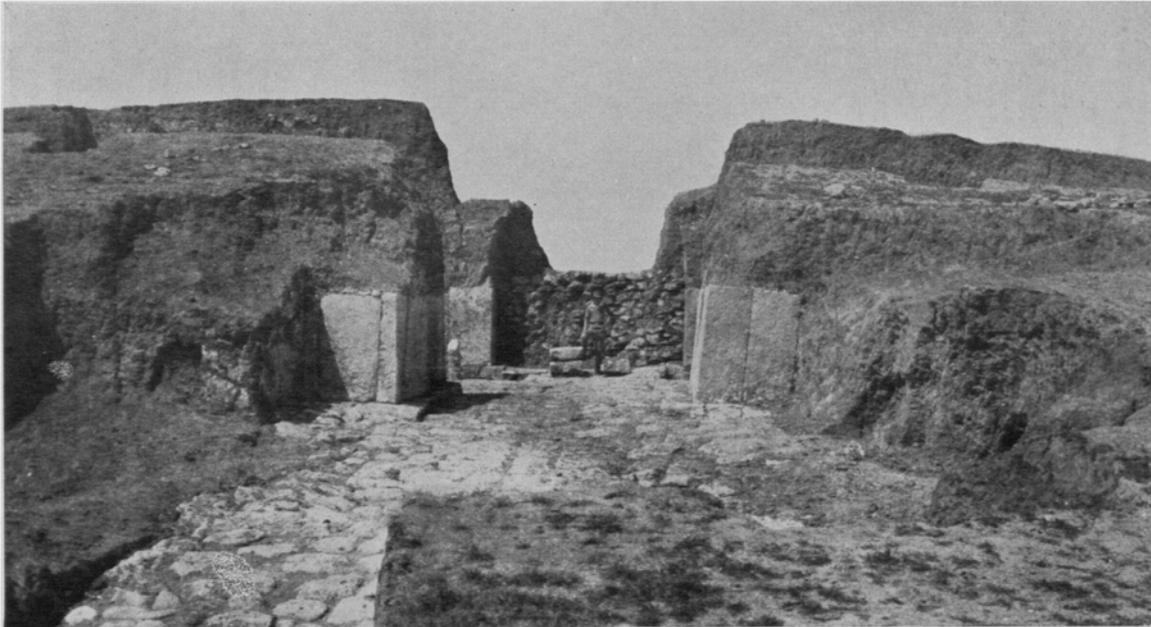
The arch of the outer portal was well preserved, and the whitewash on its soffit showed clearly above the blocking if looked at from the inside (Fig. 5). The pavement of large stones laid throughout the gateway joins one of small cobblestones, which we assume to be the pavement of a street, since it descends and can be picked up again when one digs down in front of the gateway in the fields within the city.

The inner portal also had been arched over, but here an almost continuous layer of fallen white plaster is all that remains of the soffit of the arch. A small fragment on the wall showed where the springing of the arch began; the good preservation of the arch in the outer gateway was, of course, due to the support of the barrier of rough stones which formed the blocking.

FIG. 5.—GATE 7, FROM WITHIN THE CITY

Inside the gate there are two large chambers, situated on the same axis (Figs. 4 and 6), not at right angles as Place's drawings show. It is, of course, impossible to assert with absolute confidence that the plan of the simpler of the two types of gate which Place dug is identical with ours. Since they were similar to each other, however, this is highly probable; and the divergence between his plan and ours may well be a result of his method of working out his field notes in Paris, a procedure which we suspect him of having followed on the strength of similar divergencies in portions of the palace where both he and we excavated.

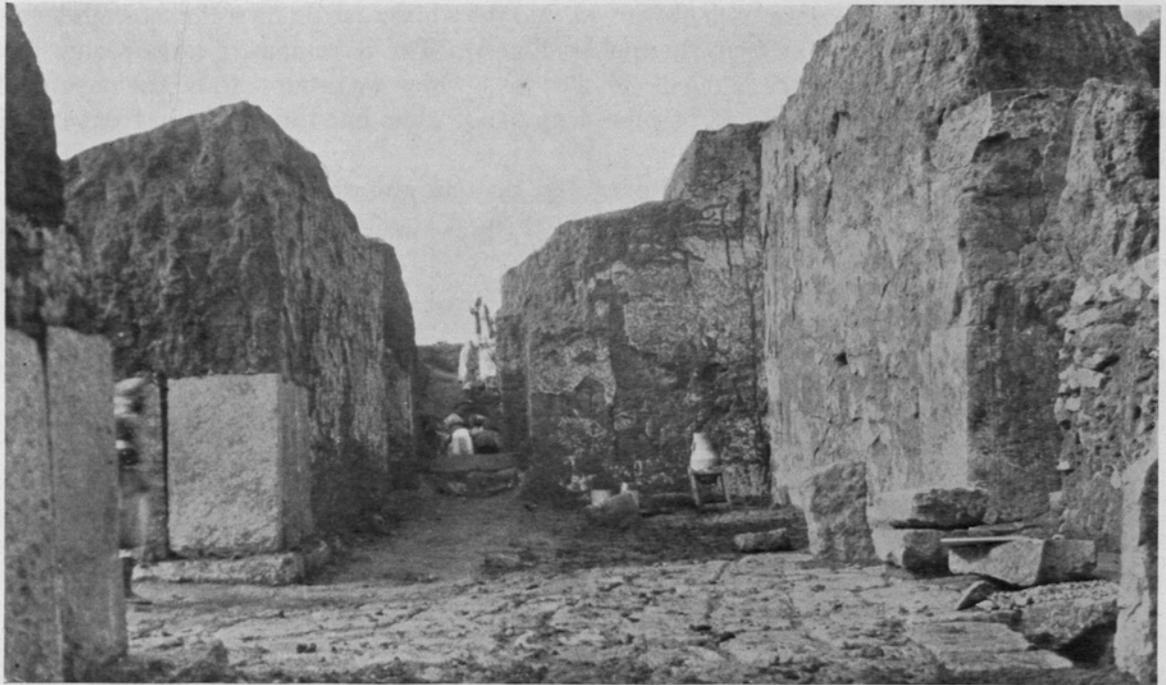
FIG. 6.—CENTRAL GATE CHAMBER, WITH INNER PORTAL AT LEFT, OUTER PORTAL AT RIGHT, AND SIDE CHAMBER IN BACKGROUND

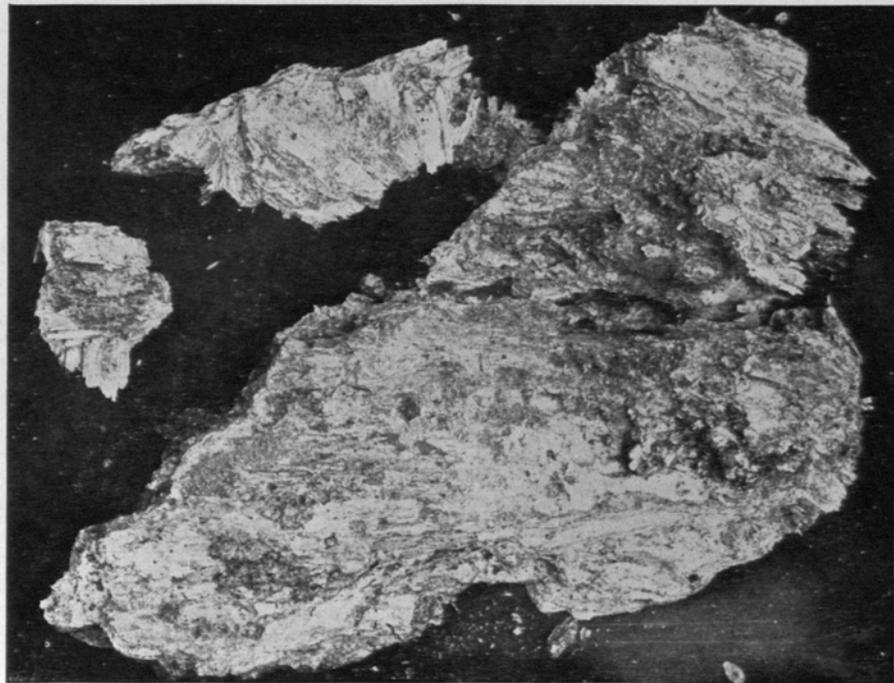
FIG. 7.—REMAINS OF A BEAM USED IN ROOFING. SCALE, 7:10

We gained sufficient evidence not only to prove that the central chamber was roofed but also to show the method by which the roofing was accomplished. Fibrous substances, the remains of beams (Fig. 7) and matting (Fig. 8), were found on the pavement. They were excavated with the utmost care, mostly with tools no bigger than penknives, so that we might

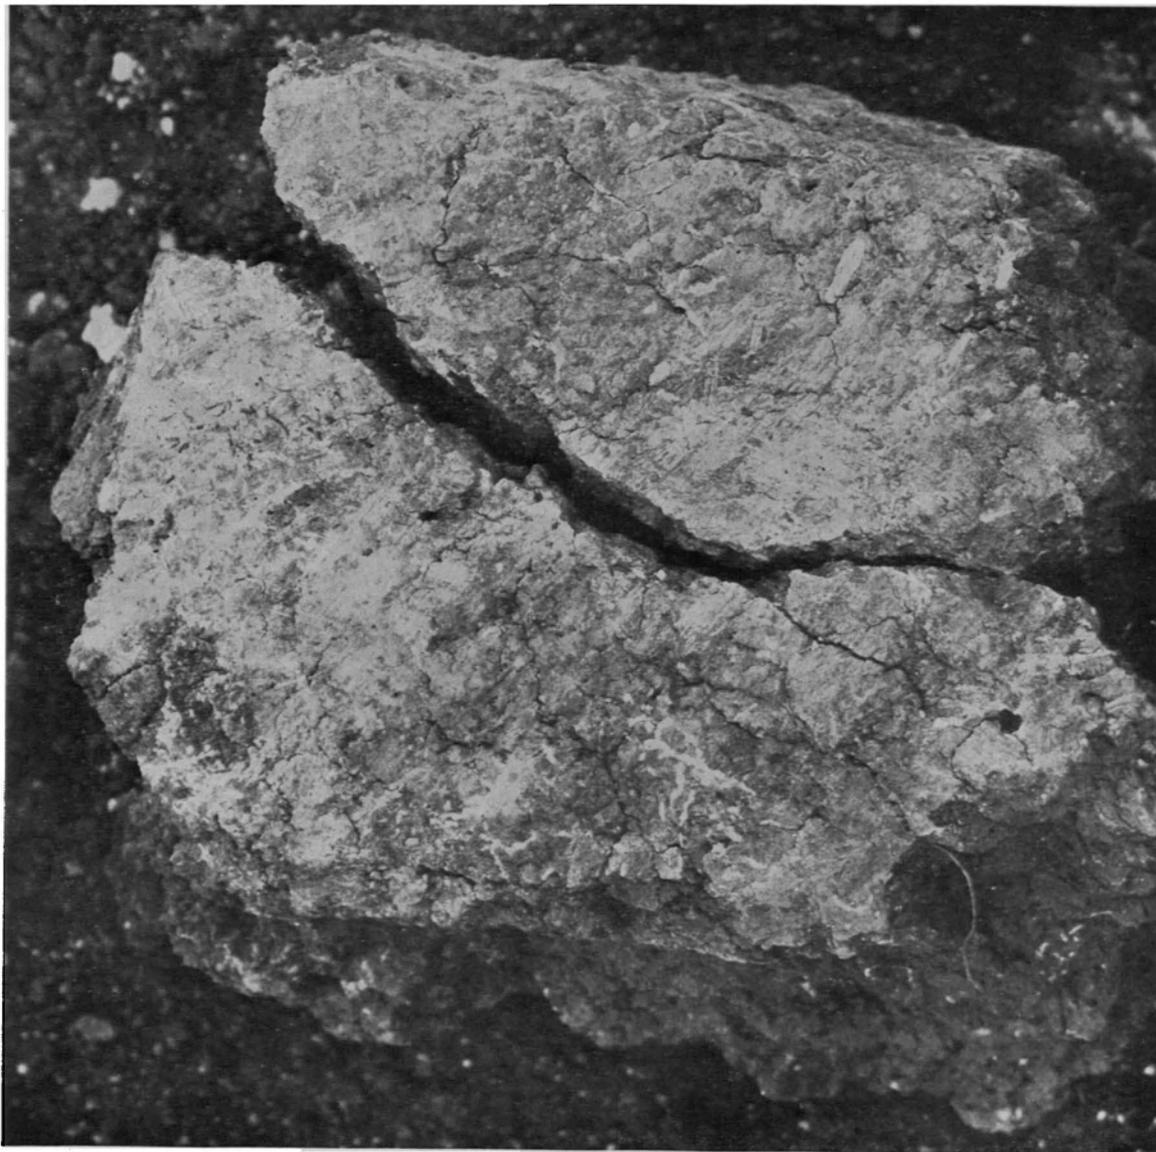
FIG. 8.—REMAINS OF MATTING USED IN ROOFING. SCALE, 7:10

not miss the smallest shred of evidence. Fortunately the fragments were numerous, and the evidence gained from them was often mutually corroborative. Moreover, work in Room 7 later gave valuable possibilities for checking our deductions, for there also wood and matting had been charred by a fire. There the edges of matting which had been buried in mud plaster and had not been burned appeared as a white, fluffy layer (Fig. 85), exactly as in the gate, where the crosswise weave could often be distinguished (Fig. 8).

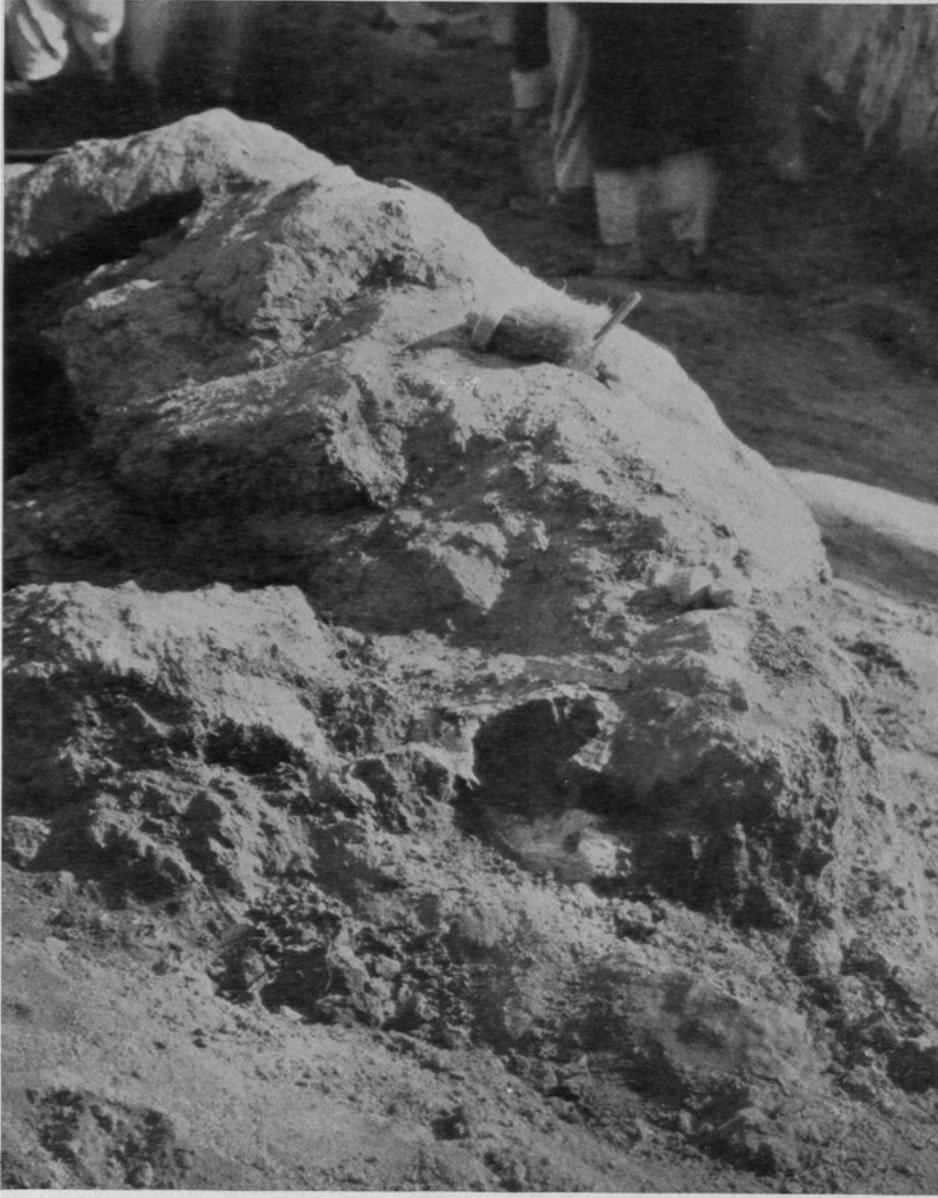
FIG. 10.—REMAINS OF FALLEN ROOFING

adjacent to it. The first pieces found were about 20 cm. wide and had a somewhat convex surface. After the remains of beams were found, it became clear that the red material was not red plaster, but red paint applied directly to wood and matting. The convex pieces were all fragments of decayed matting, which, like the remnants of wood (Fig. 7), crumbled at the merest touch. But there seemed some regularity in the convexity of these pieces; several had a width of 20 cm. and two a width of 26 cm. The explanation seems to be that the roofing

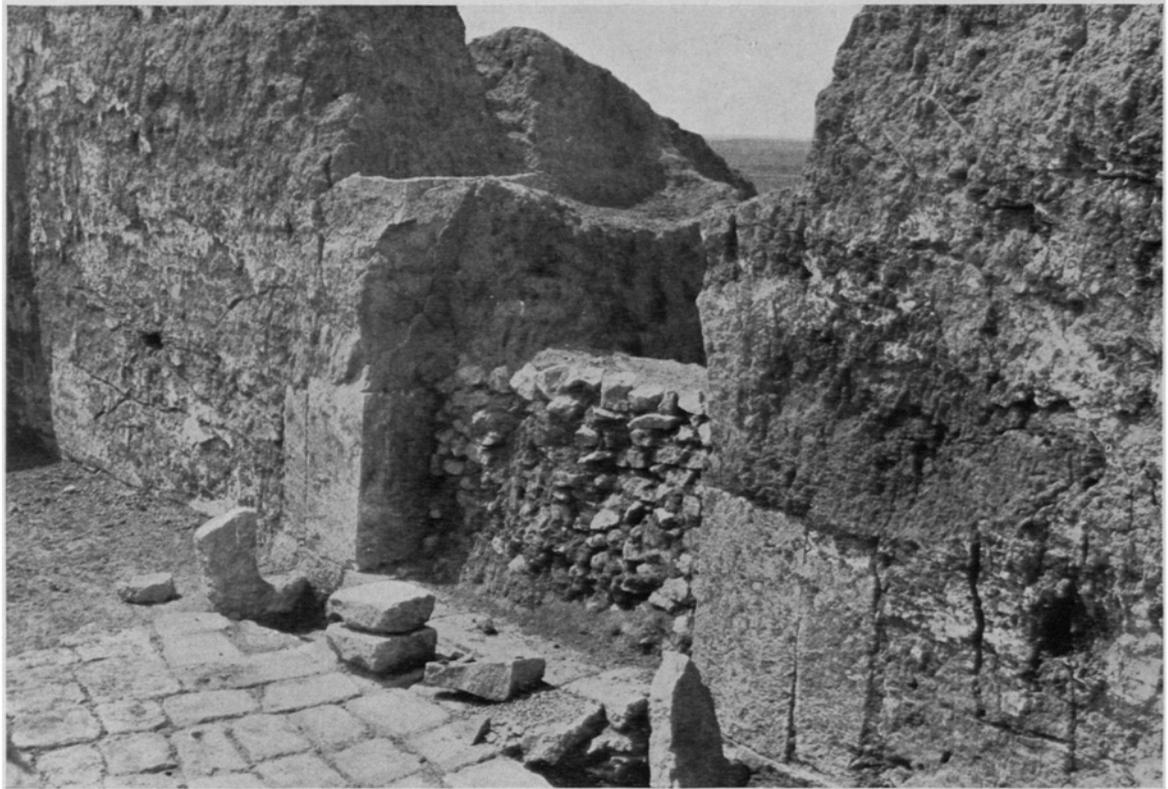
FIG. 11.—OUTER PORTAL OF CENTRAL GATE CHAMBER, FROM WITHIN. CUT-OUT PAVING STONES STAND READY TO BE DROPPED INTO PLACE AROUND THE DOOR PIVOTS

When the remains of the fallen walls and ceilings had been removed, the most interesting features of the central chamber became clear (Fig. 11). It was seen that the paving blocks on either side of the outer portal had been cut out so that they could be lowered round the pivots

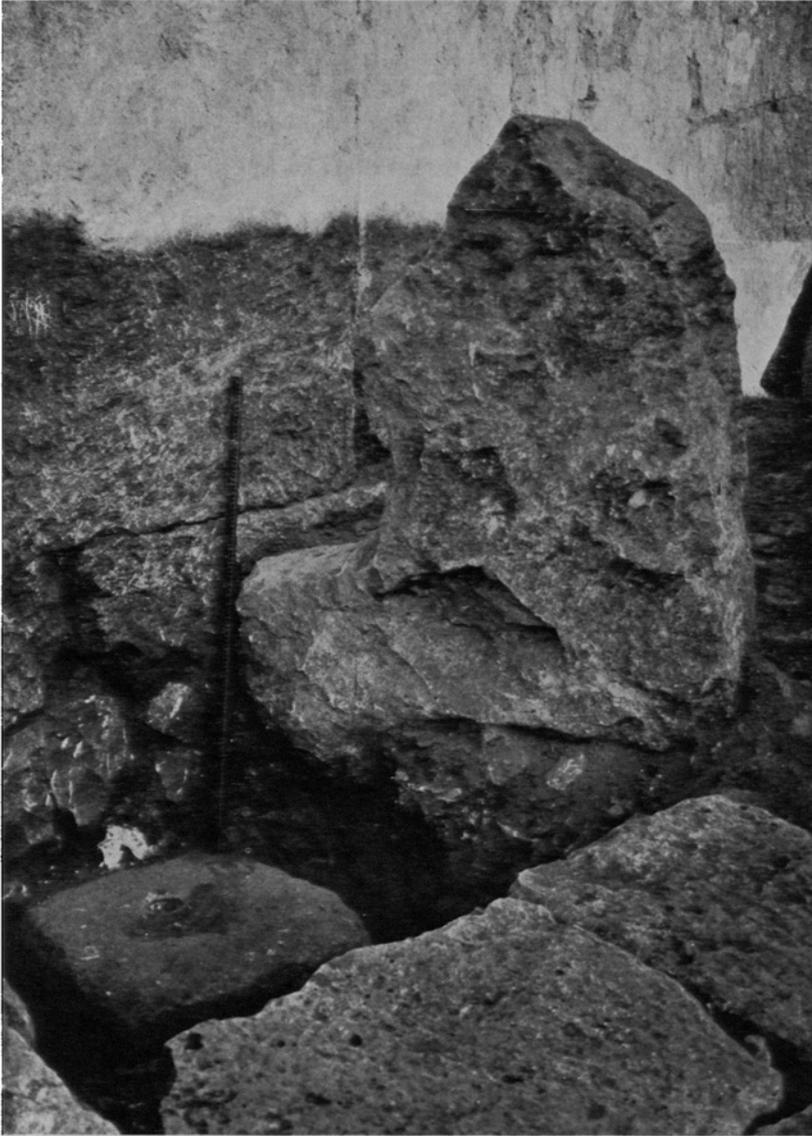
FIG. 12.—CUT-OUT PAVING STONE READY TO DROP INTO PLACE OVER PIVOT STONE

of the wooden doors after these were brought into position (Fig. 12). Furthermore, slabs were piled up near a place where a socket had been cut in a stone, ready to support a strut or brace leaning obliquely against the closed doors. The doors, however, had never been put in place; the pivot stones were there, but these show no sign of wear. Instead, the gate had been blocked with a barrier of rough stones crowned with mud brick. This blocking had been done while the gate was still in good repair—perhaps even almost as soon as it was built. For outside the blocking we found, over a depth of about 50 cm., loose wind-blown rubbish and earth, clearly distinguished from the superimposed layers of brickwork fallen from the walls and towers. In our preliminary report we have already explained this blocking as caused by “the failure of Sargon’s attempt to change the political geography of Assyria by transferring the capital from Nineveh to Dur Sharrukin. After Sargon’s death in 705 B.C. Sennacherib immediately moved the capital back to Nineveh. It seems probable that most of Sargon’s subjects, unless their attendance upon the king was obligatory, had been too closely connected

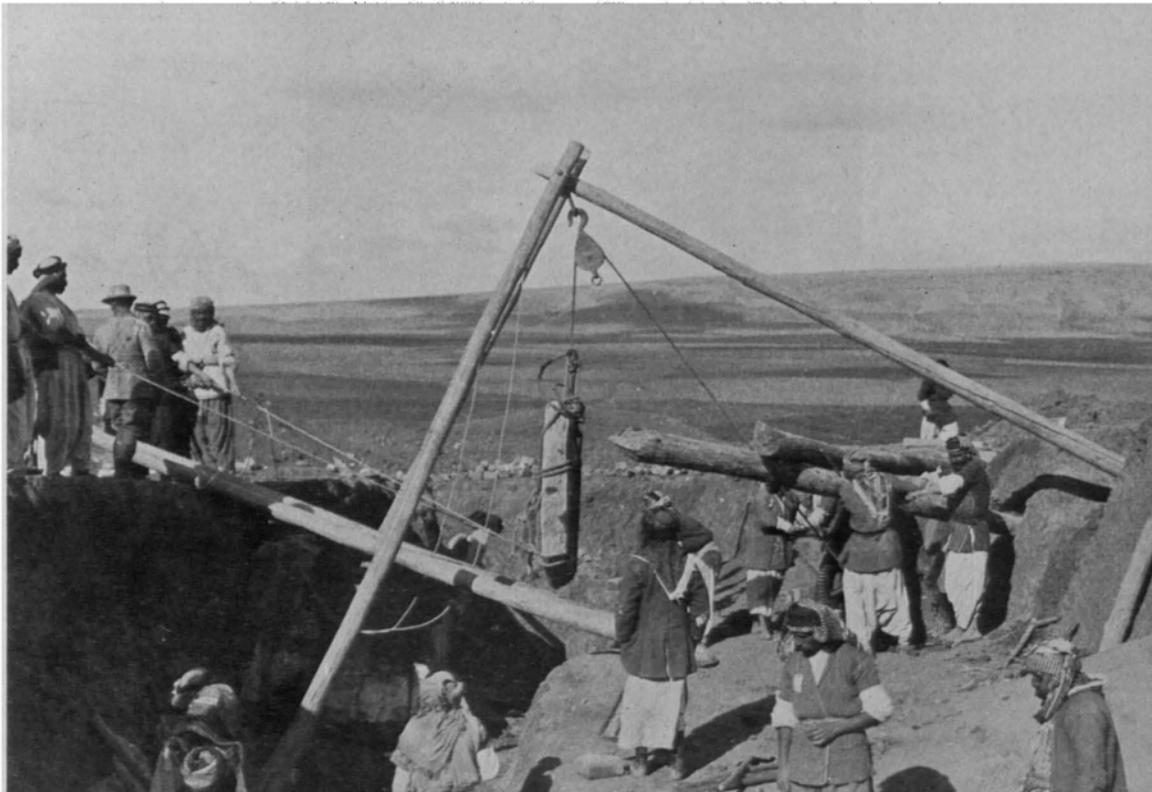
Such a widening of the trench only tended to complicate the removal of the reliefs. The small broken-off fragments and those portions of the slabs of such weight as to permit their being lifted by hand presented no problem. After being duly marked as to the slab to which they belonged they were placed upon a wooden "stretcher" and carried to the courtyard of the expedition house on the shoulders of four husky men (Fig. 15). There they were spread upon the ground, sorted according to the slabs of which they formed parts, and the complete slabs gradually assembled preparatory to being packed for shipment (Fig. 16). But in the case of the heavier pieces it was quite a different matter. A tripod of large wooden poles such as are used in the roof construction of the modern village houses was assembled and erected over the trench, this to permit a vertical pull to raise the blocks of stone the 4 or 5 meters to the ground surface. This, though simple in principle, proved not so easy in execution. For the

FIG. 17.—LOWERING A SLAB ONTO SKIDS PREPARATORY TO HAULING IT TO GROUND SURFACE

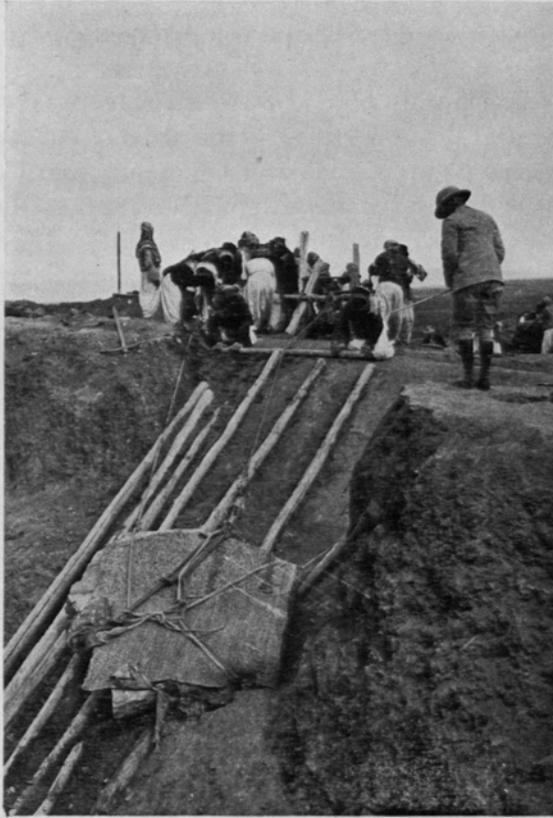
men, unused to teamwork, could not be taught to pull in unison. A team of oxen was tried and proved equally unsatisfactory. Finally a winch was obtained from the Public Works Department in Mosul, and the problem was solved. The slabs were thus raised slightly above the level of the ground surface and lowered onto two long poles laid across the top of the trench (Fig. 17). Then by man power and ropes they were pulled along these poles to the high ground. This procedure worked admirably, but it required the constant shifting of the tripod, which must be set up directly over the stone to be lifted. And when the wider part of the trench was reached, this method had, of course, to be abandoned, for the tripod could not span the opening. An inclined cut was, therefore, made in the side of the trench so that the stones could be dragged to the surface, either on skids (Fig. 18) or loaded on a heavy two-wheeled cart especially constructed for this purpose. The tripod was set up in the bottom of the trench, and by its means the slabs were lifted onto the cart (Fig. 19). The cart was pulled by

FIG. 18.—DRAGGING A SLAB TO SURFACE WITH WINCH AND SKIDS

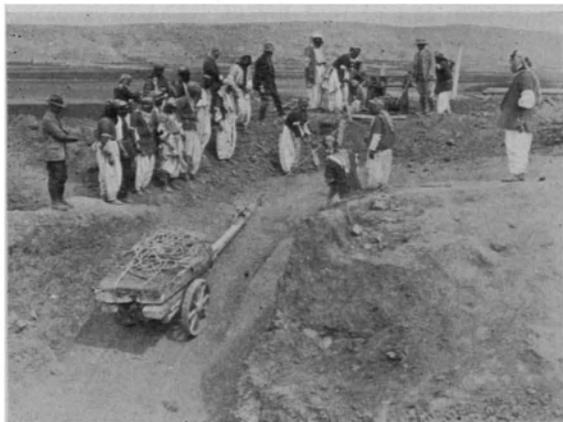
the men to the bottom of the incline and there attached to the cable from the winch, which slowly brought it to the ground surface (Fig. 20).

FIG. 20.—HAULING THE CART TO THE SURFACE

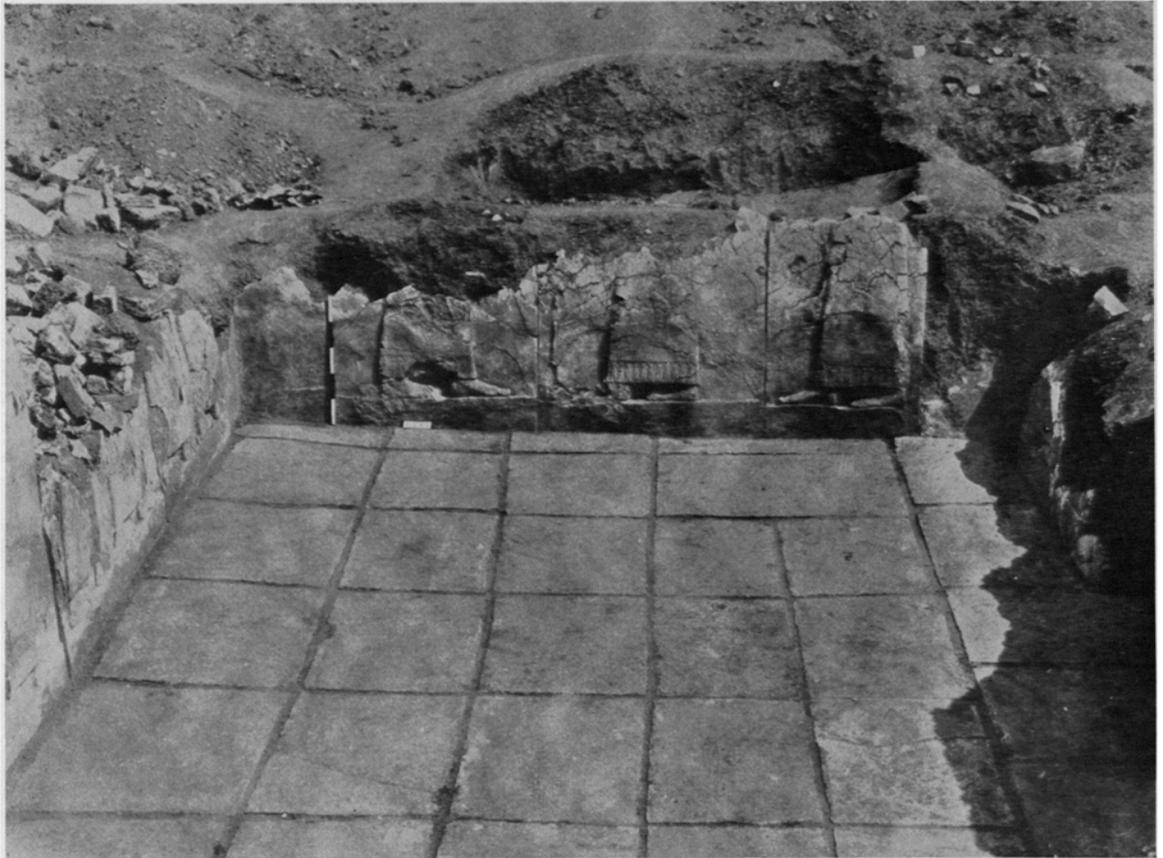
FIG. 23.—WALL RELIEFS OF SARGON'S BATHROOM, FROM SOUTHWEST. THE SECOND FIGURE FROM THE RIGHT IS PROBABLY THAT OF THE KING, WHILE HIS ATTENDANT STANDS BEHIND HIM

The walls were covered with reliefs showing figures of heroic size in procession. So great was the damage from fire in this room that little of this procession, unfortunately, remains (Figs. 23 and 24). Of the slabs facing the southeast and southwest walls, there is nothing left but a very few fragments near the floor showing only an occasional foot. The adornment of the other two walls, however, can be partially reconstructed, although any hope of salvaging the

reliefs is out of the question, for the burned stone crumbles at touch. From the feet and lower parts of the garments we know that the procession moves toward the northeast wall, turns the north corner, and meets one who is probably the king about midway along this shorter wall face (see Fig. 23). For we find the king facing the other way, as is his attendant standing behind him. The figures toward the rear are slightly more complete (Fig. 25) and show clasped hands. Obviously, then, this was not a procession of captives or subjects bearing tribute but rather one of servants or eunuchs attendant upon the king.

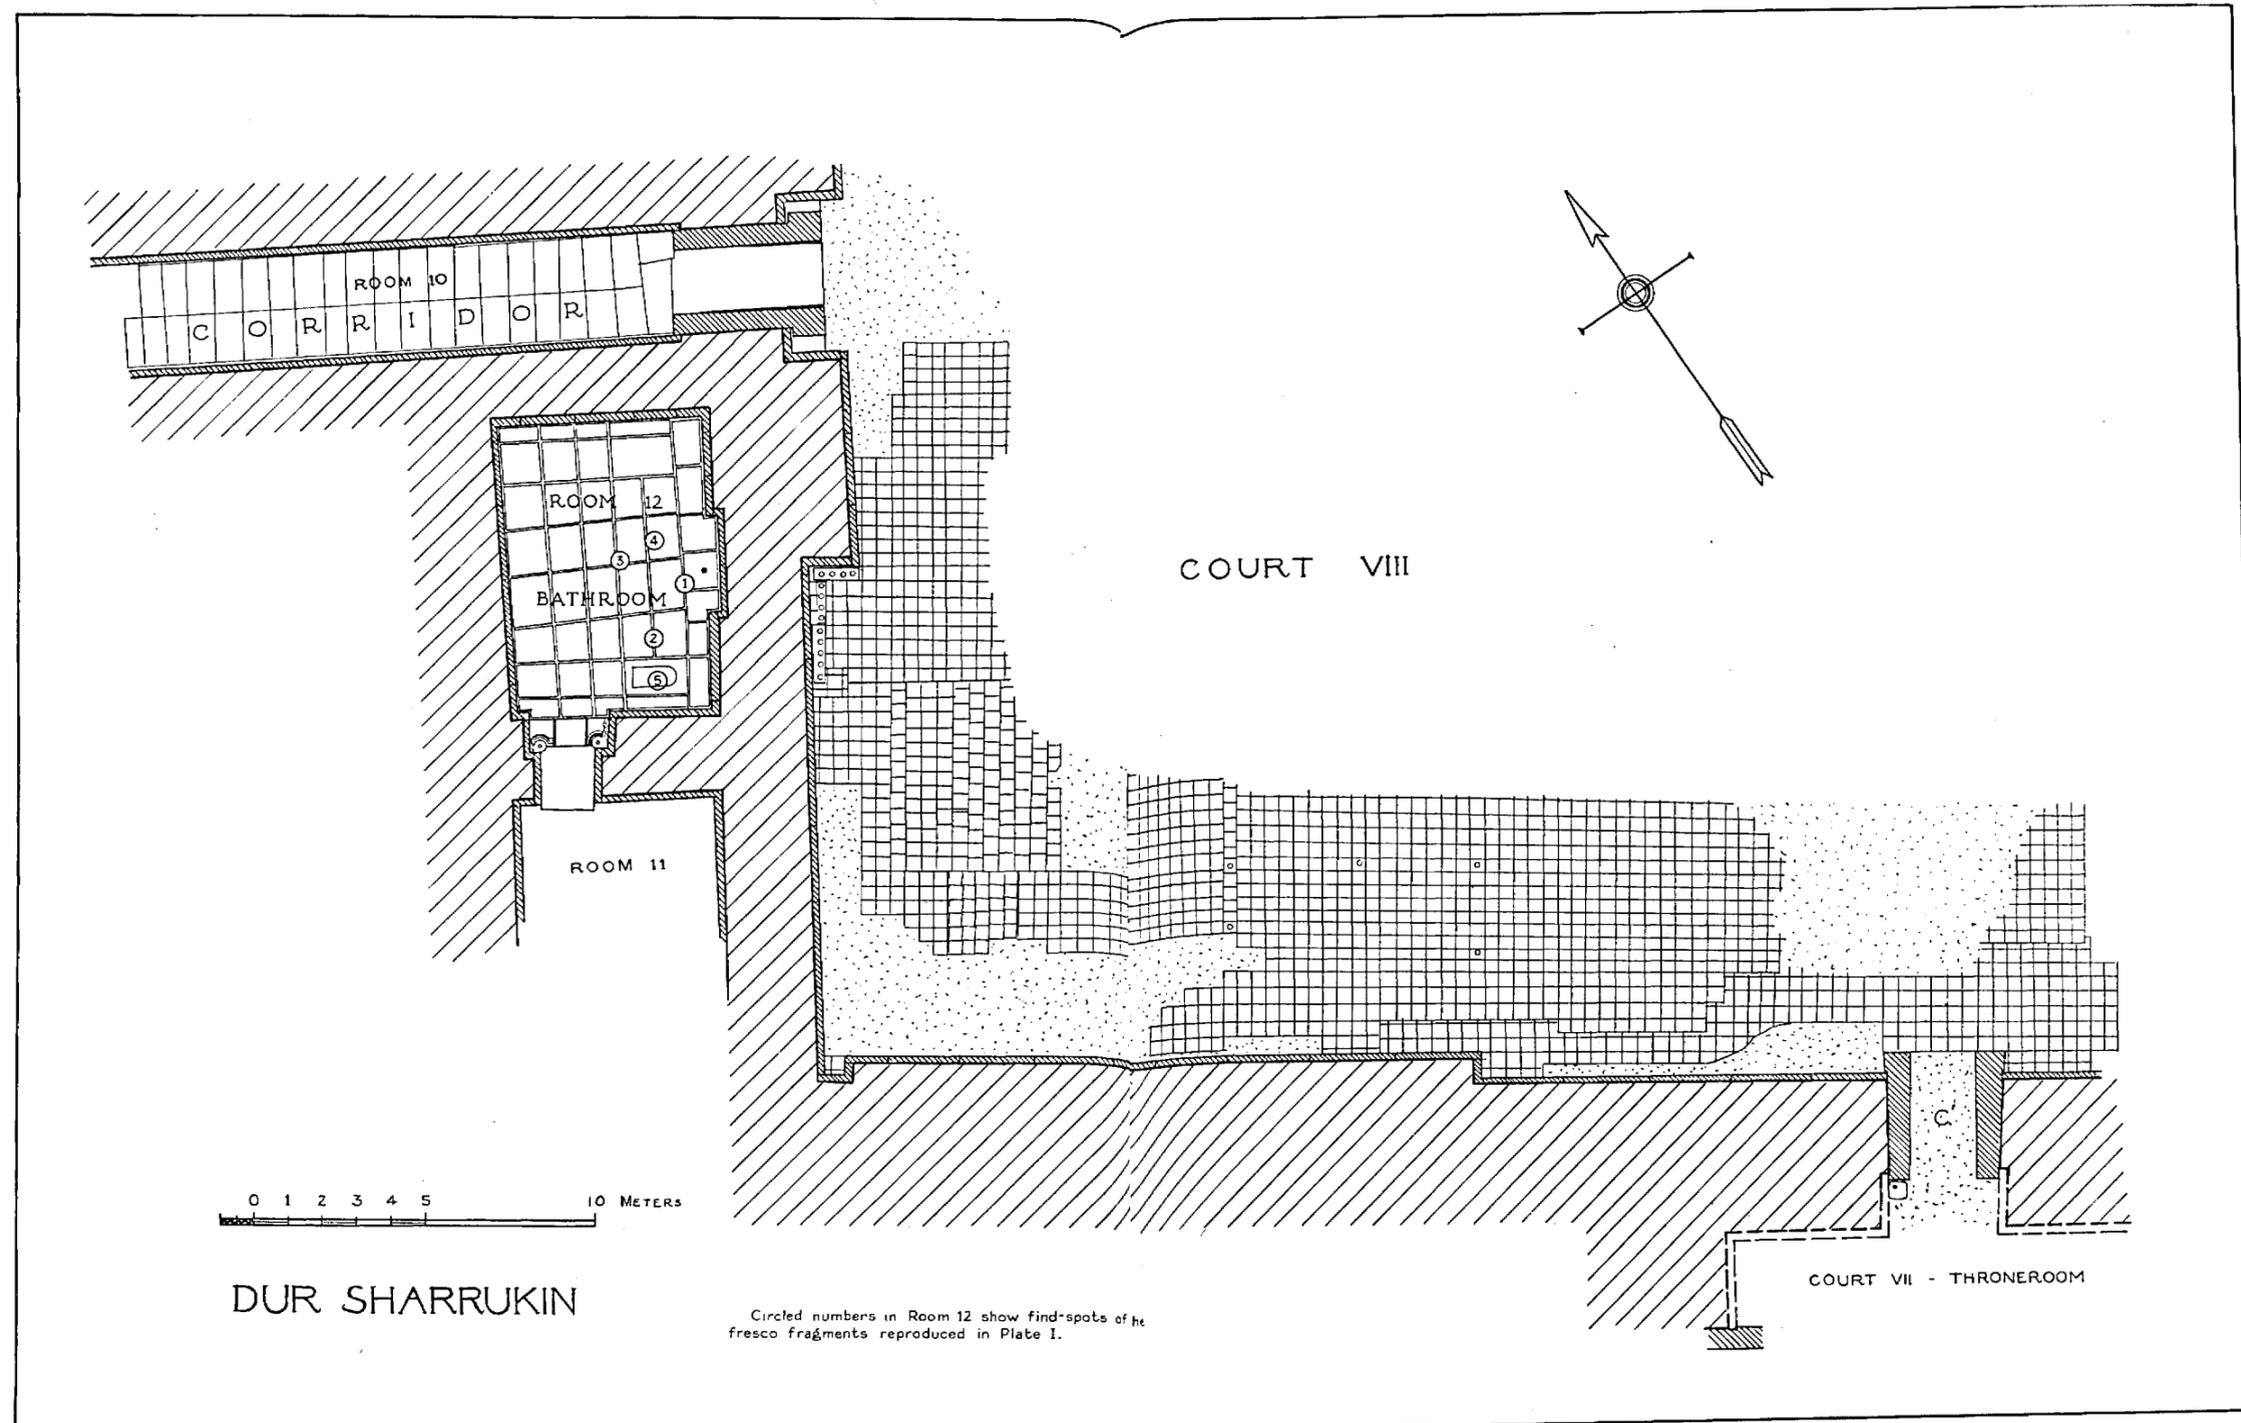
FIG. 22.—PLAN OF WEST CORNER OF COURT VIII AND ADJACENT ROOMS: THE CORRIDOR (ROOM 10), THE BATHROOM (ROOM 12), AND THE THRONE ROOM (COURT VII). SCALE, 1:200

painted plaster. For over a portion of the "bathtub" depression and scattered elsewhere on the floor were found traces of this plaster fallen from above. The plaster was so damaged in its fall that it could not be handled without going into minute pieces, but its contact with the earth upon which it had lain for so many centuries had reproduced in reverse upon this earth the design originally painted upon the plaster (Fig. 27). The color remained vivid, undoubtedly little, if at all, changed from its original hue. There was no possibility of removing these remains of fresco, but they were copied in color by Mr. Wilensky and are reproduced in Plate I. Their exact find-spots are indicated in Figure 22.

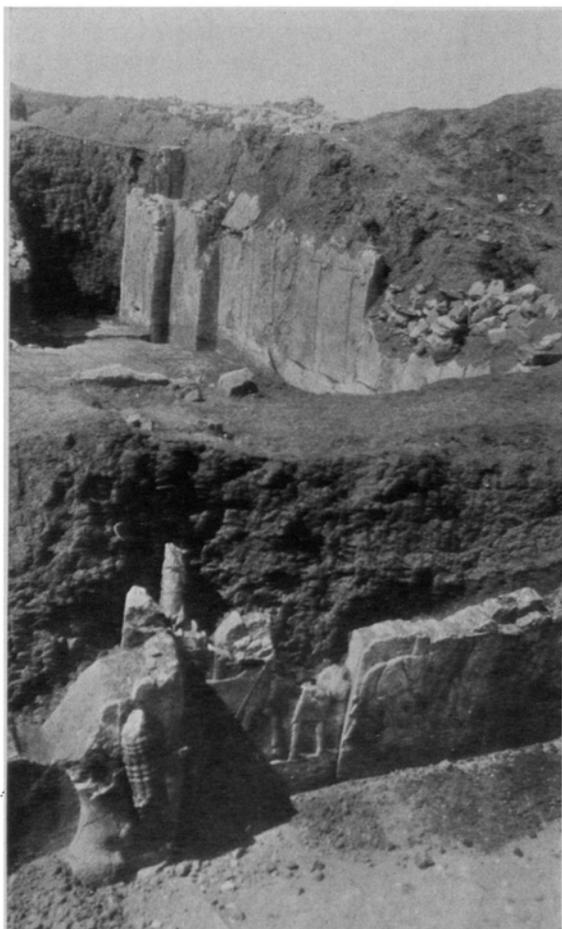
FIG. 24.—RELIEF SLABS ON THE NORTHWEST WALL OF THE BATHROOM. AT LEFT IS THE DOORWAY INTO ROOM 11. IN THE FOREGROUND IS THE SOUTHWEST WALL OF THE CORRIDOR

The doorway in the southwest wall leading into Room 11 (see Fig. 24) shows a high order of architectural development. The slabs forming the walls beside the raised threshold were carved in relief, but of these only one remains in sufficiently good state of preservation to determine the subject of the carving. Standing with his back to the procession is a figure of what is undoubtedly a soldier, for it carries bow, arrow, and quiver. The door itself opened in the middle, as is clearly shown by the sockets at either side. So that the doors, when open, would neither project into the room nor be a hindrance in the passageway, the doorway was slightly recessed to a width just sufficient to allow the leaves to fall into the planes of the slabs at the threshold and to a depth only great enough to keep them behind the face of the room wall (see Fig. 22).

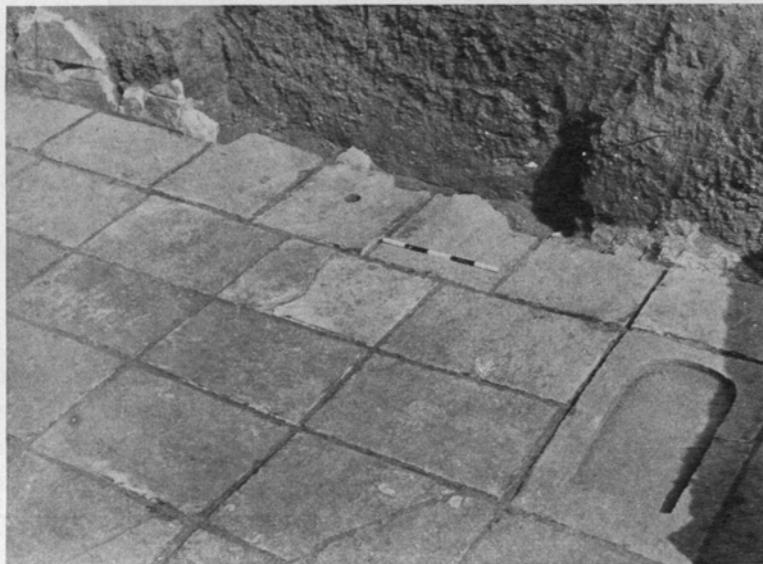
FIG. 26.—FLOOR OF THE BATHROOM, SHOWING THE DEPRESSION INTO WHICH A TUB MAY HAVE BEEN SET. IN CENTER BACKGROUND APPEARS AN OPENING INTO A DRAIN

The pavement of the room is of rectangular stone slabs of varying dimensions. One somewhat larger paving slab near the south corner of the room has cut into it a depression 1.30 long and 0.15 deep in the shape of a bathtub. Near by, centered in the niche in the southeast wall, a circular hole connected with a drain penetrates one of the paving slabs (Fig. 26). It was these irregularities in the floor that immediately suggested this as having once been Sargon's bathroom. Originally it had been roofed, so there was no need for a drain to carry away rain water. Into the depression in the floor might have fitted a tub, probably of metal, in which the sovereign bathed. And the size and location of the room suggest it as well; or, rather, they present no obstacle to such theorizing. Mr. Sidney Smith, at that time Director of Antiquities for the Iraq Government, suggested that perhaps it might have been used for some of the purification rites that are often mentioned in Assyrian tablets.

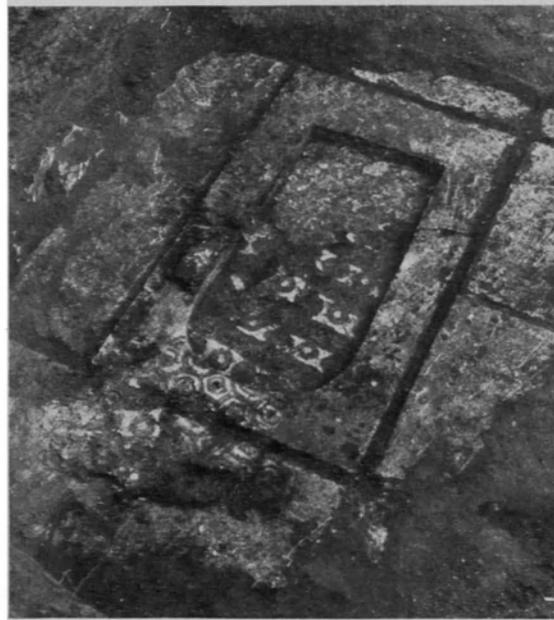
FIG. 27.—REMAINS OF PAINTED PLASTER FALLEN FROM THE WALLS OR CEILING OF SARGON'S BATHROOM

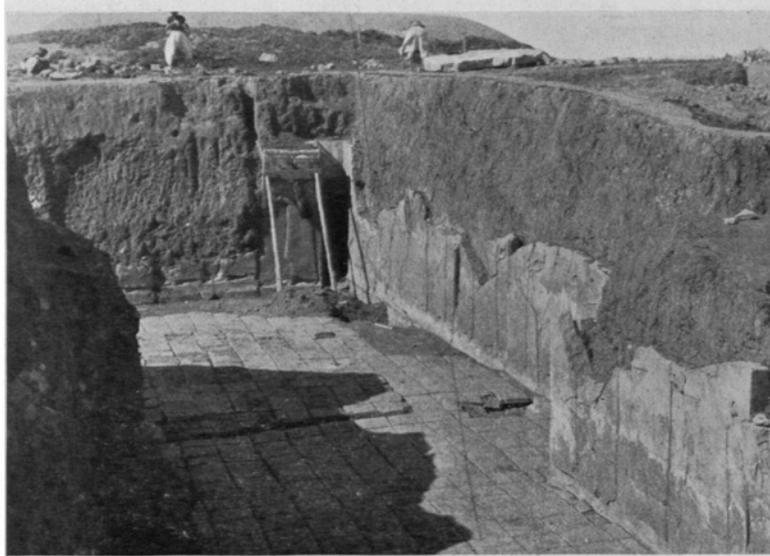
FIG. 36.—STANDING FIGURE CARRYING A BOWL. THE RELIEF WAS PROPPED UP TO PREVENT ITS FALLING, UNTIL ITS REMOVAL COULD BE UNDERTAKEN

Upon turning the west corner of Court VIII, the trench disclosed a complete standing figure bearing a bowl resting on the left hand and steadied by the right. Only a fragment of the skirt and a large portion of the face were missing. Careful digging in the débris before this slab, however, successfully produced the latter unharmed. To prevent its breaking and falling,

the upper part of this figure was bound together with rope and propped up by wooden poles (Fig. 36) until the clearance of this corner made its removal practicable. While the first figure to be found on the northwest wall of the court was that of the king, toward whom the procession moved, this first slab comprising the reliefs of the southwest wall eventually proved to picture the last figure of a somewhat similar procession headed toward another representation of Sargon. In this instance the slab containing the figures of the king and his attendant had been sawed off cleanly and taken away, probably by Place. It most likely now reposes on the bottom of the Tigris as a result of the misfortune that overcame one of the rafts on which his antiquities were being shipped to the sea. Those forming the procession are clearly eunuchs or attendants carrying gifts to their monarch. Figures 34 and 37 show only too well how but little more than the feet of the figures in this scene remained in place. It was indeed fortunate that the trench at this point was so widened as to lead to the discovery of some of these slabs at a considerable distance from their original location (p. 16). Figure 38 shows the slab which was immediately adjacent to that bearing the representation of the king, and pictures the like-

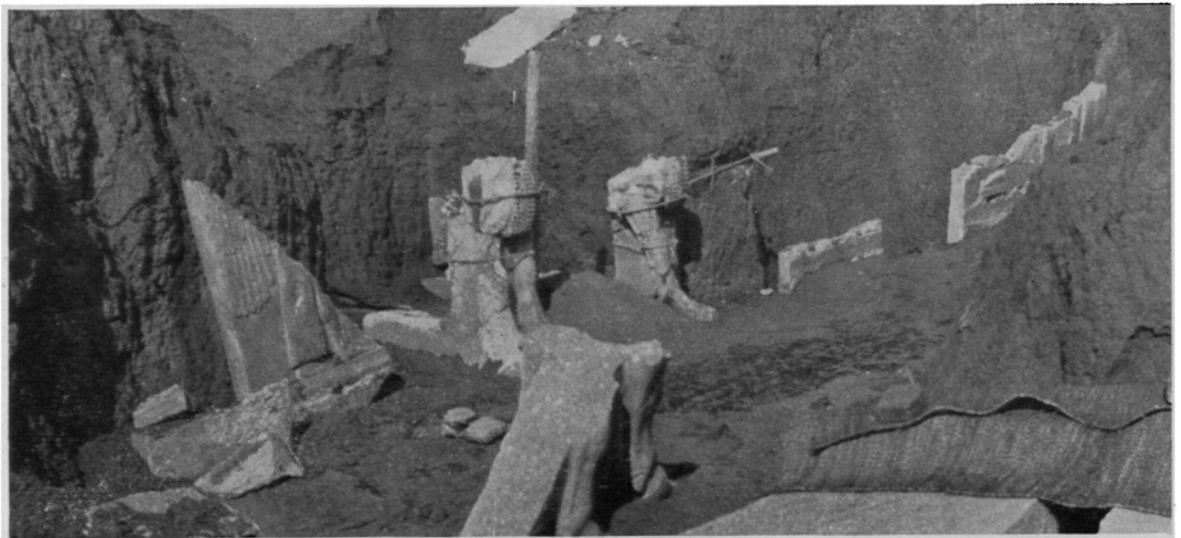
FIG. 46.—REMAINS OF THE WINGED BULLS OF PORTAL C', ONE OF THE TWO MINOR ENTRANCES FROM COURT VIII TO THE THRONE ROOM

is one of the small doorways situated on both sides of the huge central portal. This side entrance was lined with bulls facing Court VIII, and was flanked with winged human figures (Fig. 46). The discovery of these bulls solved the mystery of the provenance of the grindstone found before the agha's house. Of the same material and thickness and of a diameter approximately equal to the dimensions of the cut-out portions of these bulls, there is little doubt but that this grindstone was chiseled out of one of the sides of this door, and that in Khorsabad or a neighboring village barley is today being ground by a stone cut from the complementary bull. Figure 47, in which is drawn the condition of these two bulls as found by the expedition, clearly shows how the stone for these grinders was cut from the central portions of the bulls, leaving standing but the forelegs and tails. Close examination showed how carefully, and necessarily laboriously, these had been chiseled off.

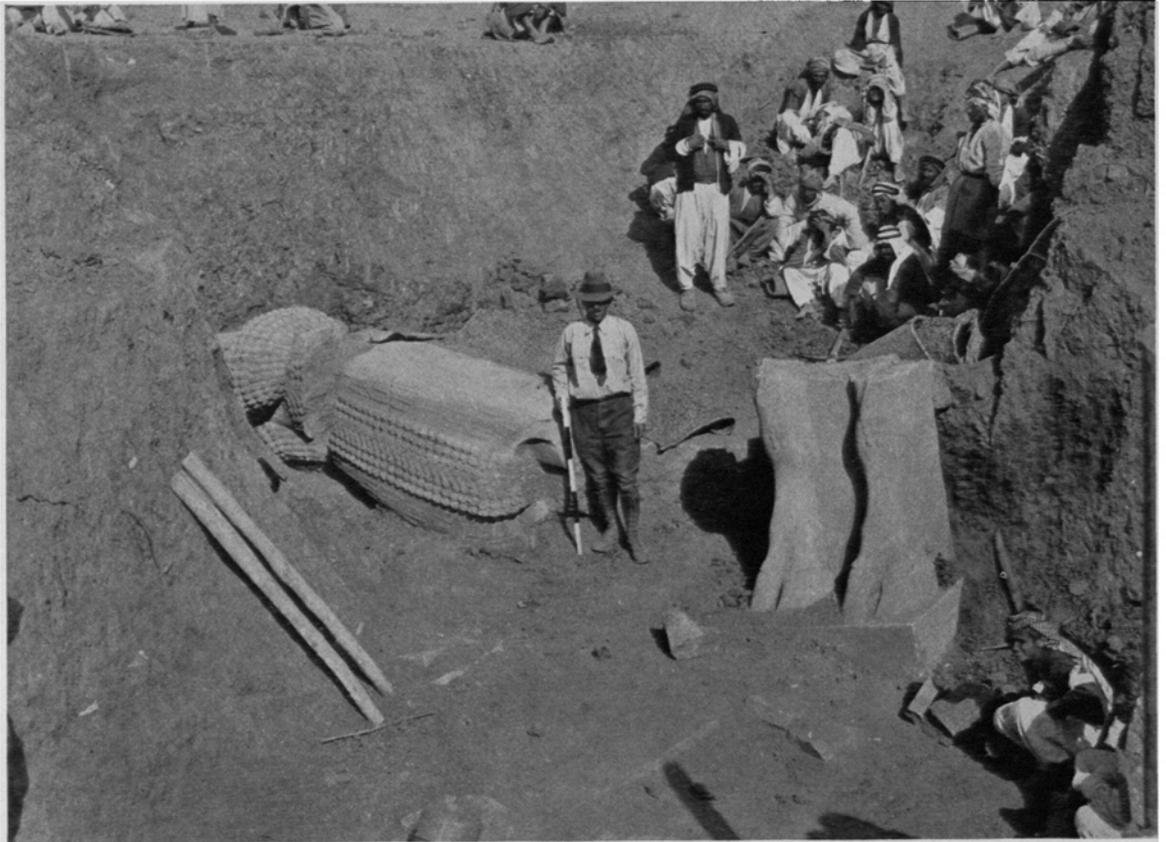
FIG. 57.—FRAGMENTS OF THE COLOSSAL BULL AS THEY WERE DISCLOSED BY THE EXCAVATIONS. DR. CHIERA STANDS BESIDE THE FALLEN HEAD

on the eunuchs of the wall reliefs. A turban composed of feathers and bands of rosettes crowns the head. Figure 57 shows the relative positions of head and forelegs as they were found.

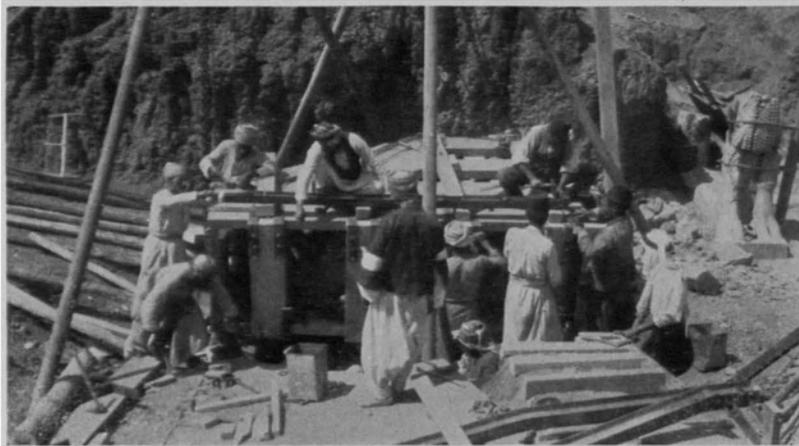
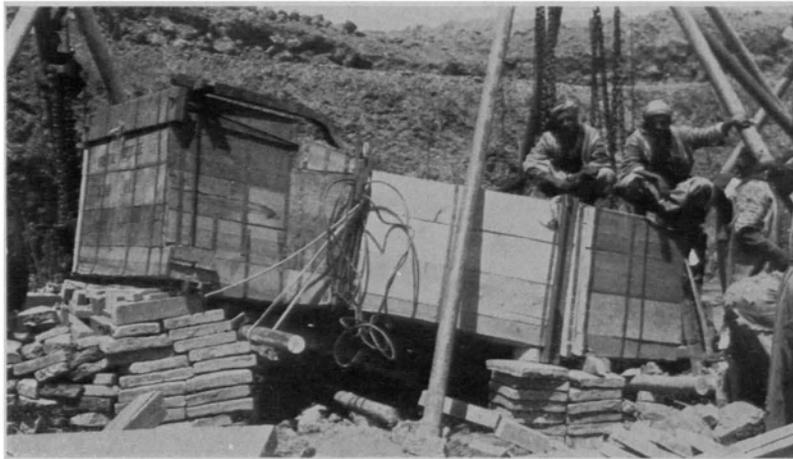
FIG. 58.—ENCASING THE LARGEST FRAGMENT OF THE BULL

The large fragments had to be lifted by means of several locally made hoists and the cases built around them (Fig. 58). Iron beams must be bent and the bolt holes drilled to provide suitable reinforcement for the heavy wood casing. All this was accomplished with no undue difficulty, though the work was considerably handicapped by lack of proper equipment and the employment of carpenters and iron-workers who, while the best in Mosul, would be classed as unskilled according to our standards. Nature too was adverse, for by this time the

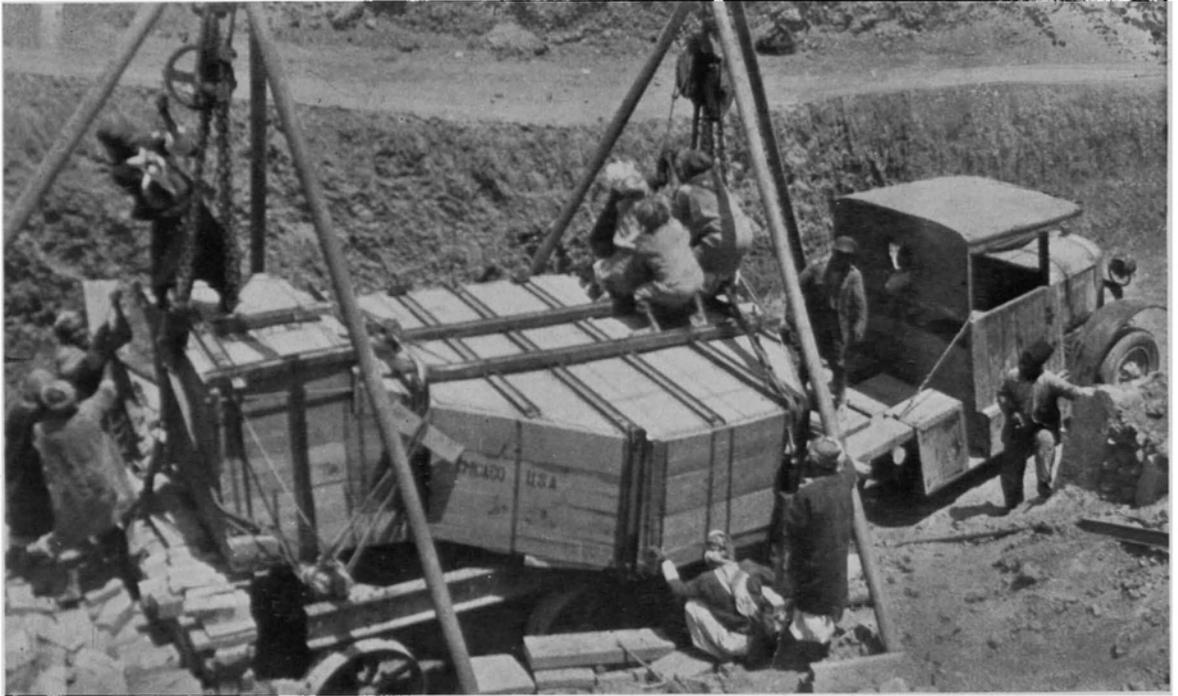
FIG. 59.—LOADING THE LARGEST FRAGMENT OF THE BULL UPON THE TRAILER

Upon the arrival of the trailer began the biggest job of all. This specially constructed vehicle was attached to the truck for a trial run and, though empty, broke. It was repaired; and after a second trial had made it seem satisfactory it was placed under the suspended case, which was then lowered upon it (Fig. 59). But at the moment when the truck began to pull, all the upper part bent. The case was lifted and the trailer extricated for further repairs.

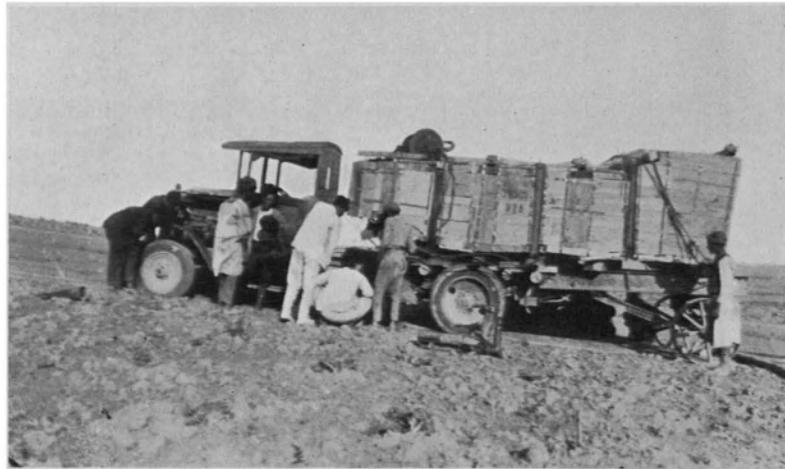
FIG. 60.—REPAIRING THE TRUCK ON THE ROAD

The troubles, however, had not yet ended. The descent from the palace mound caused part of the now six-wheeled vehicle to give way, and repairs were necessitated (Fig. 60) even before the Mosul road was reached. At the end of the first day only half the 12-mile distance to the river had been covered. The combined truck and trailer with its enormous load was but part of the procession that moved slowly along the road. In a small car was Mr. Delougaz with two foremen, the latter to be left in places where the road needed immediate repairing. Behind them came a small truck with a gang of workmen armed with picks, shovels, and wooden
