KHORSABAD

EXCAVATIONS IN THE PALACE AND AT A CITY GATE

THE UNIVERSITY OF CHICAGO
ORIENTAL INSTITUTE PUBLICATIONS
VOLUME XXXVIII

GORDON LOUD

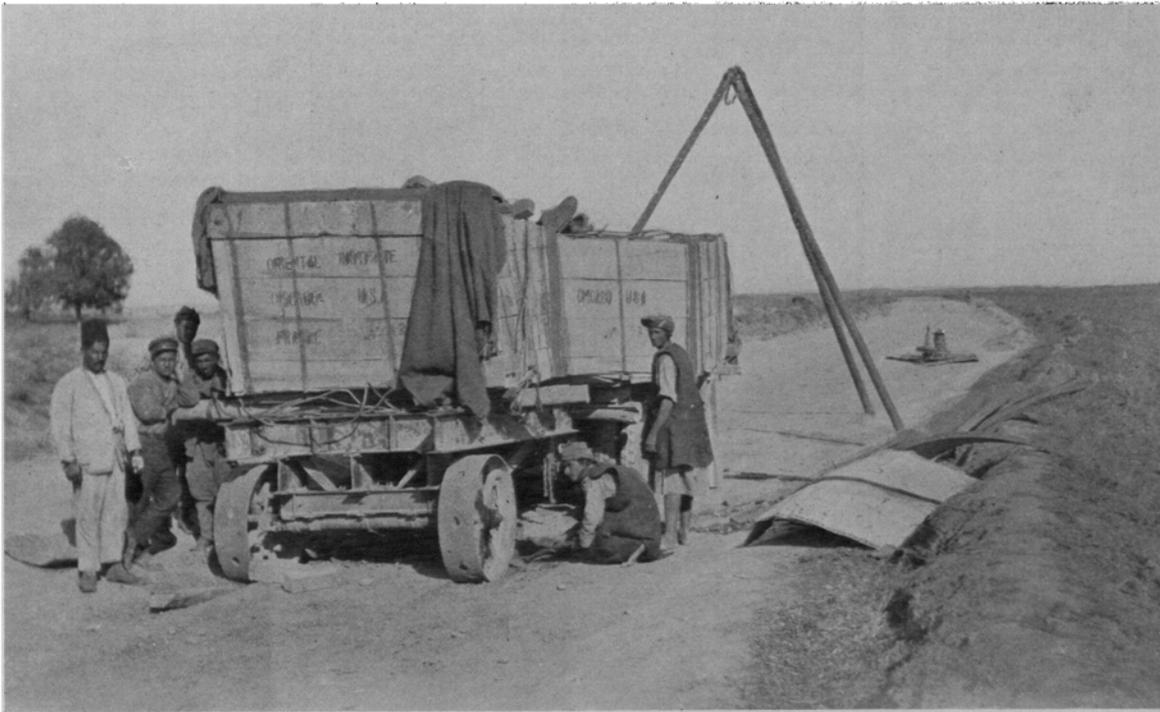
FIG. 61.—A BREAKDOWN FARTHER ALONG THE ROAD

The following day when within sight of the river there was engine trouble, and shortly after this was remedied the shaft broke (Fig. 61). During the next three days but little headway was made. By the time one repair to the truck was completed and the procession set in motion another part of the vehicle would give way, necessitating more repairs and delays. Finally upon the fifth day after leaving Khorsabad and when within but 300 meters of the river, the truck became completely disabled. It was then a case of bringing the boat to a point opposite the breakdown and of dragging truck and all over a road hastily constructed through plowed fields to the river bank by means of cables and power from the boat (Fig. 62).

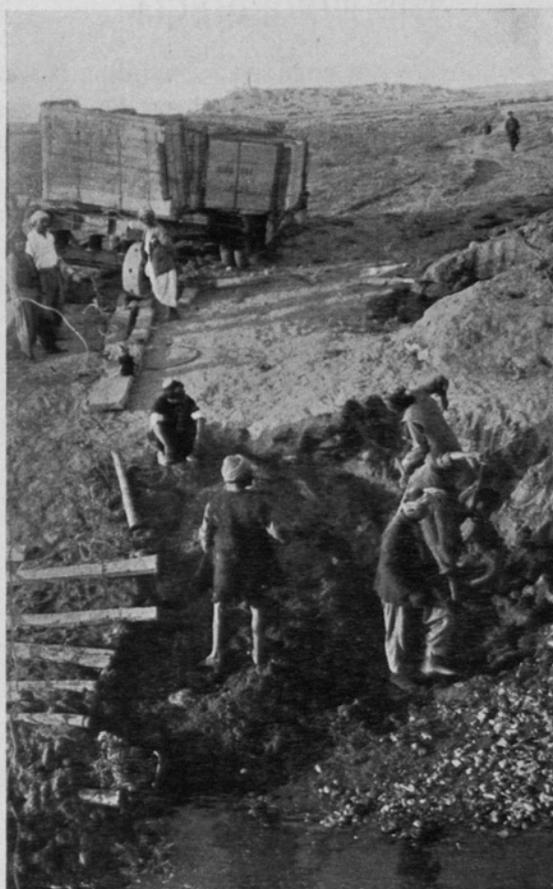
FIG. 62.—HAULING THE DISABLED TRUCK TO THE RIVER BY MEANS OF CABLES AND POWER FROM THE BOAT

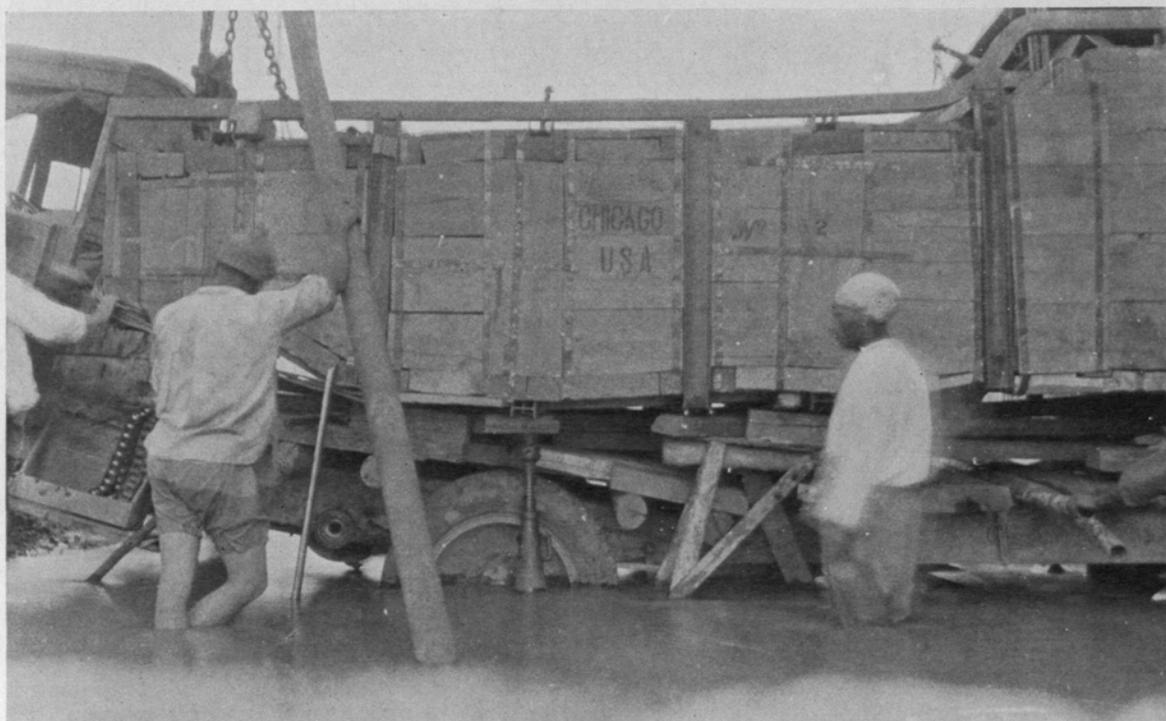
FIG. 63.—RAISING THE LARGEST FRAGMENT OF THE BULL BY MEANS OF BLOCKS AND JACKS PREPARATORY TO LOADING IT UPON THE BOAT

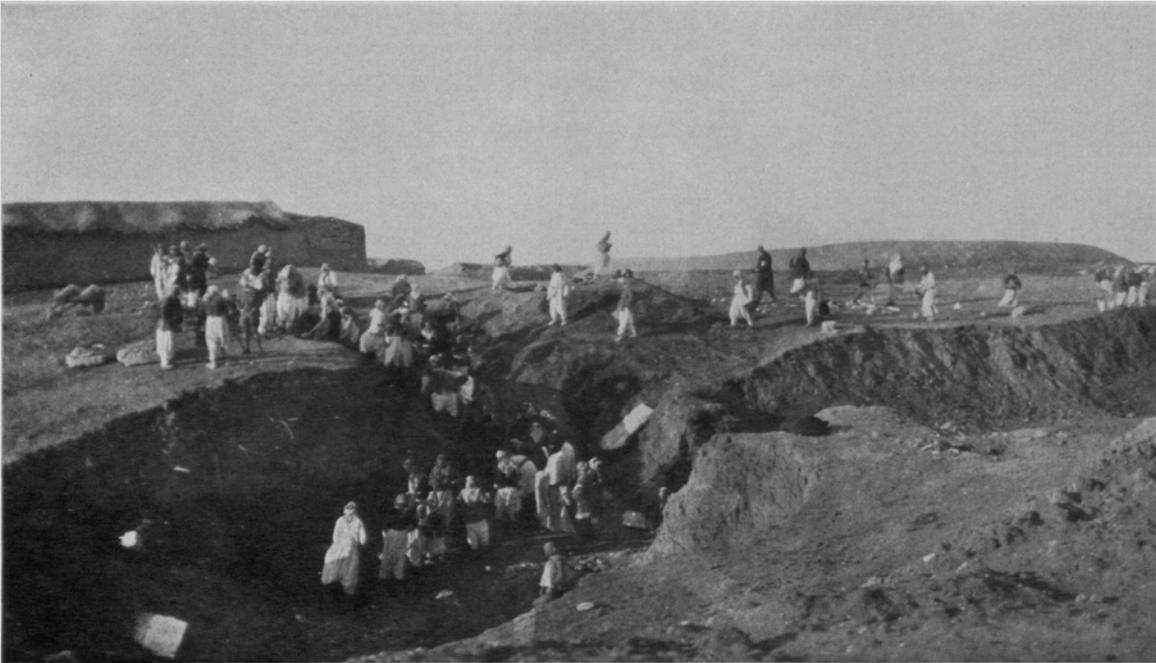
FIG. 65.—CLEARANCE OF DOORWAY C' LEADING FROM COURT VIII TO THE THRONEROOM

Since the excavations of the preceding season in Court VIII had partially disclosed doorway *C'* (frontispiece and Fig. 22), northwest of the central portal, leading into what was supposedly Court VII, the logical approach to the complete clearance of the latter was through this side entrance. The men were accordingly set to work at this point (Fig. 65) and in a few hours succeeded in clearing the remains of the bulls forming the sides of the doorway. With this doorway thus established it was possible to stake off upon the ground surface the approximate area of the "court" as given by Place, and to commence its excavation from the surface while at the same time pushing on into the lower levels through the doorway.

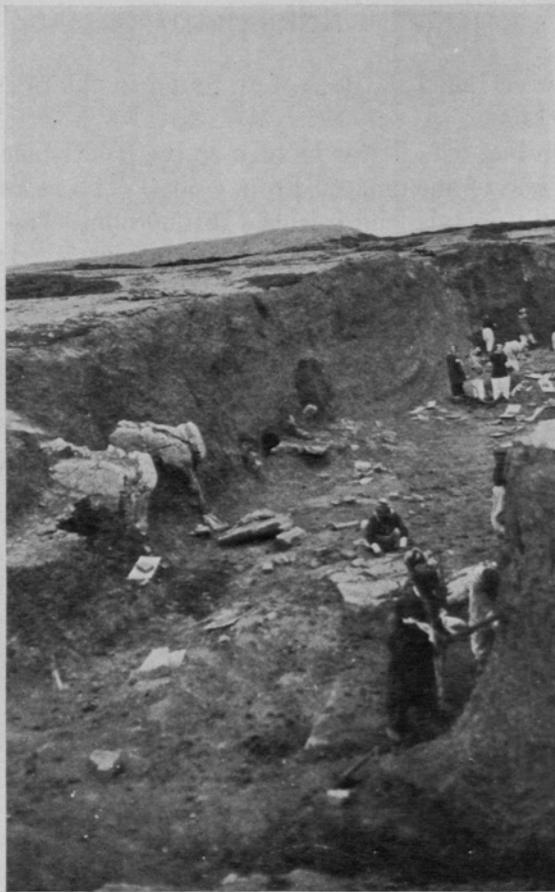
FIG. 67.—REMAINS OF BADLY WEATHERED BULLS LINING A DOORWAY IN THE SOUTHWEST WALL OF THE THRONE-ROOM

There is positive evidence not only of the existence but of the method of construction of all the other doorways. The second doorway in the southwest wall, if we assume as a fact the one just mentioned, is lined with bulls facing and extending into the room. Age and moisture have caused such deterioration that they are today a sorry sight (see Fig. 67). Enough remains of them, however, to give us the breadth of the doorway and to show, not only by their position but by grooves into which the wall slabs fitted, that their foreparts projected into the room nearly a meter beyond the plane of the wall surface.

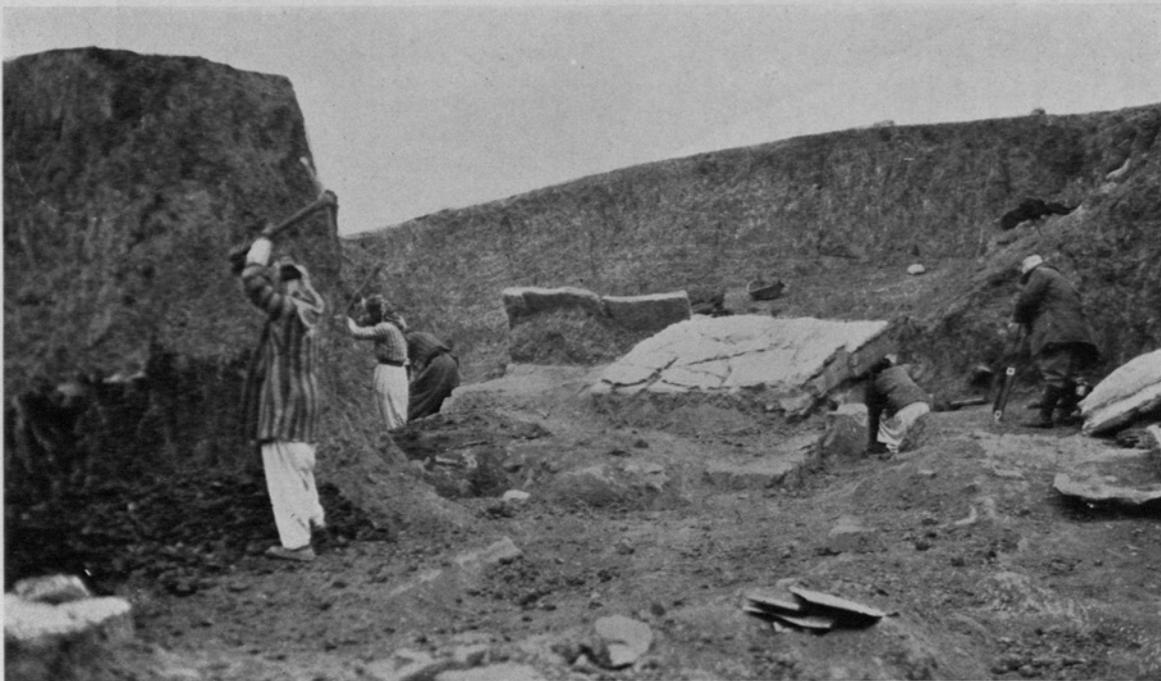
FIG. 68.—NICHE ONCE BACKING THE THRONE, AS IT WAS FOUND FALLEN OVER THE THRONE BASE

what was later discovered to be the base upon which the throne had rested (Fig. 68). Quantities of fallen plaster, painted in many designs (Figs. 69 and 70), were found throughout the entire room at varying levels, some in such position and relationship with traces of wood as to make certain the nature of the original roofing. The levels and locations of all significant plaster fragments were recorded. The various designs are discussed and illustrated on pages 67 ff. It is sufficient to state here that above the row of relief slabs which originally faced the walls the plaster was adorned with painted figures, and that the beamed ceiling was likewise plastered and decorated with brilliantly colored patterns.

Within the throneroom (Fig. 71), directly opposite the central entrance, are the remains of one huge monolithic niche, 5 meters wide, which originally may have extended to the top of the wall relief slabs or even to the ceiling. The latter hypothesis seems the more probable when we consider the width of the niche and its position opposite the doorway, the opening of which doubtless reached a height considerably above that of the reliefs. To the left of one entering through this principal portal a pavement of stone slabs measuring about 2×4 meters

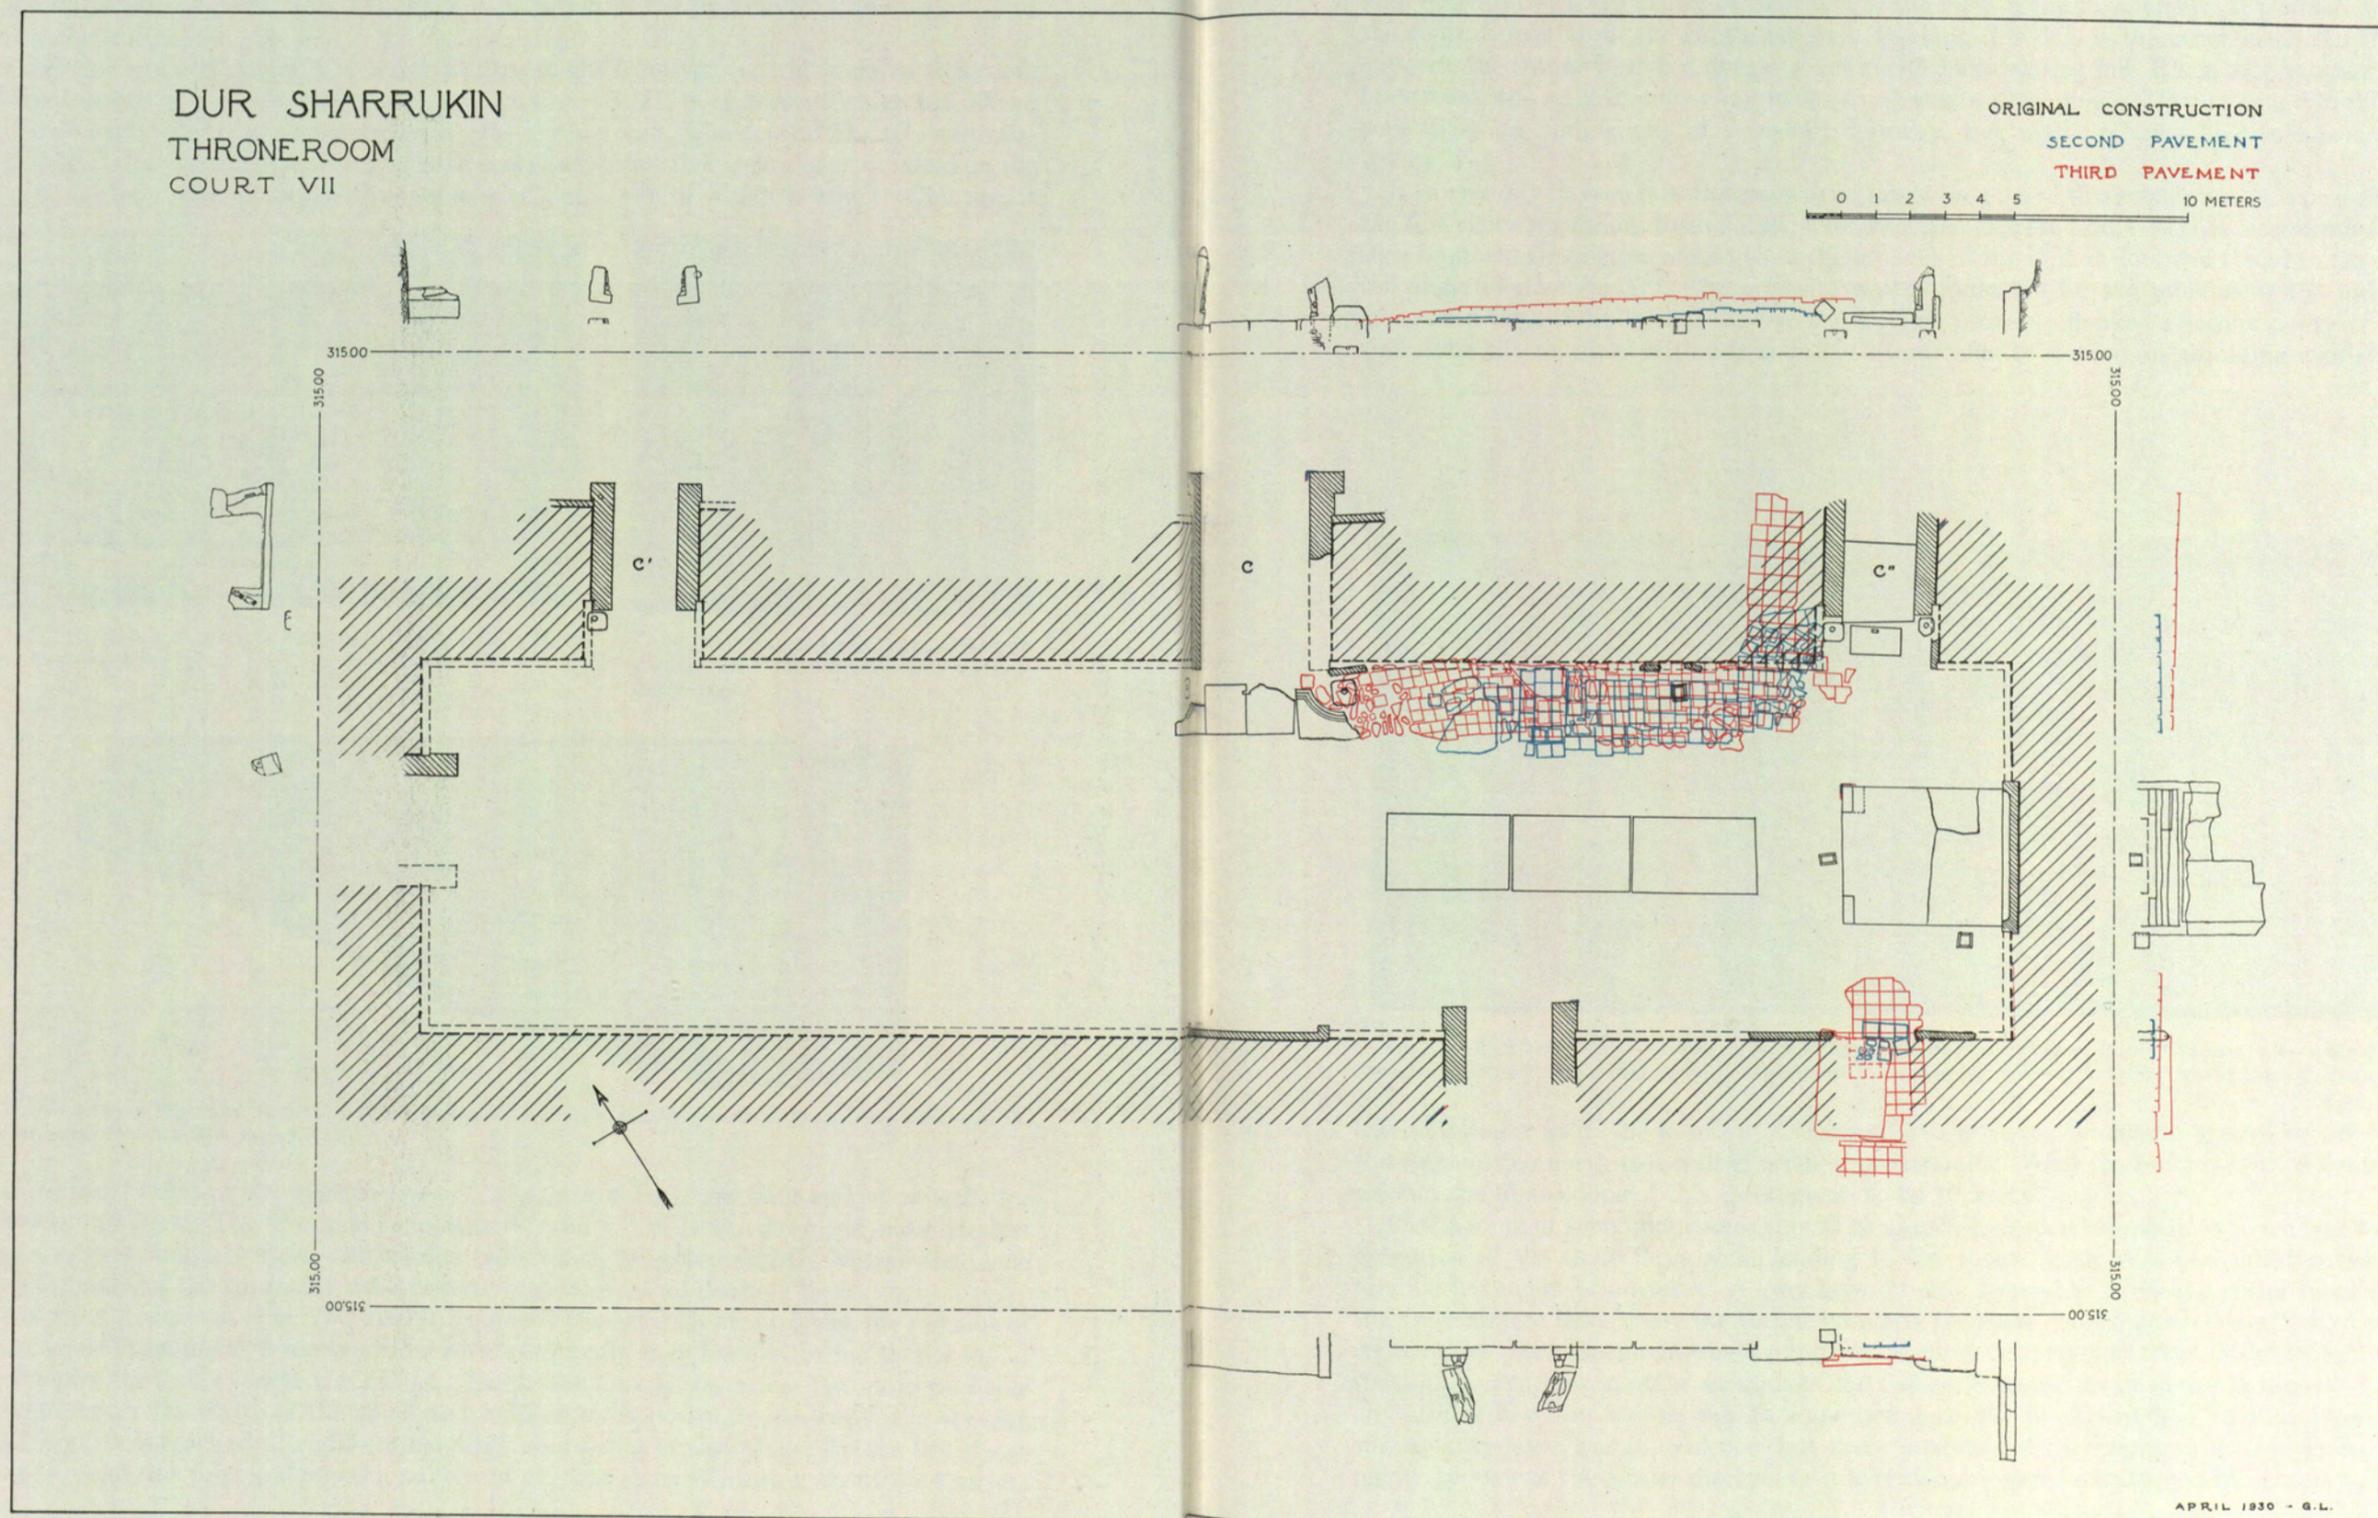
FIG. 71.—PLAN AND ELEVATIONS OF THE THRONE ROOM. THE EXISTING REMAINS ARE INDICATED IN SOLID BLACK LINES WHILE BROKEN BLACK LINES SUGGEST THE ORIGINAL PLAN. LATER PAVEMENTS ARE SHOWN IN BLUE AND RED. SCALE, 1:200

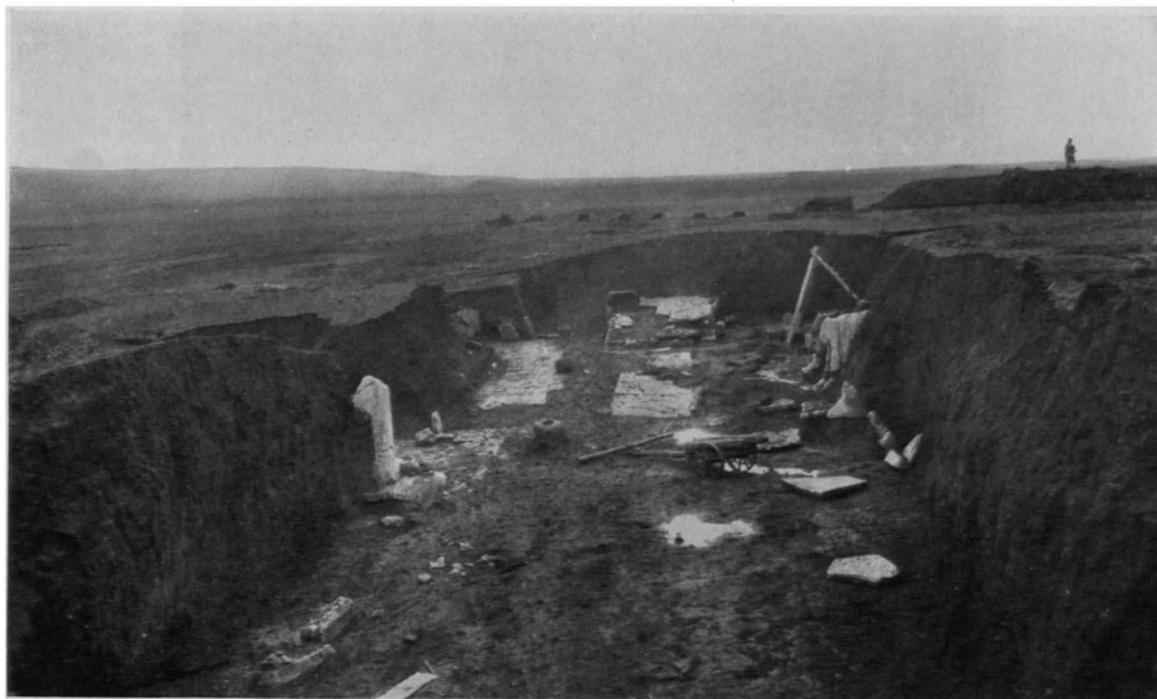
FIG. 73.—THE THRONEROOM FROM THE NORTHWEST. THE STONE PAVEMENT SLABS CENTRALLY LOCATED FORM AN APPROACH TO THE THRONE JUST BEYOND. THE BRICK PAVEMENT ON THE LEFT IS OF SECONDARY CONSTRUCTION

each extends down the center of the room to the base of the throne (Fig. 73), which occupies the central position in the southeast wall. Backing this dais is the other niche. In the wall opposite the throne base is a doorway lined with bulls leading into Room 24. Another pair of bulls forms the walls of a doorway in the southwest wall leading to Room 27; and in this same wall there are indications of a second doorway, but without bulls, likewise opening into Room 27.

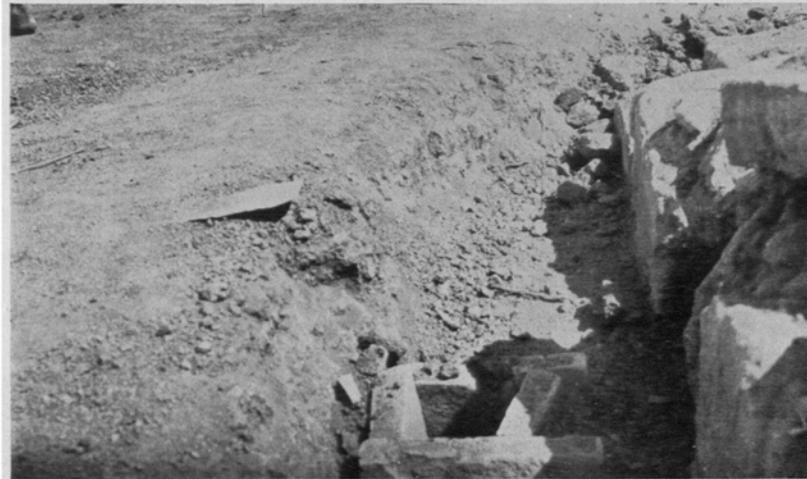
FIG. 74.—FOUNDATION DEPOSIT BOX OF BAKED BRICKS BEFORE THE THRONE BASE

once paved with stone or brick. The brick foundation deposit boxes (e.g. Fig. 74) found before and beside the throne base and along the northeast wall provide another argument. If the pavement was of stone, its floor slabs would undoubtedly have been of the standard size found elsewhere in the palace. In either case the three larger slabs leading to the throne would therefore have emphasized the approach to this important object. The gray layer can easily be accounted for as caused by water running in from Court VIII after the removal of

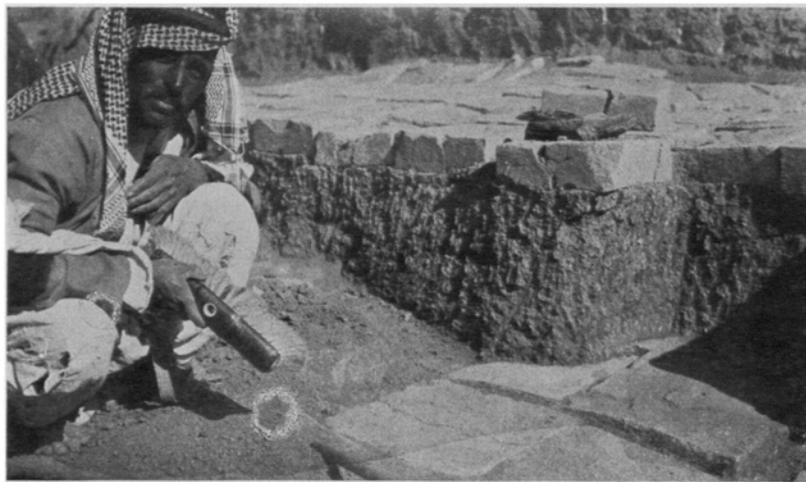
FIG. 75.—THE TWO PAVEMENTS OF LATER OCCUPATION IN THE THRONEROOM. THEY ARE SEPARATED BY A LAYER OF DÉBRIS

upward course. Figure 75 shows the juxtaposition of these two crudely built pavements. That appearance meant nothing to their builders is clear from the fact that in both cases stone was incorporated where it was handy (Fig. 76).

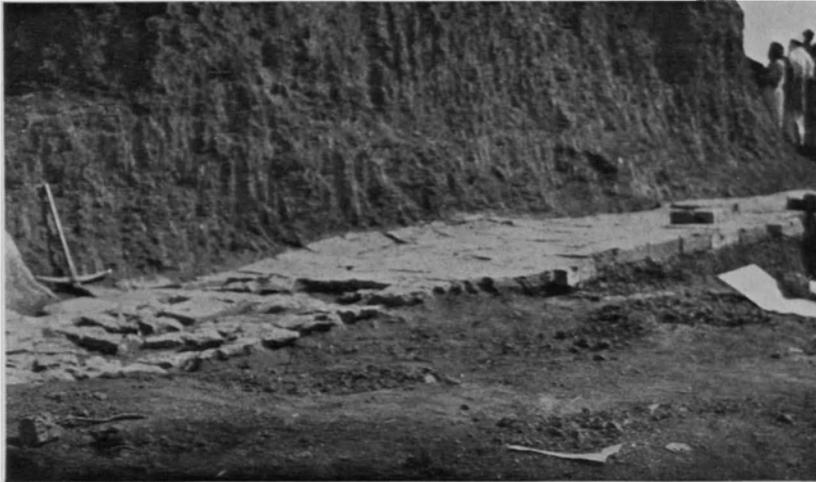
FIG. 76.—PAVEMENT OF THE SECOND PERIOD OF LATER OCCUPATION, IN WHICH SMALL STONE FRAGMENTS WERE INCORPORATED (AT LEFT)

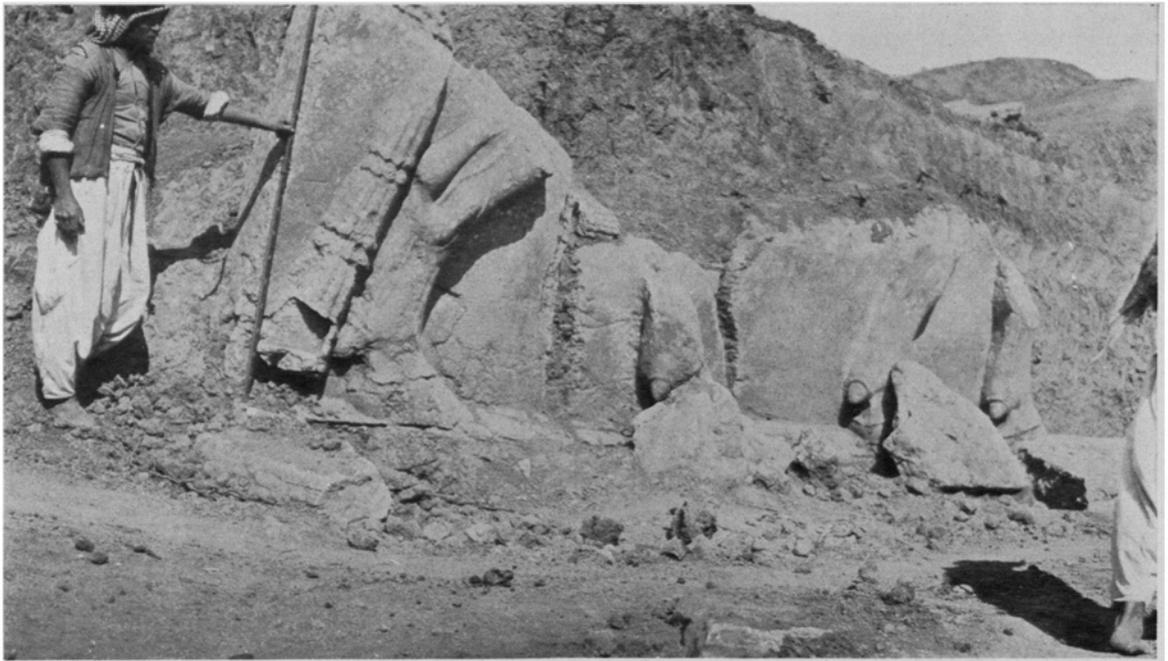
FIG. 78.—REMAINS OF THE BULL LINING THE NORTHWEST SIDE OF THE PRINCIPAL ENTRANCE TO THE THRONEROOM

It is the bull to the right (Fig. 78) as one entered the throneroom through the central portal *C* that gives perhaps the most important new information concerning this doorway. Of this bull nothing remains standing above the legs, the inscription between which is still legible. But on the reverse side, at the corner directly behind the end of the bull's tail, the stone is cut away to receive the stone facing of the wall, directly in line with the few slab fragments found in position. Corroborated by the two pivot stones found here in position set in baked brick casings, this shows beyond a doubt that the doorway was not recessed as shown on Place's plan.

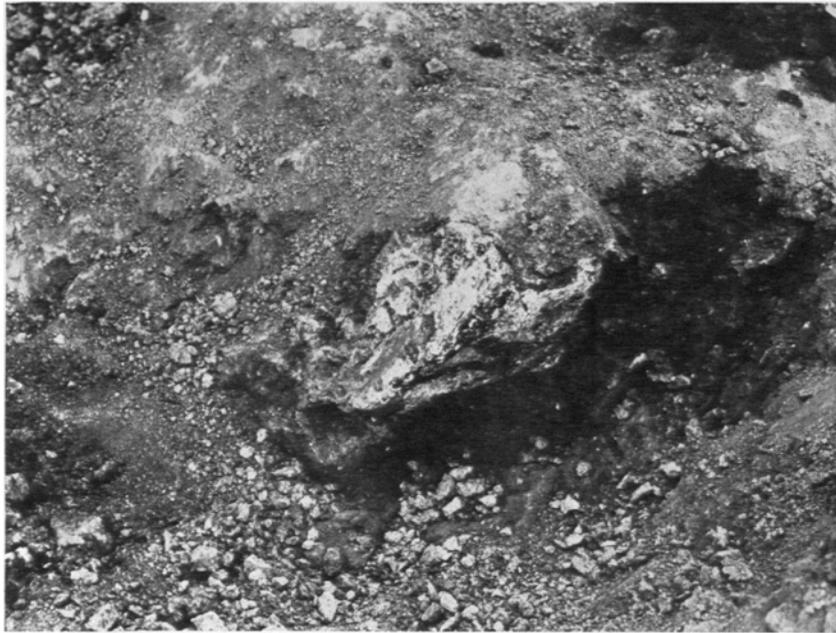
FIG. 81.—PAINTED PLASTER OF A CEILING BEAM OF THE THRONE ROOM

The treatment of the beamed ceiling is shown in Figure 81 and in Plate II 4 and 4a, where the design is reproduced. Although the wooden beam had in this instance decayed, the plaster covering two adjoining surfaces had survived. Upon one face is a row of circles, while a band of rosettes appears upon the other. Their common border band runs along the angle made by the two perpendicular surfaces. It is therefore probable that the three exposed faces of the

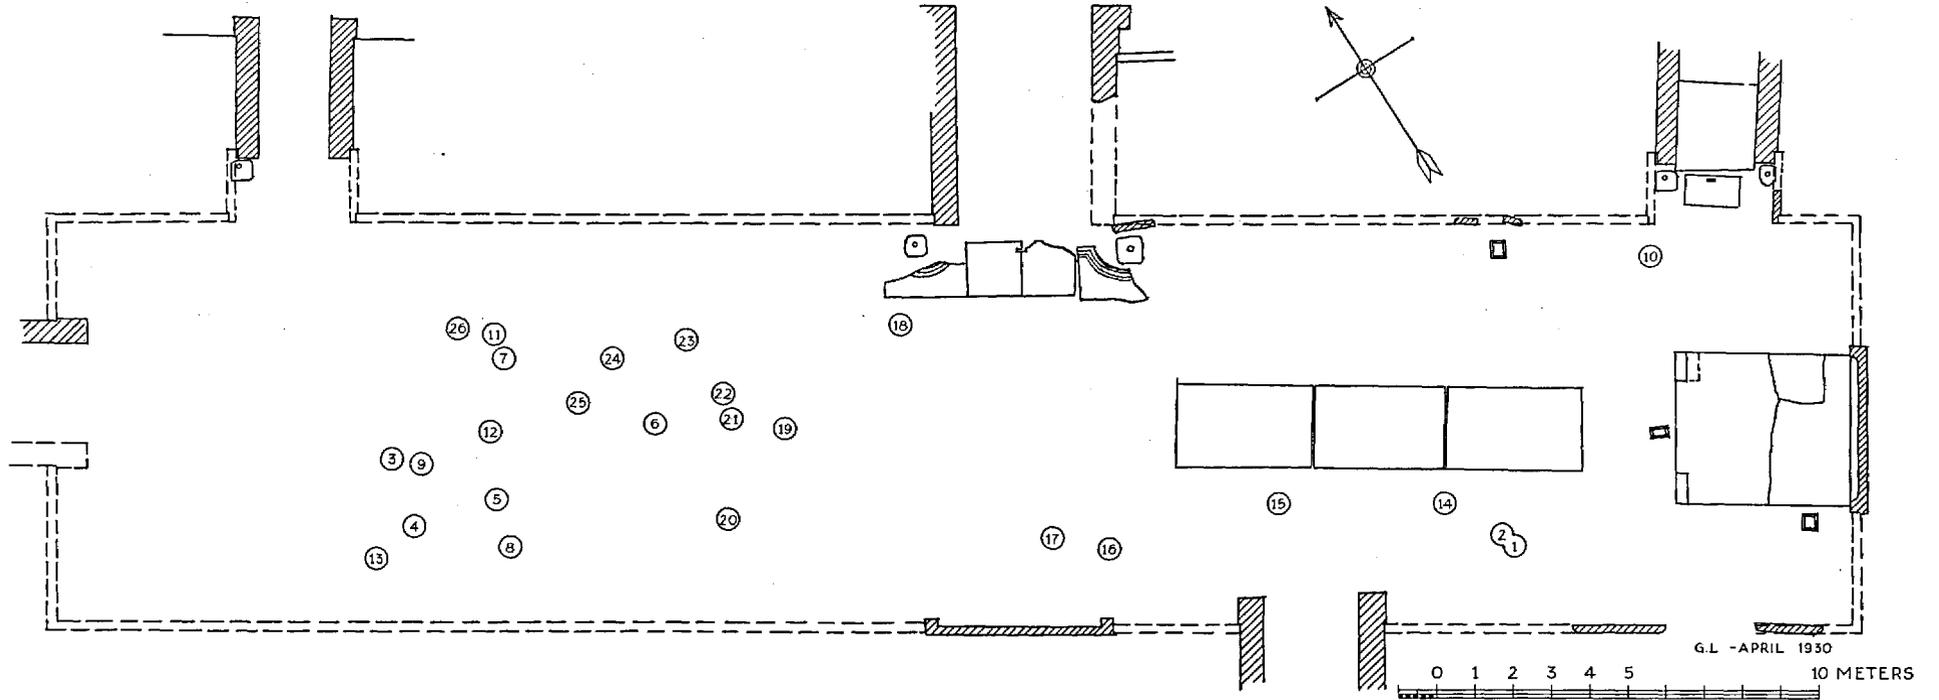
FIG. 82.—PLAN OF THE THRONEROOM, SHOWING LOCATIONS IN WHICH FRAGMENTS OF PAINTED PLASTER WERE FOUND. SCALE, 1:200

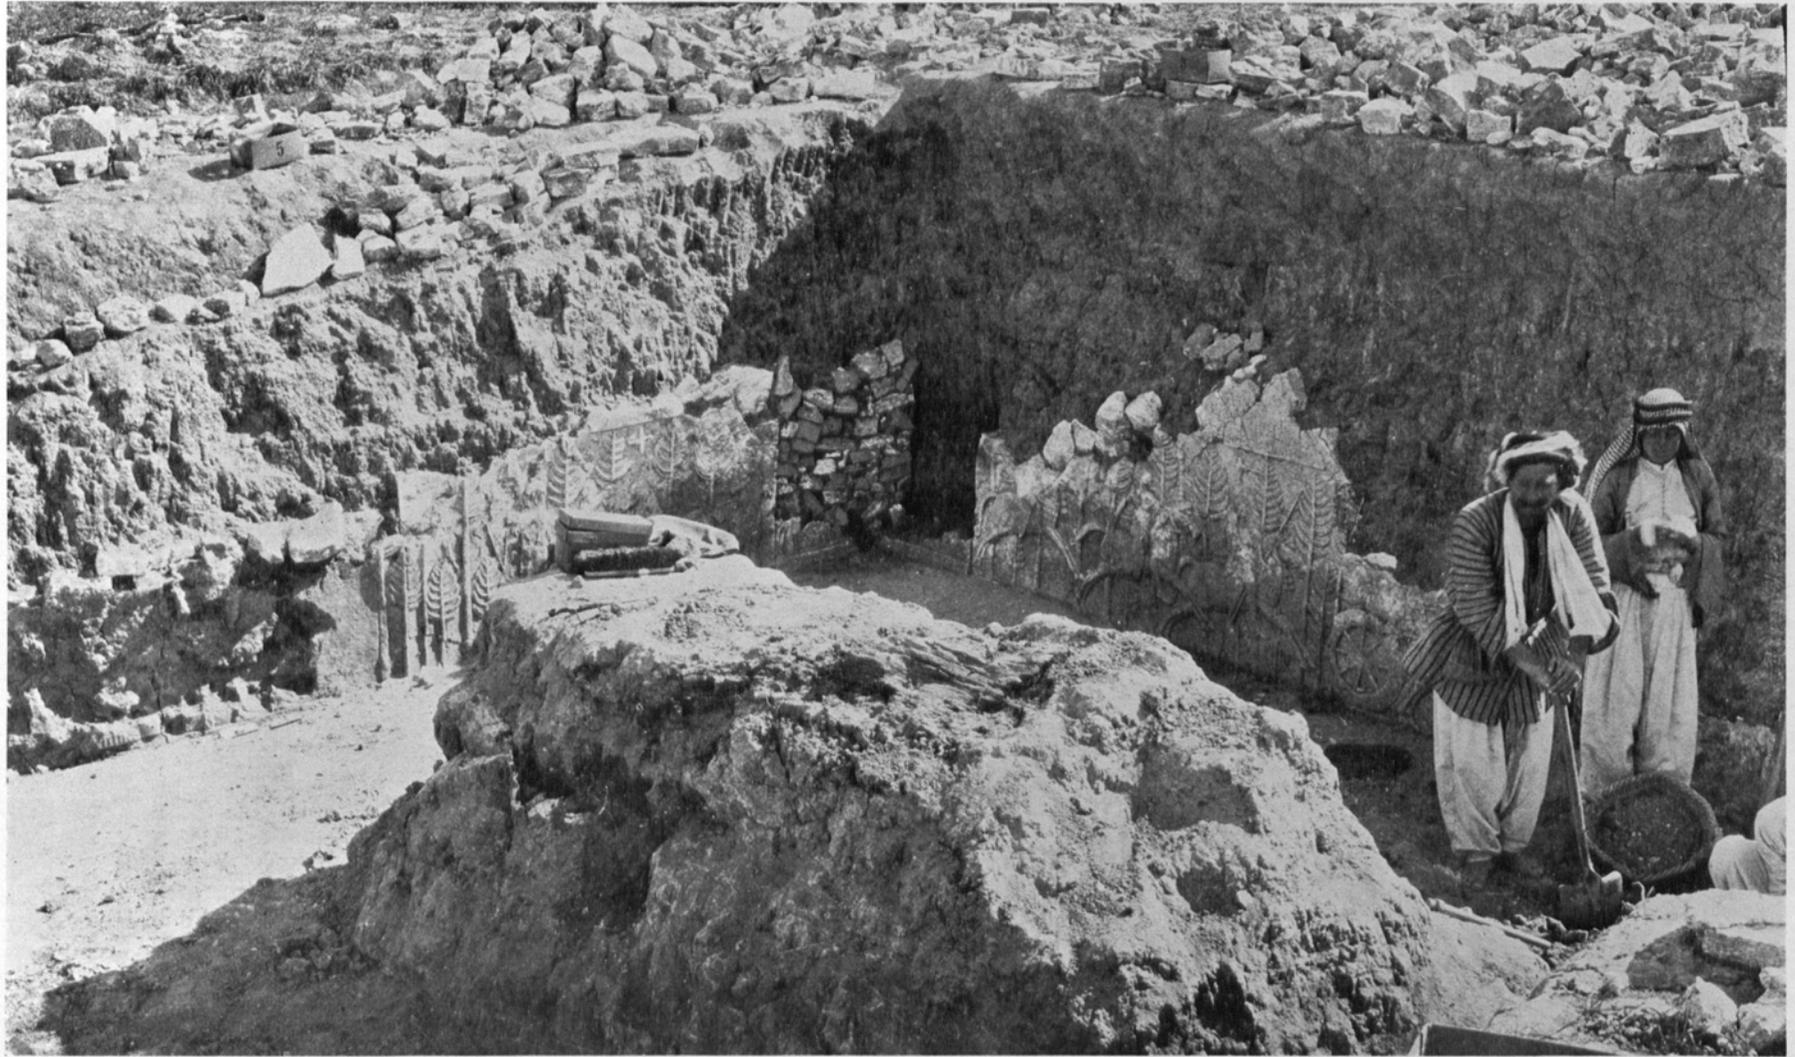
FIG. 84.—ROOM 7, WITH HUNTING SCENES PICTURED IN ITS FRAGMENTARY RELIEFS. IN THE FOREGROUND CAN BE SEEN THE REMAINS OF A ROOFING BEAM AND CHARRED MATTING. VIEW FROM NORTH

with baked brick and stone fragments (Fig. 84). The half not so blocked may have served these later occupants as a doorway, for the original doorway is filled with blocking similar to that in this south corner.

Figure 84 shows the wretched condition in which we find the reliefs today, with the lower register badly damaged and with but few remnants of the band of inscription or the upper register. A comparison with the drawings of Flandin shows us how great have been the deterioration and destruction caused by moisture and lime-burners since these reliefs were first discovered some ninety years ago.⁵

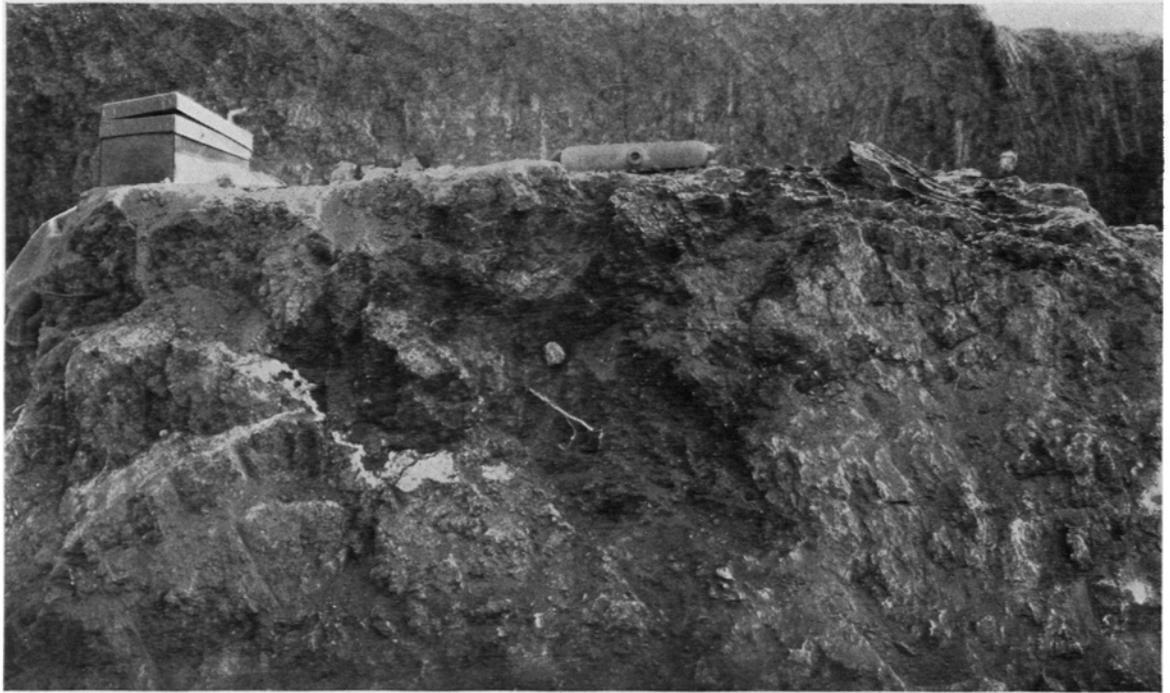
FIG. 85.—DÉBRIS IN THE MIDDLE OF ROOM 7, SHOWING A ROOFING BEAM AND TRACES OF DECAYED MATTING (BELOW AT LEFT)

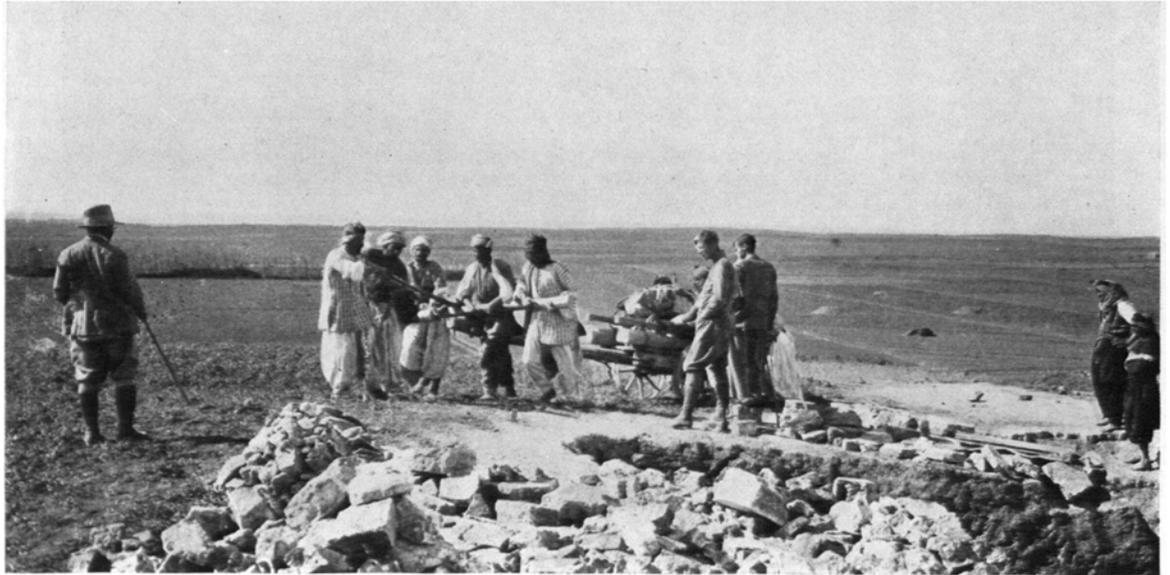
FIG. 86.—REMOVAL OF THE RELIEFS OF ROOM 7

The removal of these reliefs (Fig. 86), some to Baghdad and some to Chicago, where they have since been set up and partially restored (Figs. 87, 88, and 89), made some interesting disclosures. The slabs were backed and supported by a rough stone filling, indicating that they had been set in position before the surrounding walls were erected. This would seem offhand to be a reverse procedure, but when one considers the size and weight of these slabs it becomes evident that it would be a simpler task to build brick walls around standing slabs than to move without damage several tons of finely sculptured stone into place inside a comparatively small room. The stone slabs were thus probably first set up and then carved on front and back. In this instance a long inscription covered the backs of the slabs.

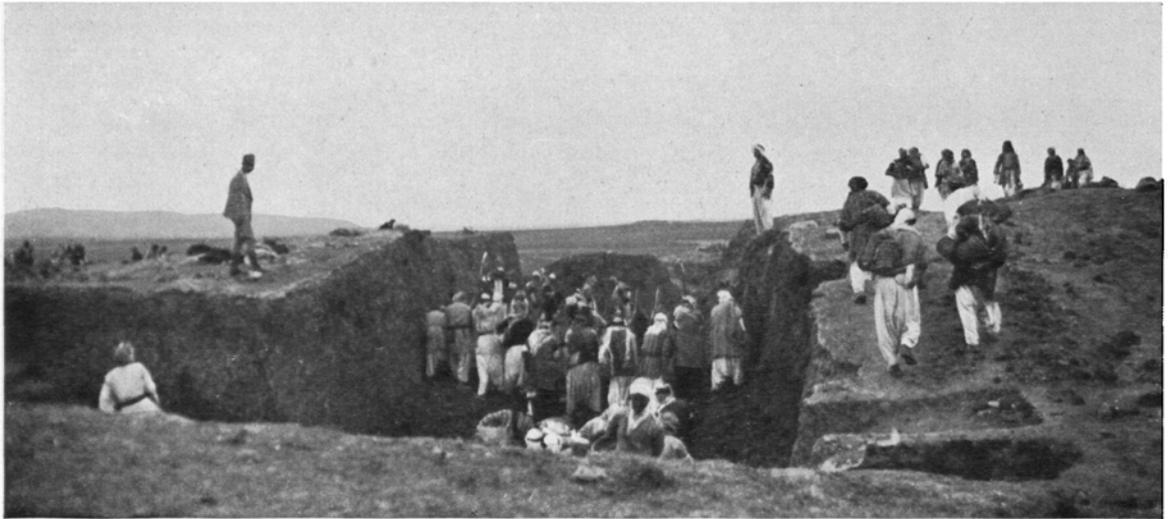
FIG. 94.—TRENCH ALONG SOUTHWEST WALL OF COURT XXVII

With the work of clearing the three principal portals of Court XXVII now under way, it seemed wise at this time to investigate the doorway and façade comprising the northwest side of Court XXXI, behind which lay the third of the larger temples. It was an easy matter to locate this from our points now definitely established elsewhere in this area; and but a few days elapsed before we had picked up the wall of the actual doorway, and from that the façade of this temple (Fig. 93). It was constantly becoming more and more evident from the mammoth scale upon which these temples were built and from the enormous trenches (Fig. 94)

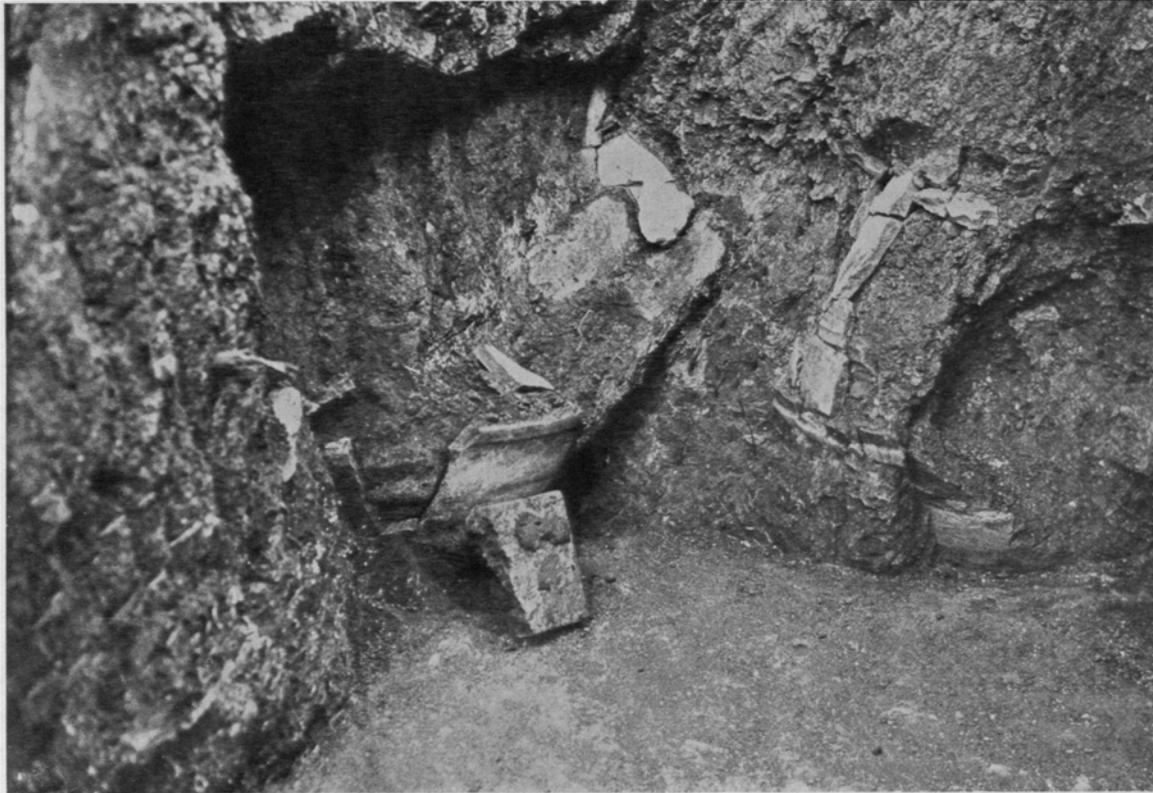
FIG. 97.—STORAGE JARS CONTAINING FRAGMENTS OF SMALLER POTS IN ROOM 84

Greatly to our surprise we found, when once within the room, large *hubb's* or jars of pottery, these in a badly broken state, within which were quantities of fragments of smaller jars (Fig. 97). Here then, obviously, pottery was stored; and the iron implements, if any still exist, doubtless repose in Room 86, designated by Place as a storage place of pottery. It is not improbable that his field notes made upon the spot were confused, and that when his detailed account was written in Paris after the completion of the excavations these two room numbers were unintentionally interchanged.⁴
