KHORSABAD

EXCAVATIONS IN THE PALACE AND AT A CITY GATE

THE UNIVERSITY OF CHICAGO
ORIENTAL INSTITUTE PUBLICATIONS
VOLUME XXXVIII

GORDON LOUD

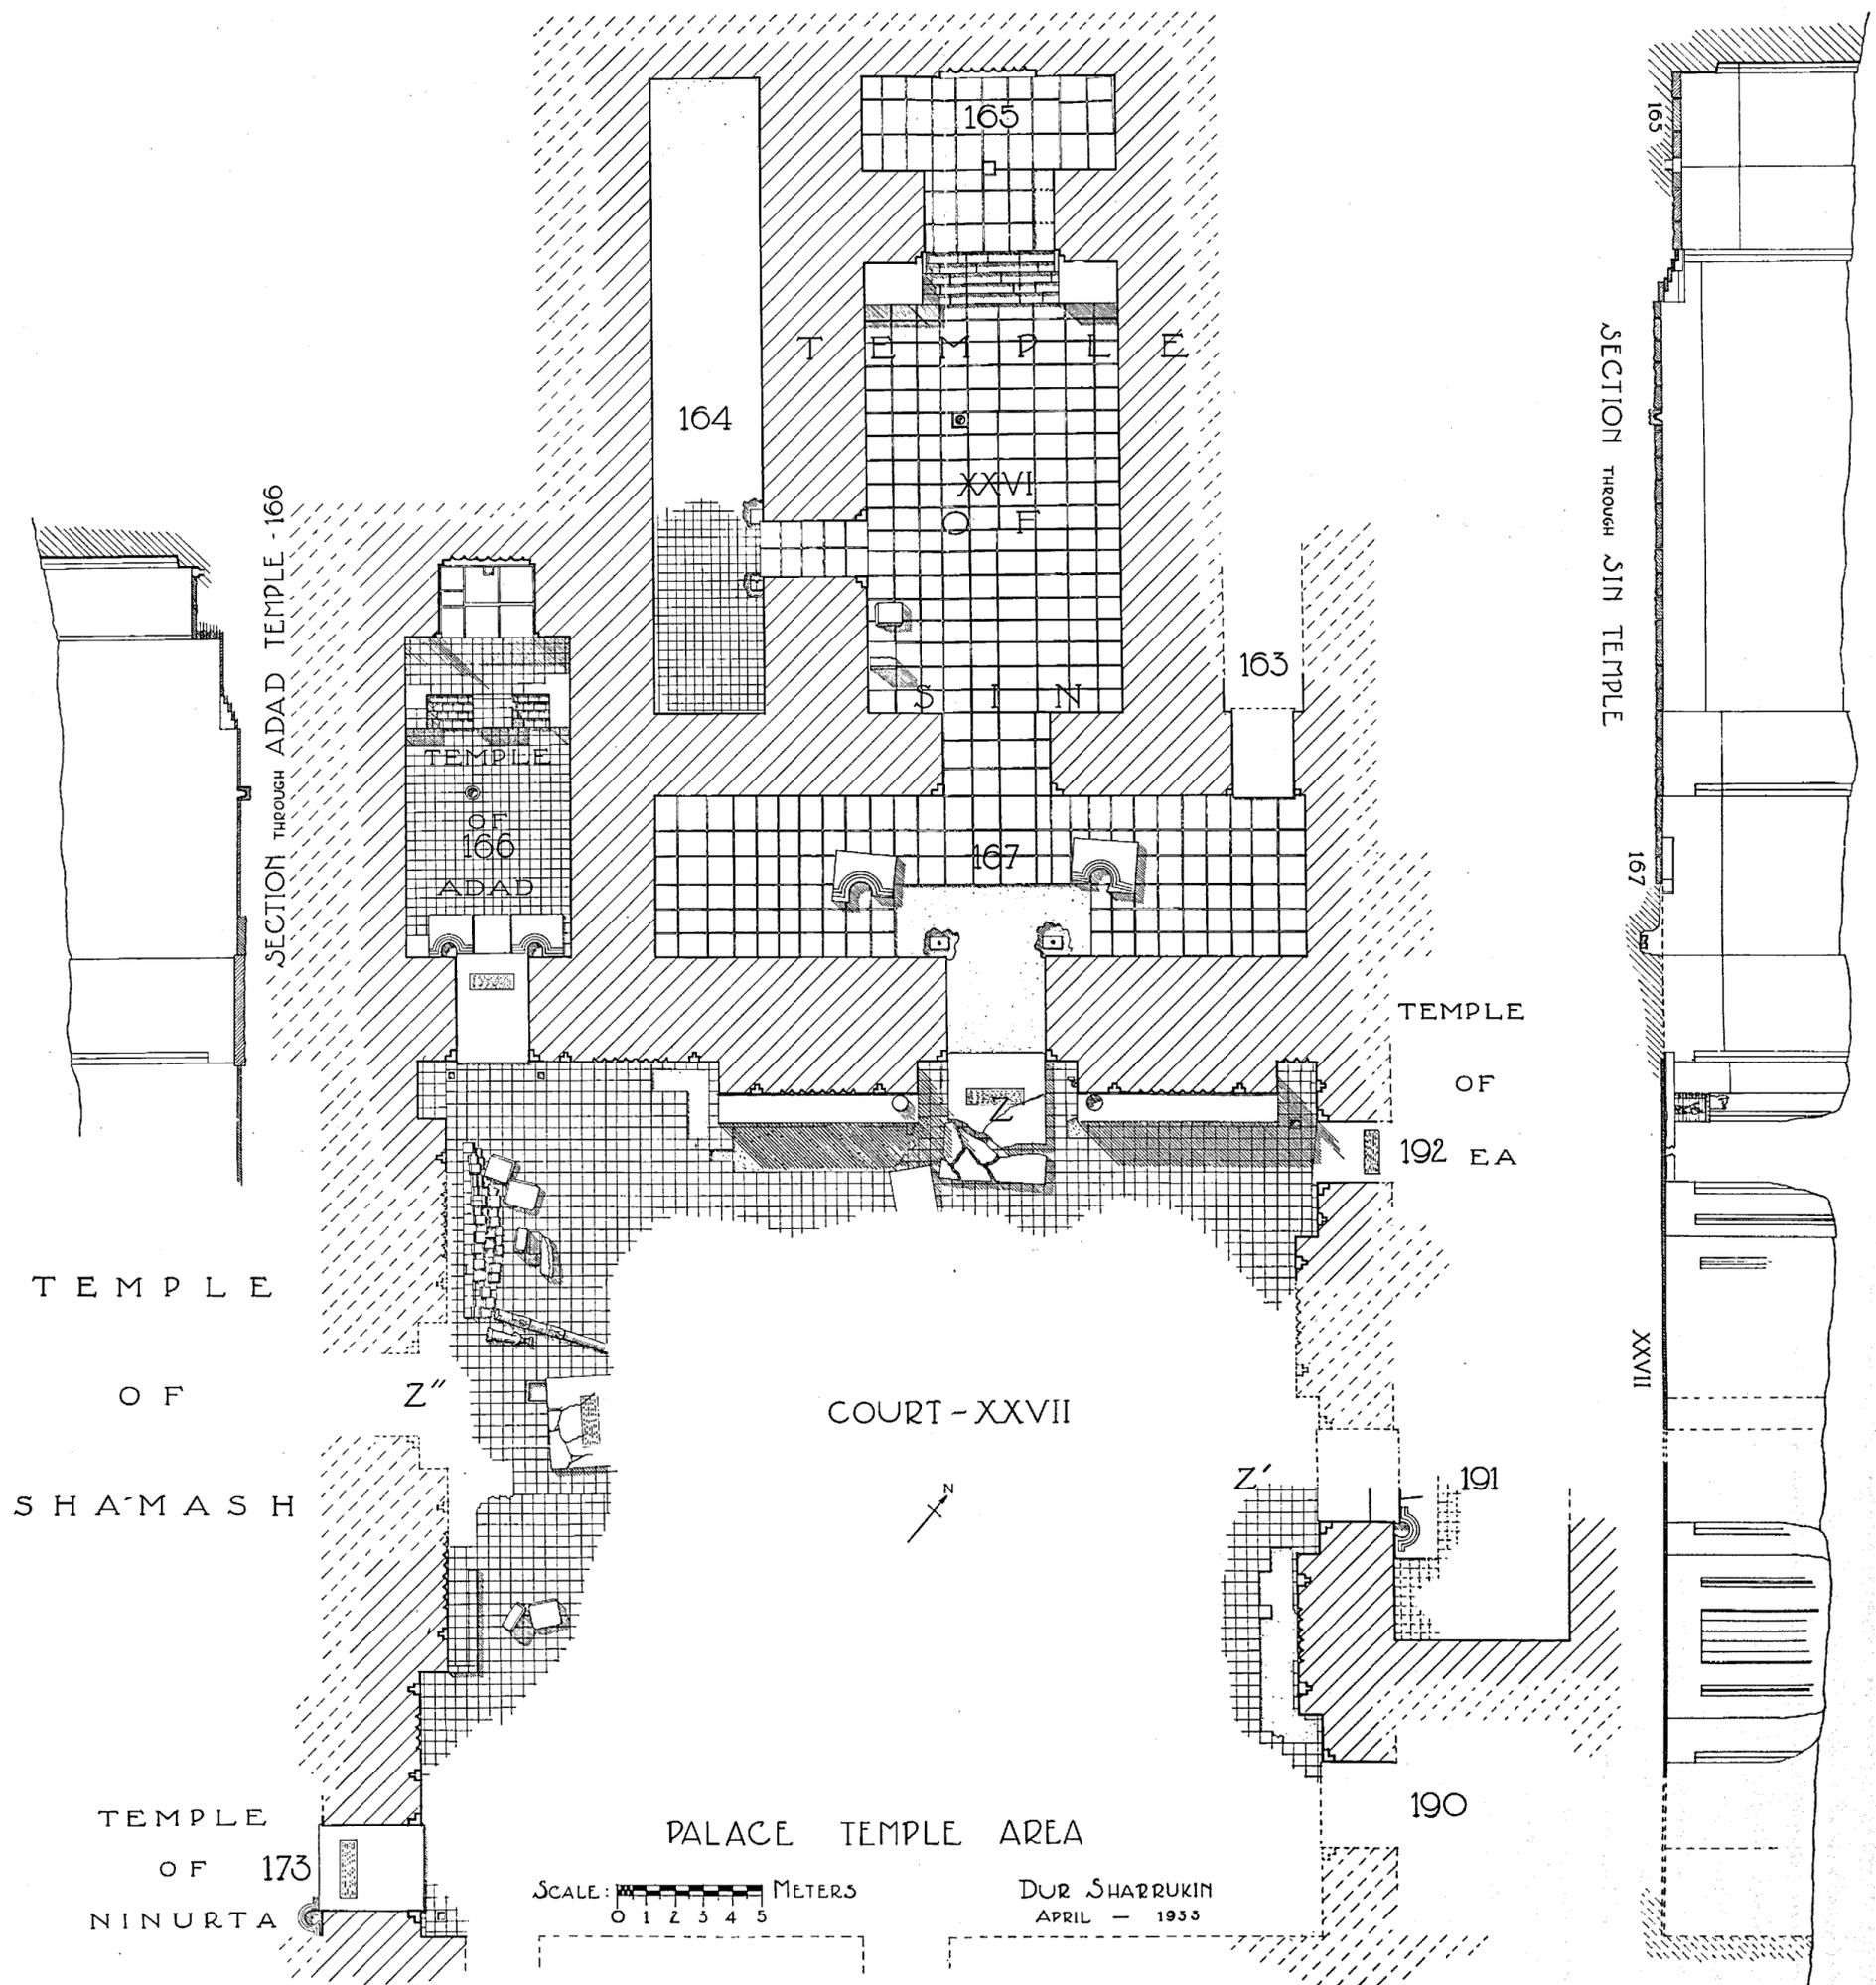
FIG. 98.—PLAN AND SECTIONS OF COURT XXVII AND THOSE ADJOINING ROOMS WHICH WERE EXCAVATED BY THE IRAQ EXPEDITION. SCALE, 1:200

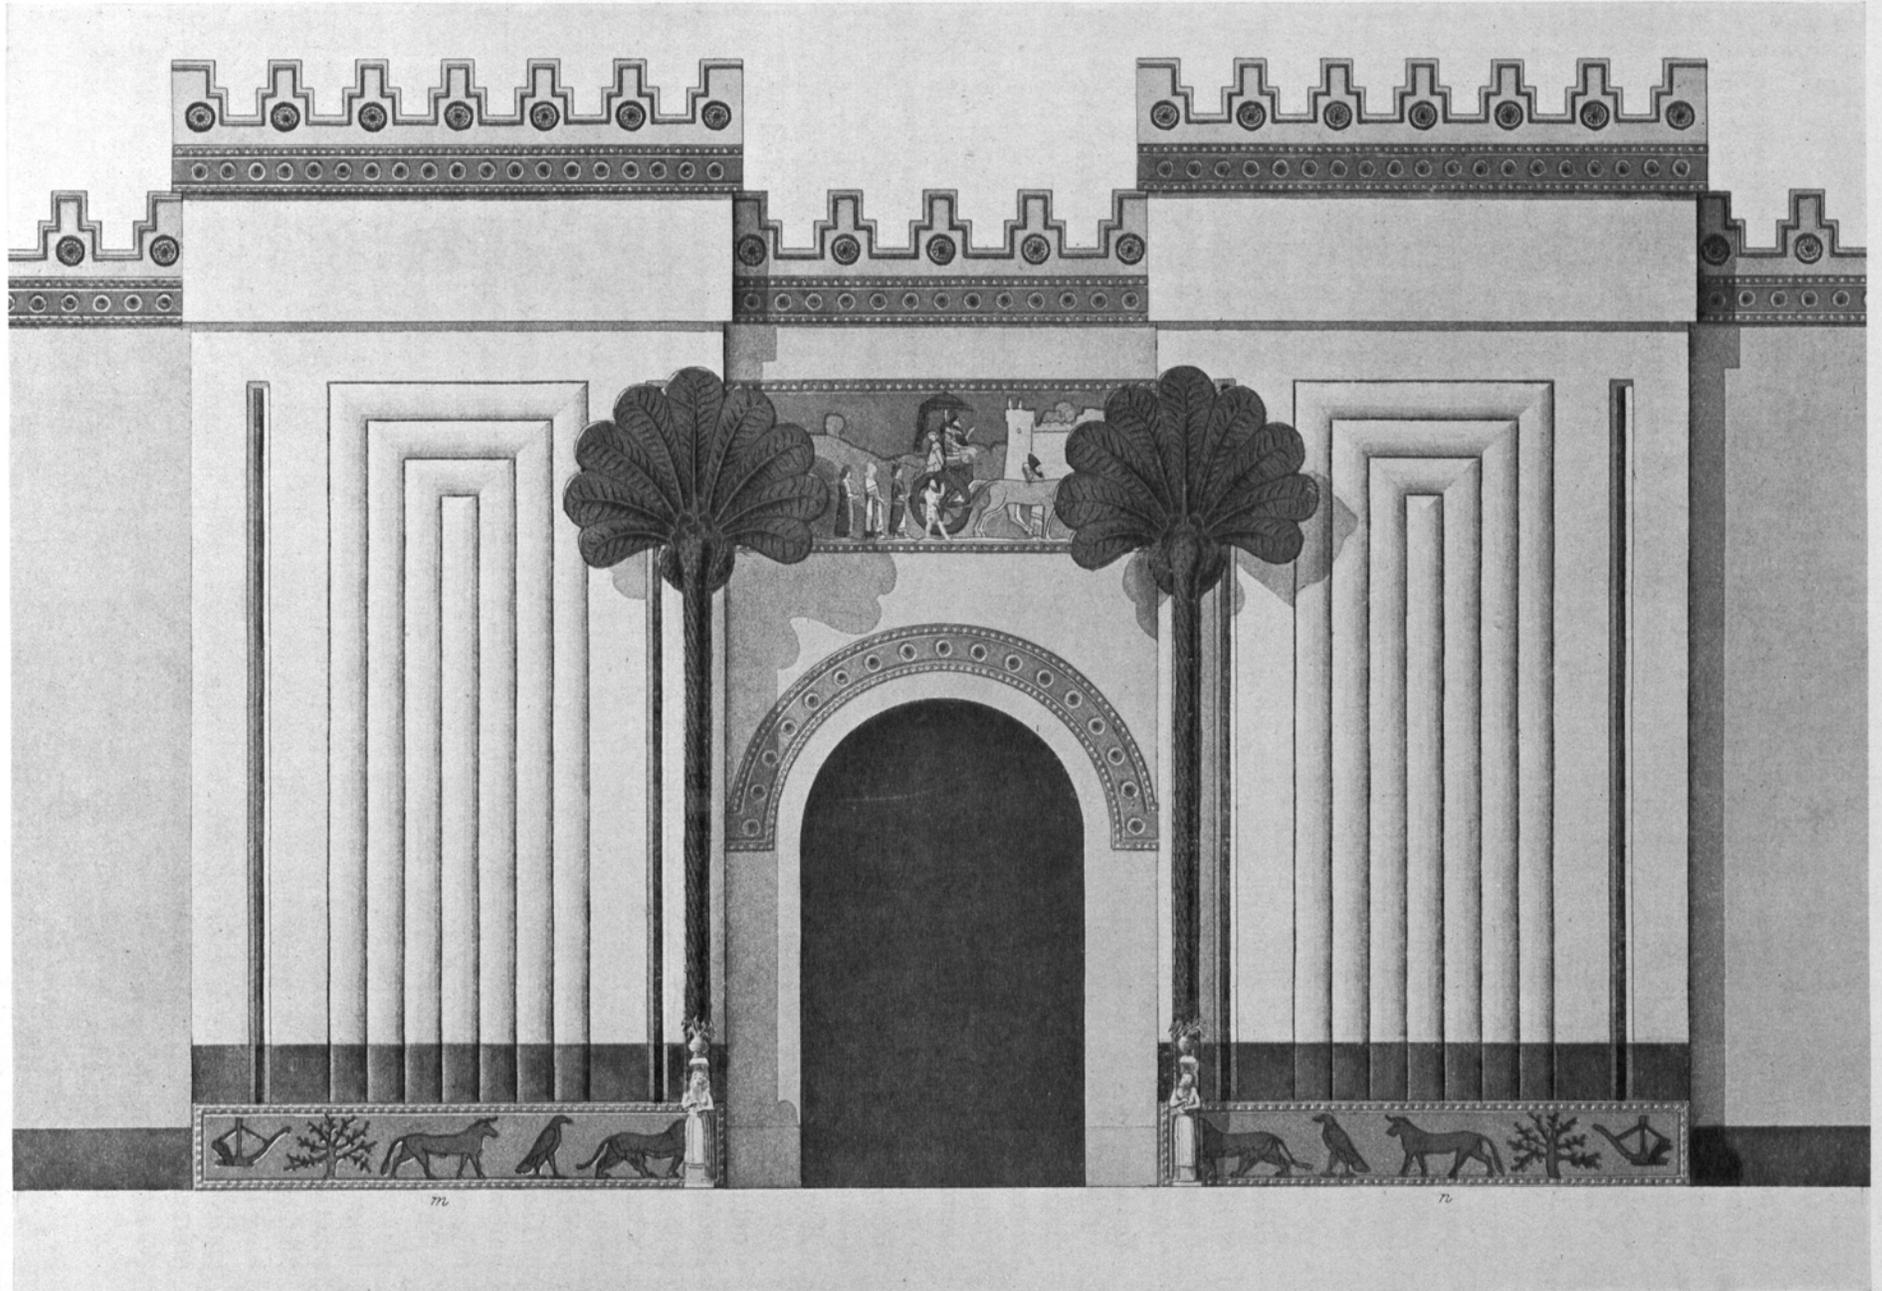
FIG. 99.—PLACE'S RESTORATION OF THE FAÇADE OF WHAT HAS PROVED TO BE THE SIN TEMPLE. SCALE 1:100

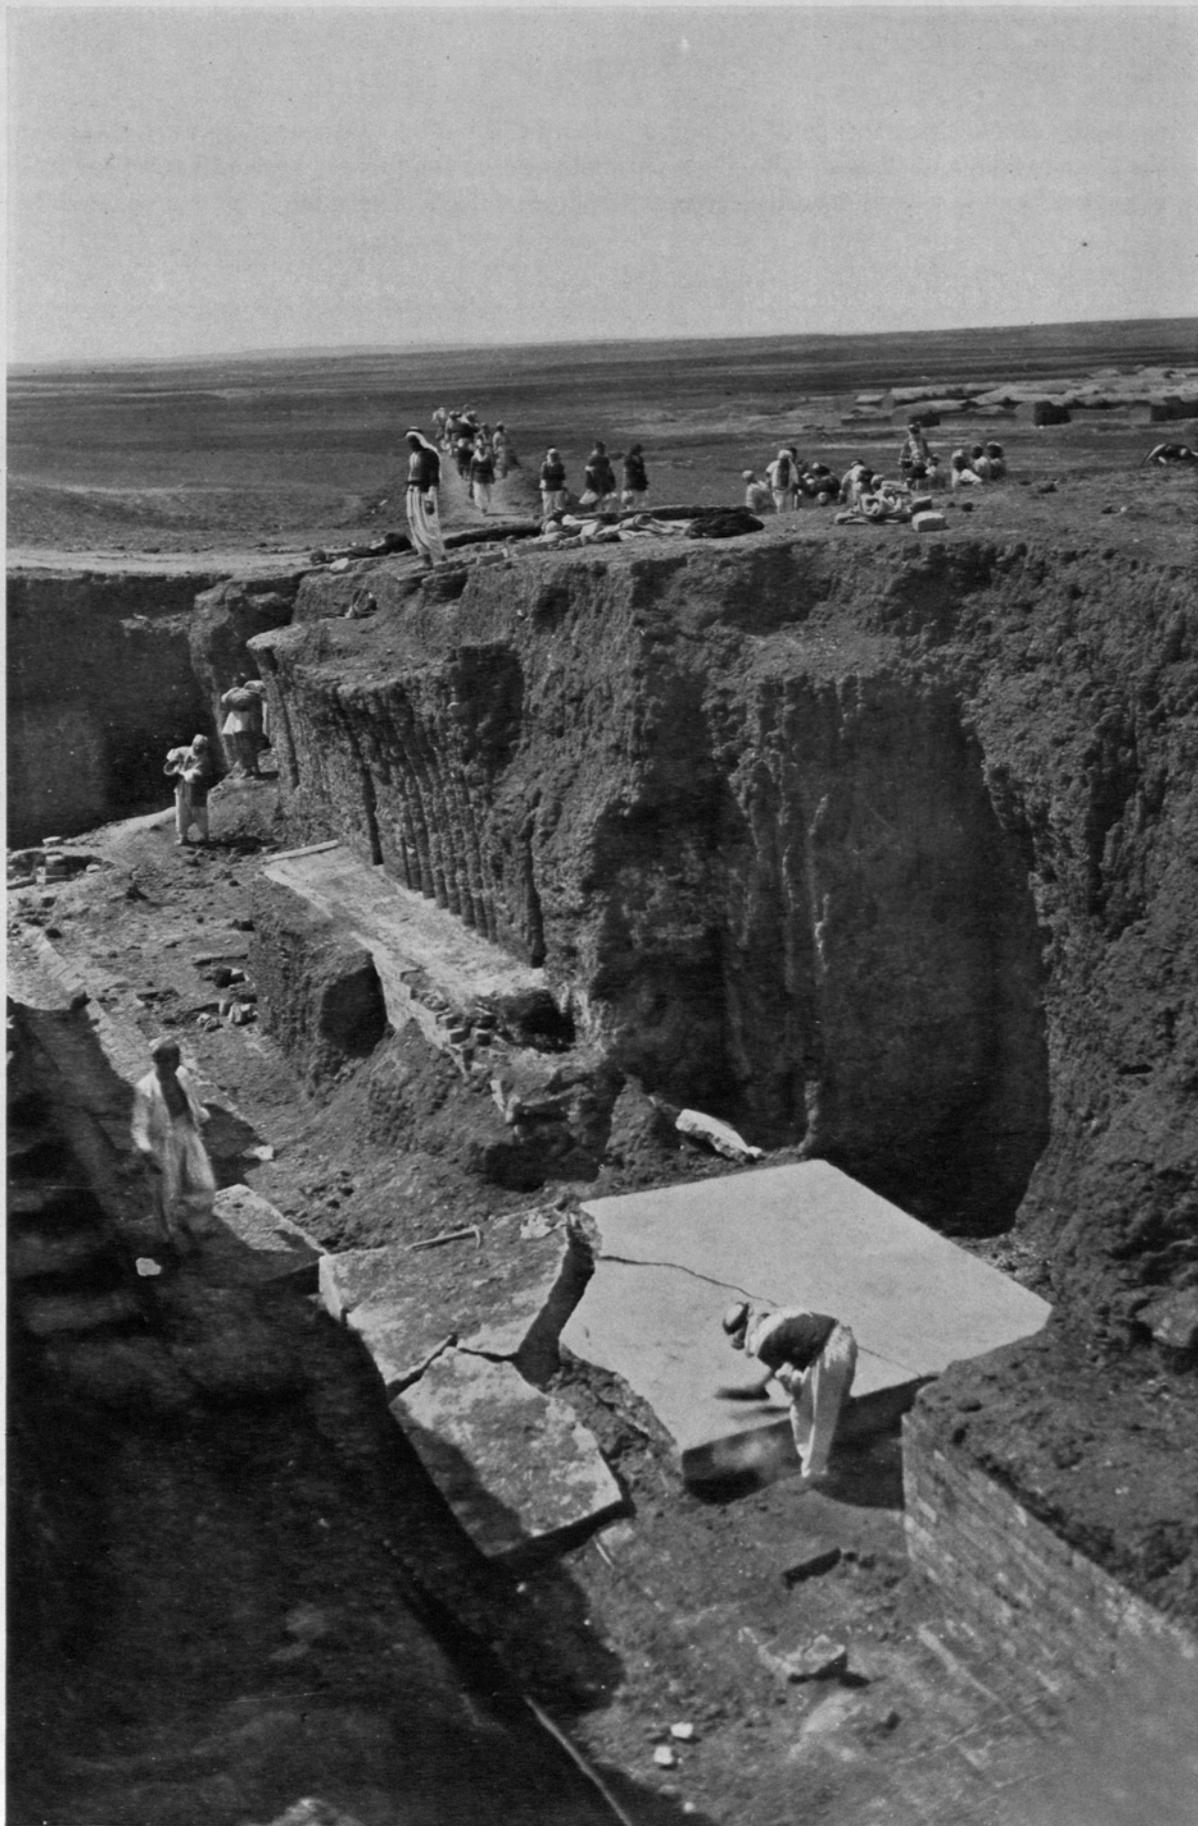
FIG. 100.—A PORTION OF THE NORTHWEST WALL OF COURT XXVII. IN THE FOREGROUND IS THE THRESHOLD OF THE DOORWAY INTO THE SIN TEMPLE. THE DOORWAY IS FLANKED BY GLAZED BRICK TABLEAUS, SHOWN ONLY PARTIALLY CLEARED. AT THE FAR END OF THE TRENCH WORKMEN CARRYING BASKETS OF EARTH ARE EMERGING FROM THE ADAD TEMPLE DOORWAY

Probably the greatest decorative feature of the entire northwest wall is the pair of shelves faced with glazed bricks forming the earliest known tableaux of this material. These project a meter in front of the faces of the buttresses on either side of the doorway, extend their entire width of 7 meters each, and rise from the floor to a height of 1.50 (Fig. 100). They were

constructed after the buttresses had been finished, for the plaster on the buttress walls extends to the floor behind them. The baked brick facing, consisting of alternate courses, fifteen in all (though Place shows only twelve), of square and half-square bricks, was set up, and filling was packed in behind it. In this instance the ledge was topped with a layer of plaster (Fig. 103) probably covered with bitumen to shed the rain.⁸ The baked bricks undoubtedly were set up in a workshop, painted, and then taken down to fire the glaze before being finally reassembled in the court. The eventual removal of the tableaus disclosed how the bricks were marked for reassembly prior to being baked, for crudely painted upon the top faces are identifying marks.

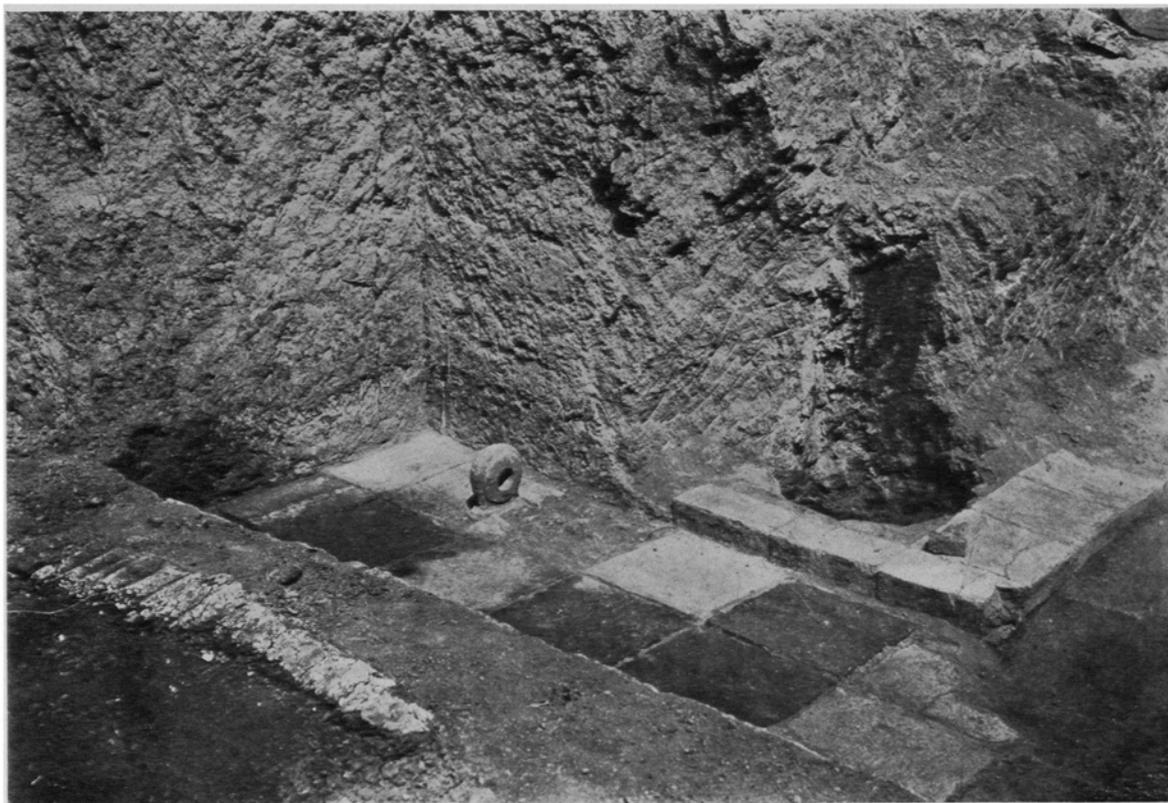
FIG. 102.—CORNER FORMED BY WALL AND BUTTRESS TO THE RIGHT OF THE ENTRANCE TO THE SIN TEMPLE. NOTE FASTENING-RING IN CENTER AND LOWEST COURSE OF CORNER OF TABLEAU AT RIGHT. BEHIND TABLEAU IS THE IMPRINT OF THE WOODEN SHAFT SET INTO THE FILLING OF THE SHELF

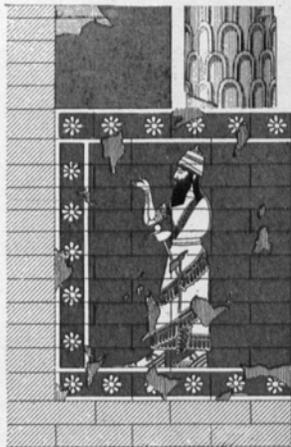
FIG. 104.—TABLEAU AT RIGHT OF ENTRANCE TO THE SIN TEMPLE, AS FOUND BY PLACE. SCALE, 1:30

The much stylized design (Fig. 104) is identical on both tableaux, but in reverse, so that the figures in each case face the entrance. Place's restoration of one complete tableau, made, fortunately, before its general condition reached its present deplorable state, is an invaluable aid in filling in the parts now missing. Nearest the portal end we have a lion, sovereign of the earth, a symbol perhaps of the power of the Assyrian Empire. It is probably the most realistic of the living figures, done in good proportions and with a strong sense of motion. The head, with jaws apart, is especially fine, and highly expressive of the ferocity that makes of this animal the symbol that it is.

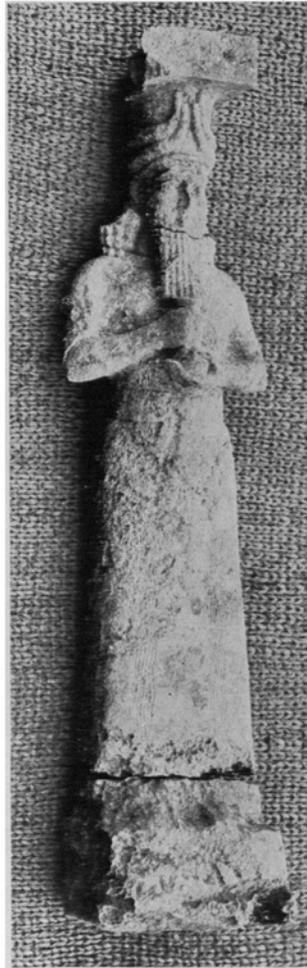
FIG. 107.—STATUE FROM RIGHT OF ENTRANCE TO THE SHAMASH TEMPLE. SCALE, 1:15

That these figures were not cult statues is clear not only from their position outside the temple but also because of the saucer-like hollows cut into the tops of the square blocks resting upon the crowns. They were obviously intended to support something, possibly the golden dishes used in the New Year festival. They are slightly less than life-size, conventionalized in the figure though lifelike in features (Fig. 107). Surmounting the head is a crown with two pairs of horns, from under which falls a mass of curls covering the back of the neck. A heavy beard extends well down the chest. Altogether the head and crown strongly suggest those of a human-headed bull. Held by both hands against the breast just below the beard is a jar (Fig. 108) from the mouth of which extend wavy bands (the conventionalized method of rendering water spouting forth from a vase), two over the shoulders and down the back, two down the front. The garment is otherwise plain except for a fringe through which protrude the feet.

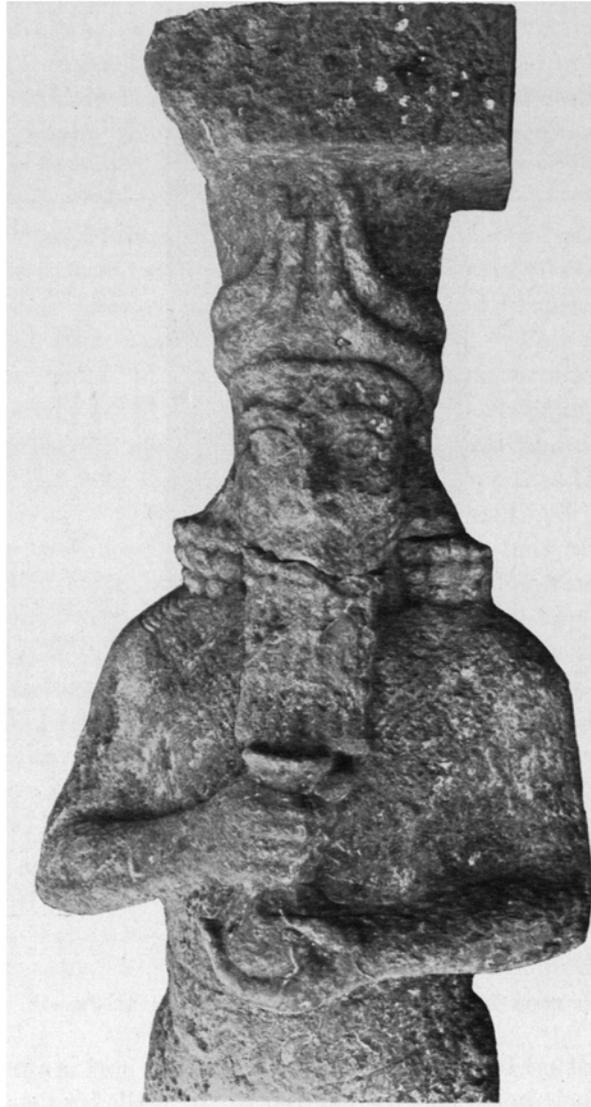
FIG. 108.—UPPER PART OF STATUE, SHOWING BOTTLE HELD IN BOTH HANDS

The jars held by these figures are suggestive of a type found in great quantities throughout the temple area. Such jars, of coarse pottery, are carafe-shaped, very similar to the water bottles used to this day by the inhabitants of this district. One curious feature of the ancient ones, however, is a circular aperture about 0.01 in diameter directly at the bottom of the bulging base. Obviously they could not hold a liquid substance unless this hole were stopped up, presumably by the thumb or palm as indicated in this figure. That bottles of this type

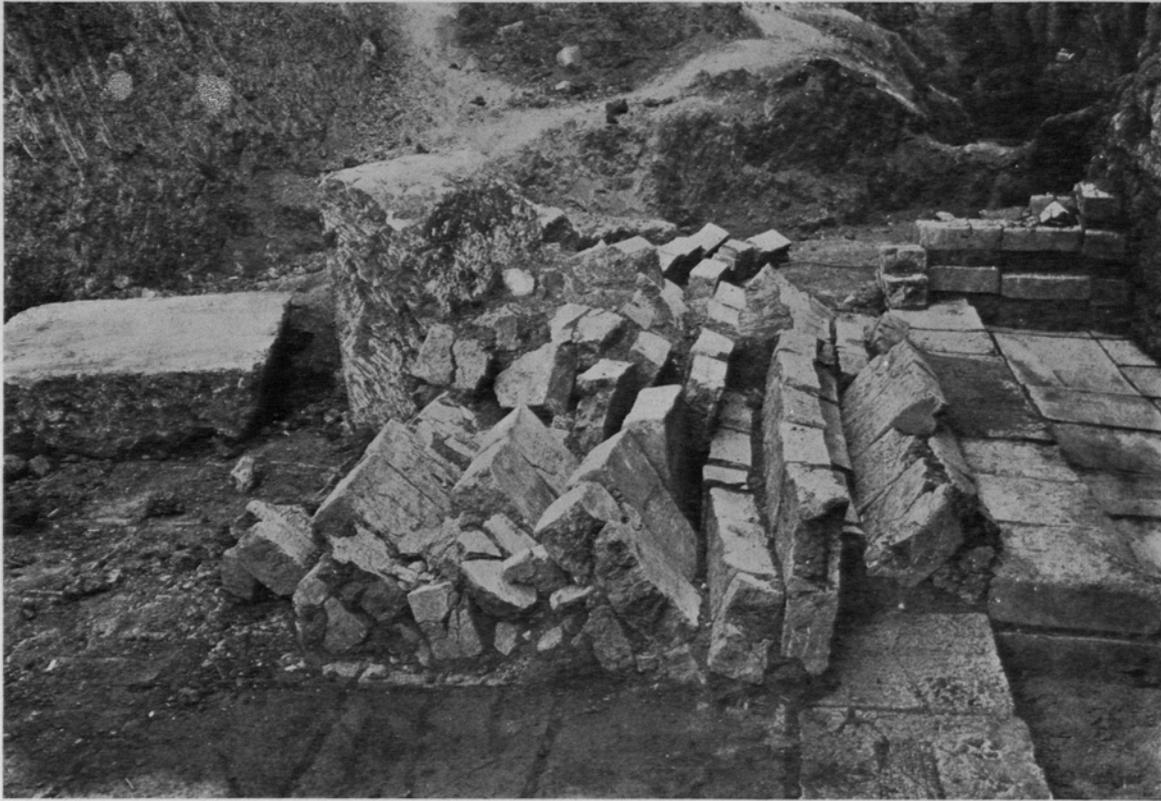
FIG. 110.—REMAINS OF TABLEAU AT LEFT OF ENTRANCE TO THE SHAMASH TEMPLE

The tableaus which originally faced the shelves projecting from these buttresses present a sorry sight today (Fig. 110). They lie with the glazed surfaces downward, directly upon the pavement, the few lower courses intact as to relative position, the top courses incomplete and scattered everywhere about. Their fallen state, however, is not to be too highly deplored, for,

The construction of these tableaus is identical with that of those at the Sin temple—alternate courses of square and of half-square bricks. Similarity of design and color also prevails. Although restoration of these tableaus was out of the question, it was at first thought that good individual bricks from here could be salvaged and used in the restoration of the tableaus from the Sin temple, substituting them when their better condition warranted. A closer study of them, however, showed that while the design was the same on each tableau it was not identical in its relationship to individual bricks. A section that might appear entirely upon one brick in one tableau might on the other be distributed over portions of four bricks. Clearly, then, substitution was out of the question; but the coloring of these bricks should be invaluable to those working upon the restorations, both for itself and because it naturally clarifies the design and may therefore prove extremely useful in supplying bits of detail which have already disappeared from the tableaus being restored.

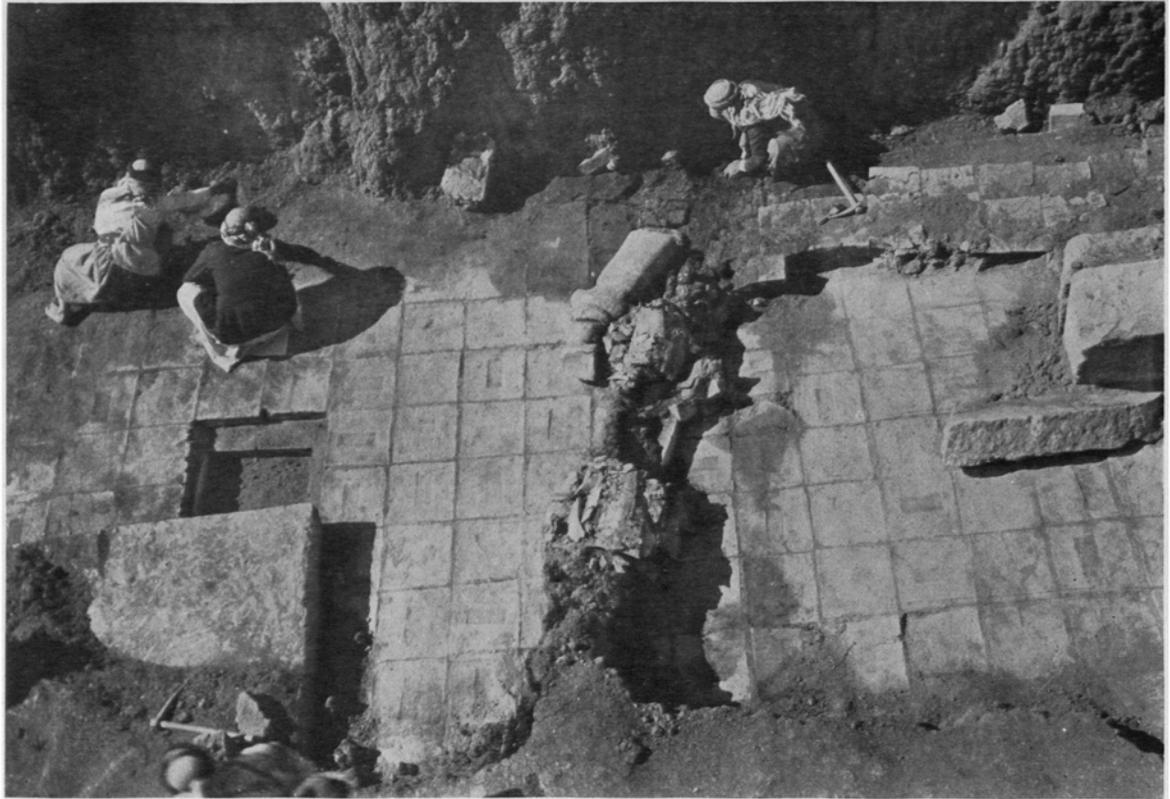
FIG. 111.—SECTION OF PAVEMENT BEFORE ENTRANCE TO THE SHAMASH TEMPLE. IN THE LEFT FOREGROUND IS SHOWN A CORNER OF THE THRESHOLD AS FOUND NOT IN POSITION. IN THE CENTER MAY BE SEEN THE STATUE, LYING FACE DOWNWARD, AND THE TWO BRONZE BANDS SURROUNDING THE WOODEN STAFF. IN THE RIGHT BACKGROUND ARE THE REMAINS OF THE TABLEAU FLANKING THE RIGHT SIDE OF THE ENTRANCE

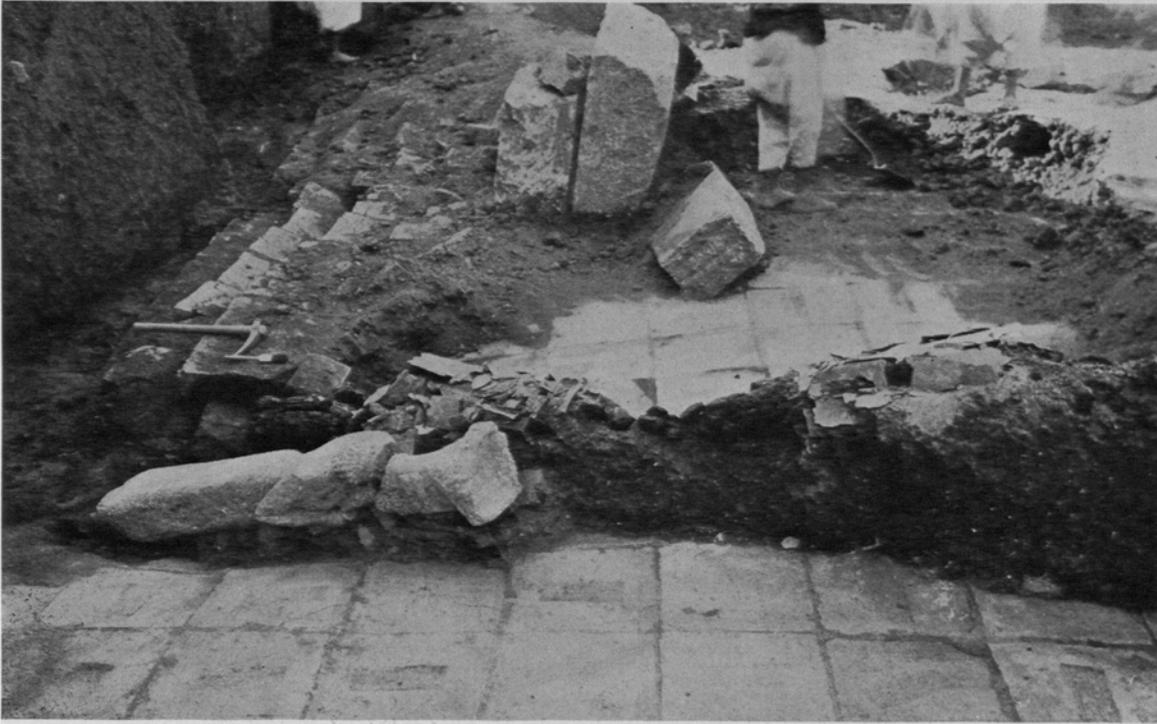
FIG. 112.—STATUE AND BRONZE BANDS OF THE "TREE" AS FOUND BEFORE ENTRANCE TO THE SHAMASH TEMPLE

Unlike the "tree" at the Sin temple, which was entirely incased in bronze, this "tree" was adorned with bronze rings or bands extending around its circumference and overlapping at their joints. Within the distance uncovered we find two of them, each 0.70 wide, separated from each other by a slightly narrower interval. Figure 112 shows the fragmentary state in which these bands were found; but from their numerous fragments we learn that the bands were embossed, the design being raised above the background. Not all of the figures compris-

ing the complete design can be ascertained from the fragments that have survived. Enough remains, however, so that we have entirely or in part in several instances representations of a man leading a bull by its horns, a man (possibly the king) walking in the procession, a bird in flight, a barren tree reminiscent in the distribution of its branches of the fig trees pictured on the glazed brick tableaus, and what may easily be the plow likewise pictured on the tableaus. These figures appear in two registers separated by a band of rosettes. Two similar bands serve as borders above the upper register and below the lower one respectively. Through the centers of the rosettes were driven nails whereby the bands were fastened to the wood, the heads of the nails forming the eyes of the rosettes. Many nails were found actually extend-

The statue found at this entrance has already been mentioned (p. 98). As in the case of the "trees," but one was found, that to the right of the entrance. Figures 111 and 112 show its prostrate position, face downward, parallel to and almost touching the fallen "tree." Here we have direct proof of its original position at the corner of the tableau, for the lowest of the three fragments in which this figure was found was still standing upright where the builders of the palace had placed it. And although the tableau had fallen forward, its position was evident from the lowest course of bricks, which remained intact.

Several limestone blocks of the dimensions of paving stones were found upon the pavement in the débris before this wall face. To account for them is a difficult matter. From their position so near the fallen tableaux (Fig. 112) they could scarcely have fallen from a place as high as the roof must have been. The most likely assumption is that the Shamash temple was incomplete at the time of its destruction and that these blocks were lying in the courtyard awaiting their final places in the pavement of interior rooms. Remains of timber, the lengths laid upon the pavement parallel to one another (Fig. 114) where a large number of the blocks were found, suggest skids upon which they were moved.

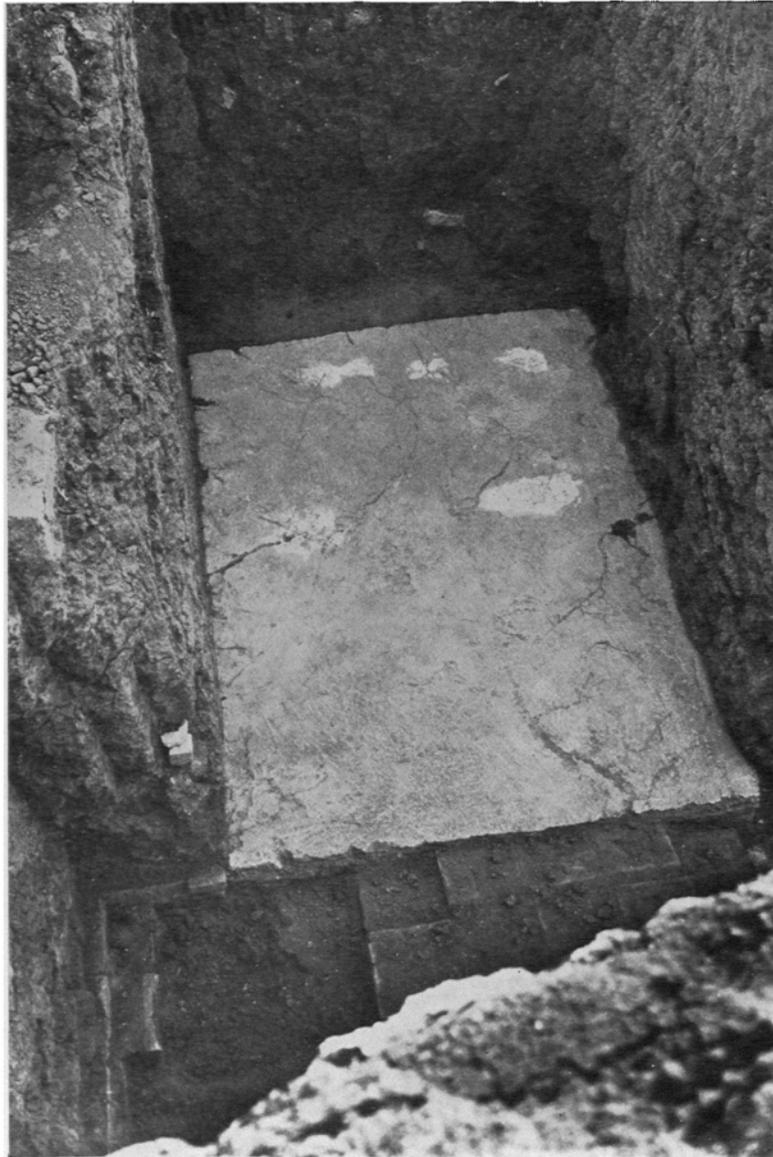
FIG. 113.—THRESHOLD IN ENTRANCE TO THE NINURTA TEMPLE. ITS INSCRIPTION (NEAR FAR END OF BLOCK) IS BADLY WEATHERED

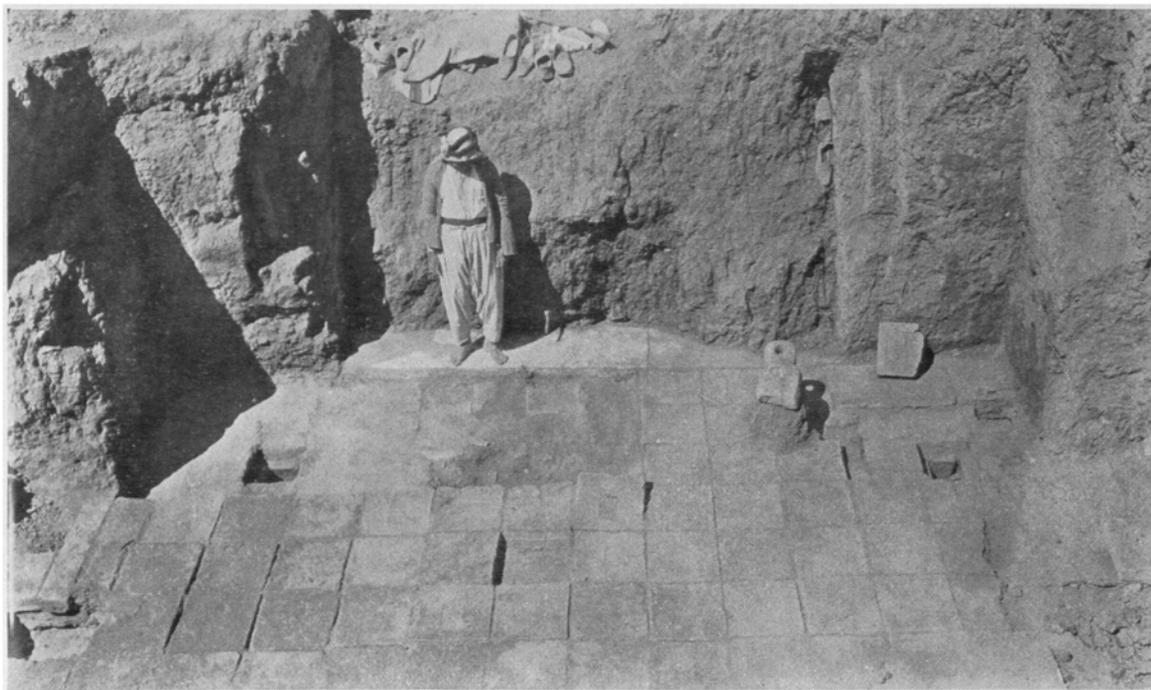
FIG. 117.—ENTRANCE TO THE NINGAL TEMPLE. THE TWO SQUARE HOLES IN THE PAVEMENT ARE FOUNDATION DEPOSIT BOXES, ONE AT EACH SIDE

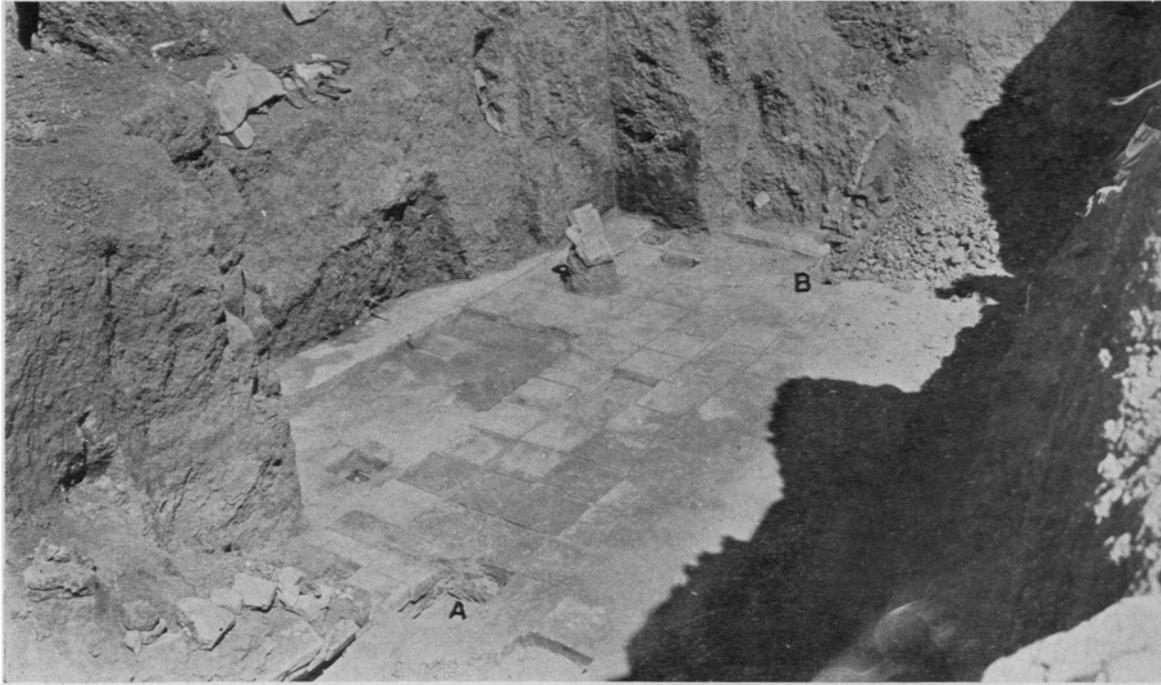
FIG. 118.—PAVEMENT BEFORE ENTRANCE TO THE NINGAL TEMPLE, SHOWING AT CORNERS OF THE TABLEAUS HOLES (A AND B) IN WHICH STATUES ORIGINALLY STOOD

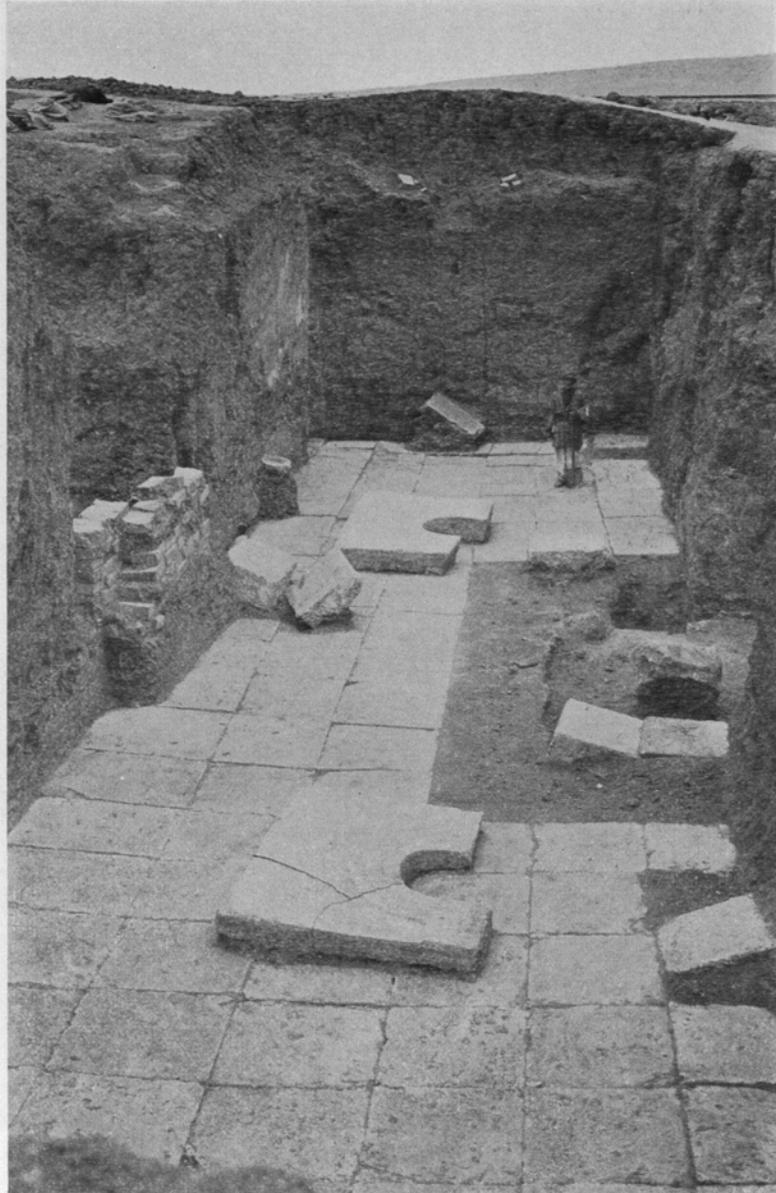
FIG. 120.—ROOM 167 FROM SOUTHWEST

The walls are plastered with mud and are whitewashed. An unusually high dado of 2 meters extends around the room. The present height of the walls approximates 6 meters with no sign of the springing of the arch in any one of the three doorways. Were the arch to start just above the present height, the roof could not be less than 8 meters above the floor; and as there was doubtless a decorative band of glazed bricks above the supporting arch it is more than likely that the ceiling height considerably exceeded this minimum.

No objects of any significance were found within Room 167. Evidence of a later occupation, however, appeared in the blocking of the doorway leading to Room XXVI. This occupation did not immediately follow the abandonment of the site as a royal palace but rather after 0.70 of débris had accumulated within this room, for the crudely built baked brick wall blocking the doorway rested upon rubbish of that depth (Fig. 120).

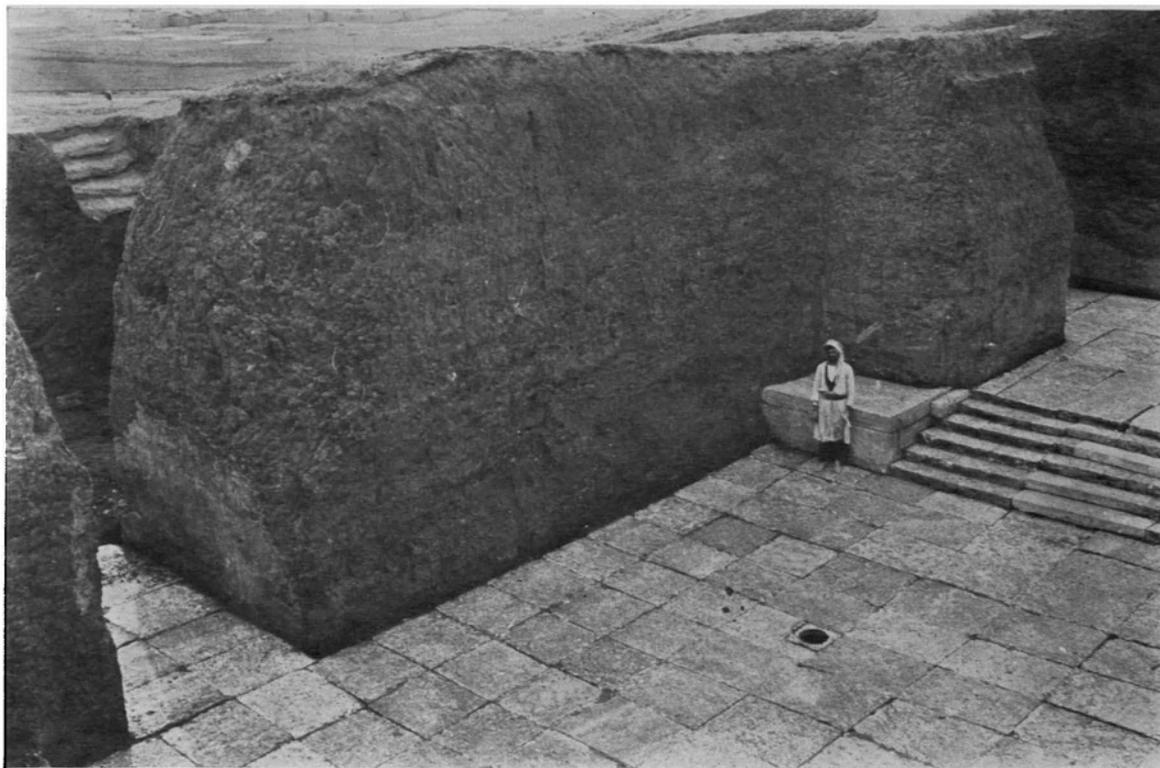
FIG. 122.—CENTRAL HALL OF THE SUN TEMPLE, WITH STONE JAR IMBEDDED IN THE FLOOR. IN THE LEFT FOREGROUND IS THE ENTRANCE TO ROOM 164

The area, 8.90×15.80 , is the largest covered by any one room of the temple. The pavement, similar to that of Room 167, remains completely intact. At a point slightly to the left of the central axis and about two-thirds of the distance down the length of the room there is set into the pavement a stone jar (Fig. 122) tapering in section. At the rim the stone becomes square, occupying about a quarter of the surface area of a paving slab. The inside diameter measures 0.30 at the top, constantly decreasing to but a third of that at the saucer-like bottom, 0.35 below the floor surface. There is no question but that this jar played a part in the temple ritual. Its position in the floor suggests a receptacle for refuse, possibly from the sacrifices. The lack of any outlet points on the other hand to the impracticability of this. It might very well have served as a container of holy water or oil, which could be dipped from it by means of a long-handled spoon or ladle and poured over the suppliant or the sacrificial animal. Perhaps the altar stood near by, placed centrally before the flight of steps. In such event the priests conducting the service before the altar would have ready access to this jar imbedded in the floor.

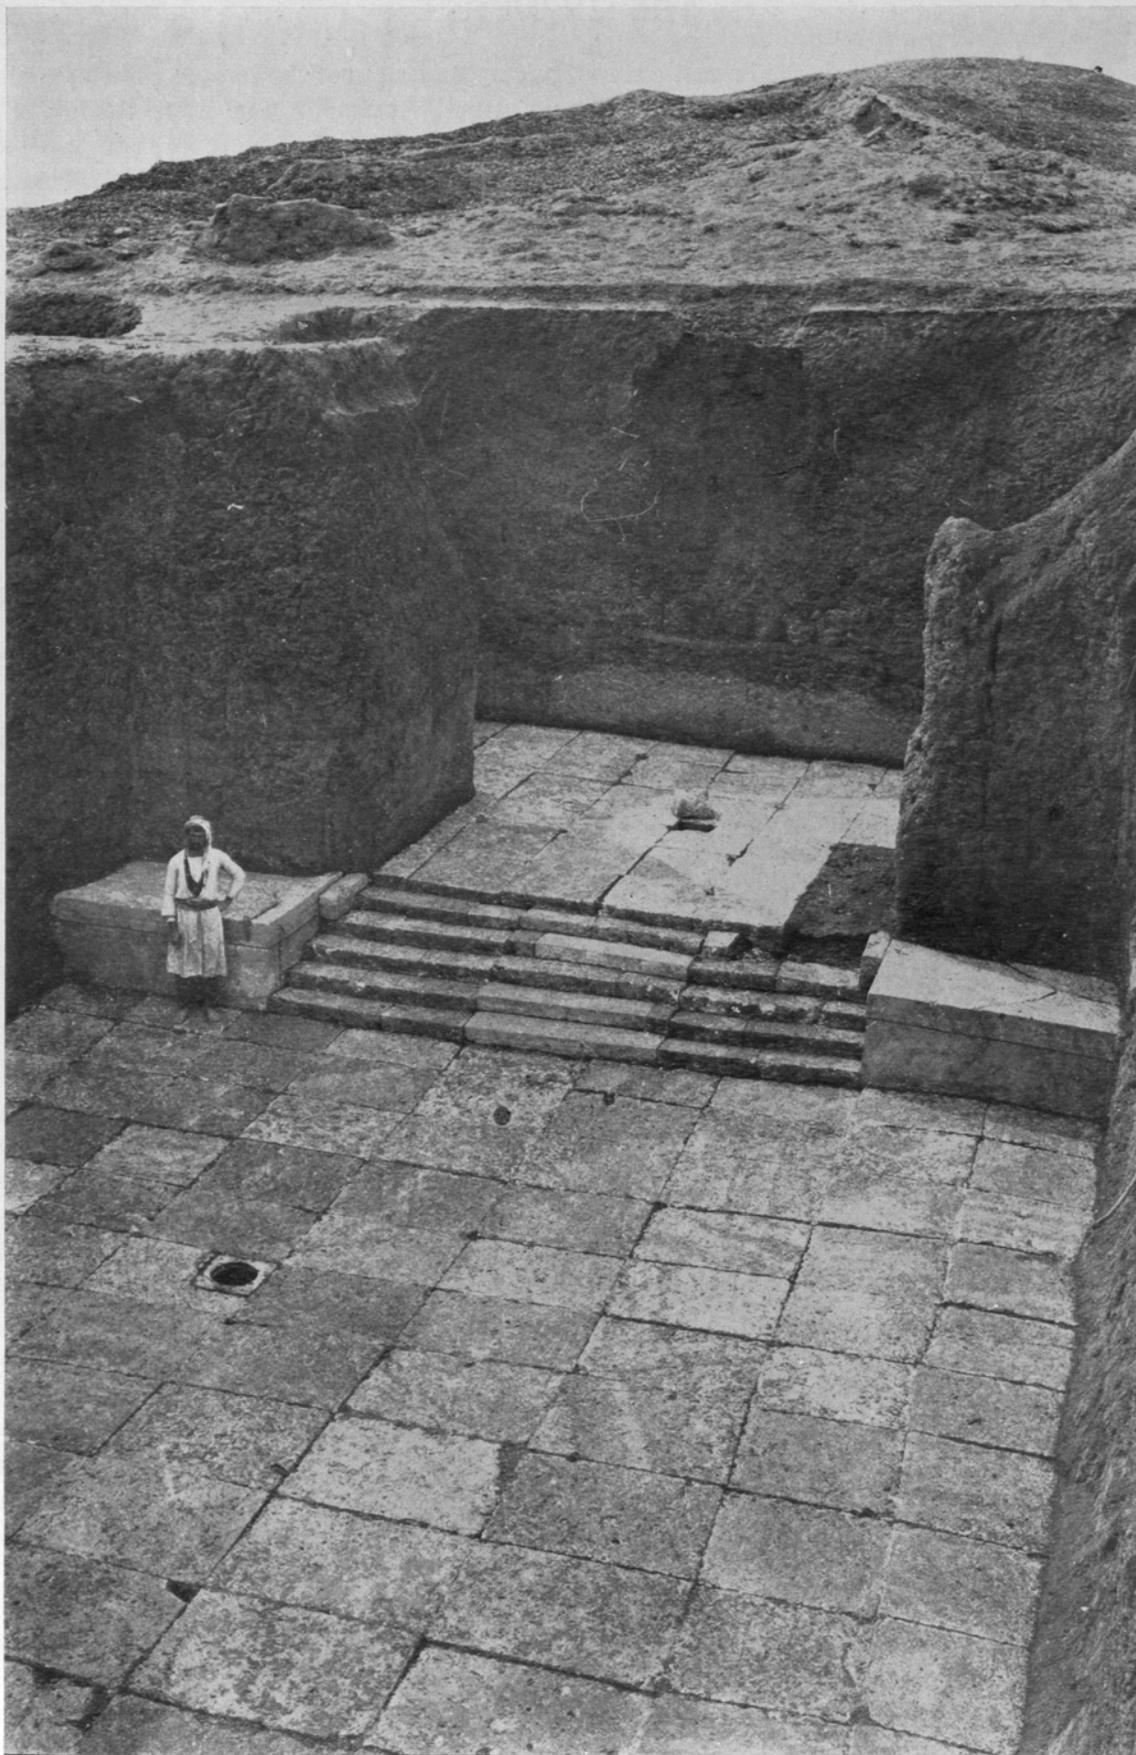
FIG. 123.—STAIRWAY LEADING FROM CENTRAL HALL TO SANCTUARY OF THE SIN TEMPLE
