KHORSABAD

EXCAVATIONS IN THE PALACE AND AT A CITY GATE

THE UNIVERSITY OF CHICAGO
ORIENTAL INSTITUTE PUBLICATIONS
VOLUME XXXVIII

GORDON LOUD

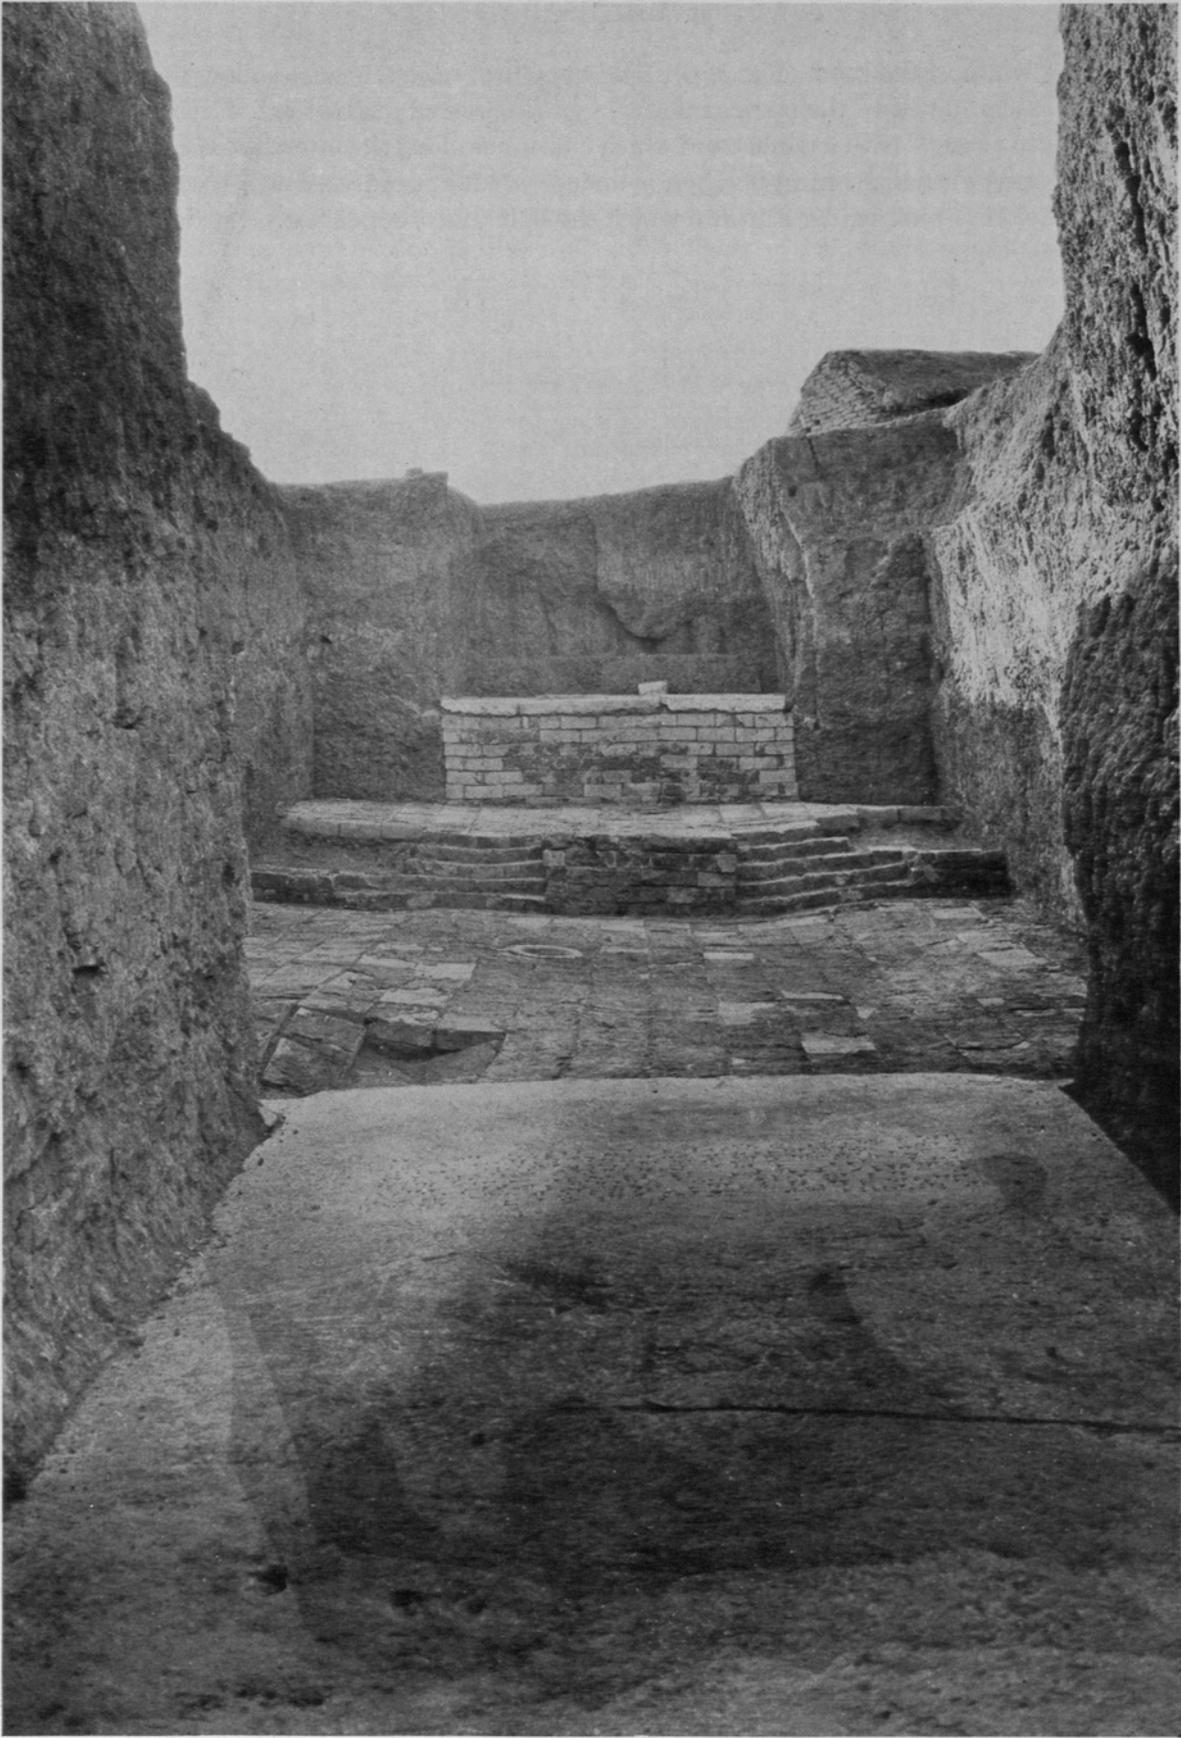
FIG. 125.—THE ADAD TEMPLE

The platform extending across the entire northwest end of the room projects 3.25 into it (Fig. 125). It is 0.60 above the level of the room and is reached by two flights of stairs of five risers. As the lowest riser is in the line of the face of the platform, the two stairways divide the edge of the platform into three projecting sections perhaps serving as podia for temple furniture. These stairways are of unequal width to allow the central projection to be on the axis of the entrance, as noted above, and at the same time to maintain equal widths for the two side projections. They are of bricks covered with bitumen, that to the left having a width of 1.60 while that to the right measures but 1.30. The size and position of the platform indicate that an altar may have been placed before the niche.

Included within the same architectural unit or wing of the temple complex, but having no direct communication with the Sin temple, is the Adad temple, Room 166 (Fig. 98). Though but a single room, only 5.70×11.10 in size, sufficiently small to permit its being placed within the central hall of the Sin temple, its arrangement of platform and niche is so similar in scheme to that of its larger neighbor that the same form of ritual might easily be carried on in both shrines. The stone vessels imbedded in their floors occupy the same relative positions. The sanctuary of the Sin temple is here replaced by a platform and a deep raised niche, the platform being reached by two flights of steps (Fig. 125). Whereas in the Sin temple there are but two levels, floor and sanctuary, here there are three: floor, platform, and niche.

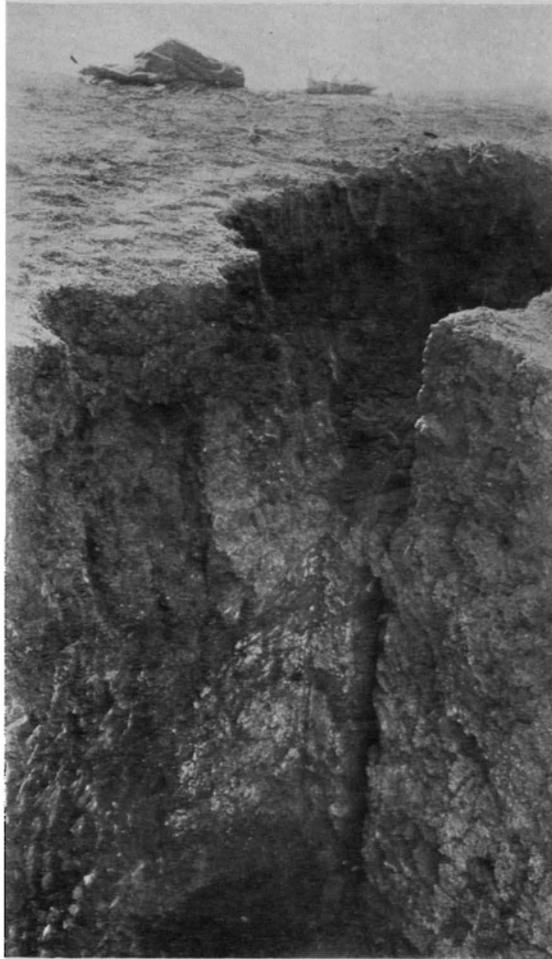
FIG. 128.—SOUTH CORNER OF ROOM 170. ABOVE IS THE TRENCH WHEREBY IT WAS HOPED TO TRACE THE NICHE

Figure 128 shows how an attempt was made to trace this "window" to the outer wall surface. The narrowness of the niche made work impossible beyond an arm's length from the room. It was therefore necessary to clear away the surface débris in order to trace the niche from above. This examination gave us nothing but negative proof. It exploded our theory of

windows extending through to the exterior wall surface, but failed to give the solution. From it, however, we know that the side surfaces of the niche were plastered only as far in as the plasterer could reach, and that the niche extended at least a meter into the wall. Its exact depth we were unable to determine.
