KERKENES PROJECT

SCOTT BRANTING | kerkenesproject.org

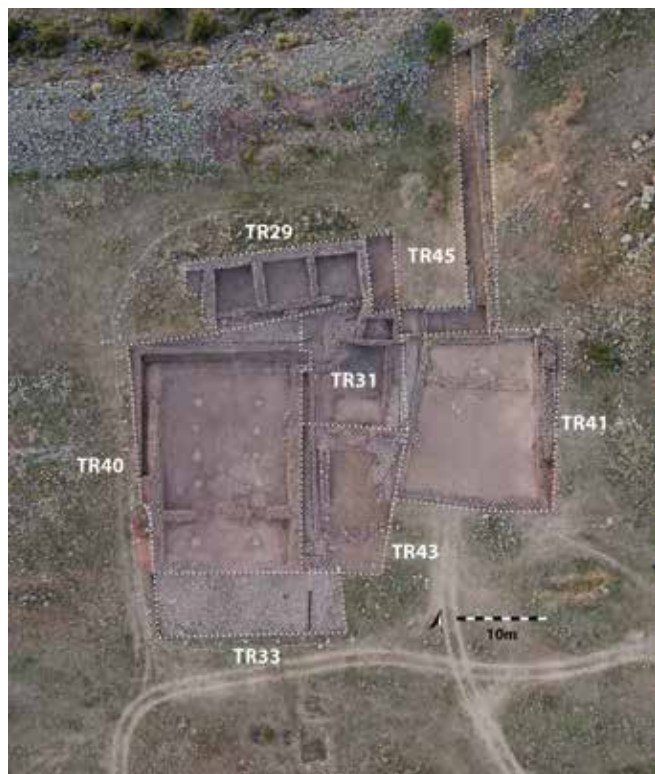
LEFT: Figure 2. Aerial Photograph of the Excavation Areas of Trenches 45, 41, 43, 33, 40, 29, and 31 in Urban Block 8.
BELOW: Figure 3. Aerial Photograph of Trench 45.

Excavations within the southern end of TR45 began in areas adjacent to the previous areas of excavation in Trench 29 (TR29), Trench 31 (TR31), and Trench 41 (TR41). An 8.6 m x 2.8 m exterior space extending from the edges of the prior excavation areas were exposed all the way up to the two free-standing buildings. A small section of an original stone paved surface was found running up to the northernmost building, though no significant finds were discovered on this surface.

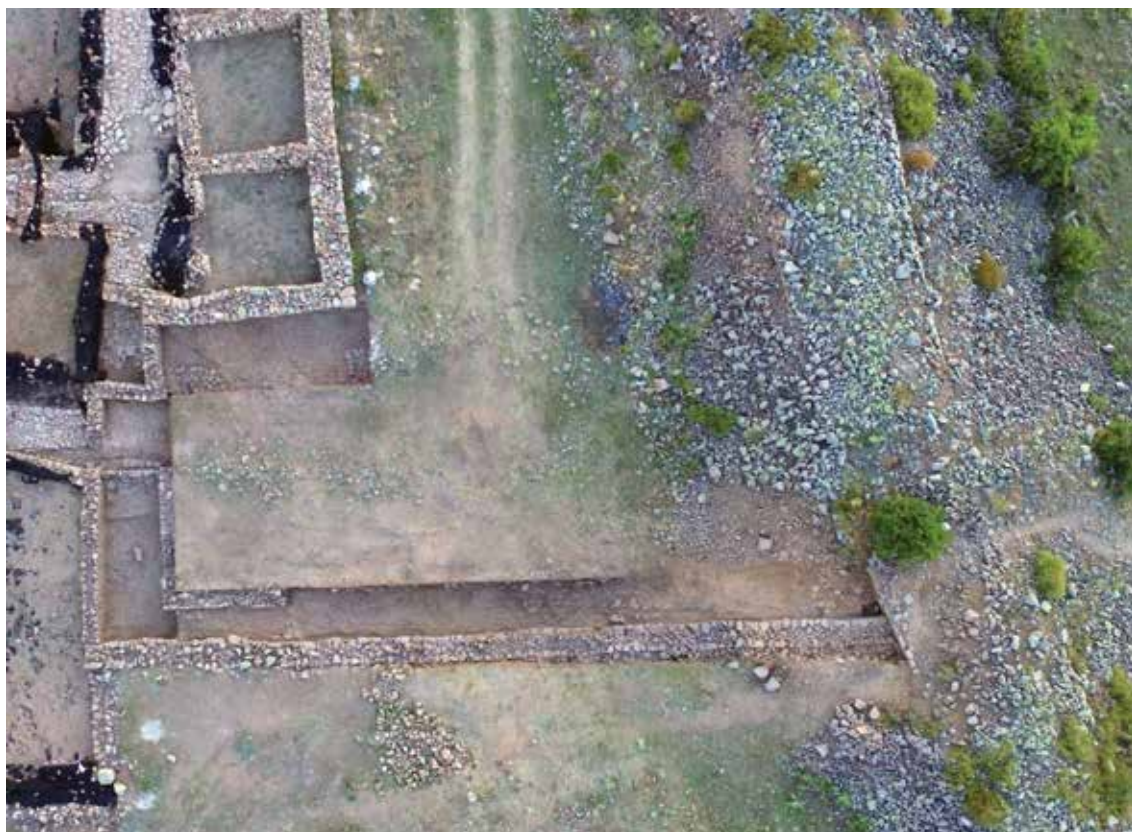
ABOVE: Figure 4. Excavated area of TR45 just inside the threshold between TR45 and TR41. The stone staircase that leads up to the raised area is to the left and the black patch of burning just above it is the remains of the wooden door that once stood in the threshold.

Meanwhile, a range of exterior spaces was excavated around two other sides of the southernmost building. To the south of the area is a wall that we excavated in 2017 within TR41. A threshold was found in this wall, which is the only known entrance into the area within TR45. In 2019, we excavated the area just to the north of the doorway and discovered a long, granite stone staircase that led up to a raised area just to the south of the southernmost freestanding building. Laying on top of the stair, we discovered the heavy burnt and poorly preserved remains of the wooden door that had once stood in the doorway of the wall between TR41 and TR45. On a raised

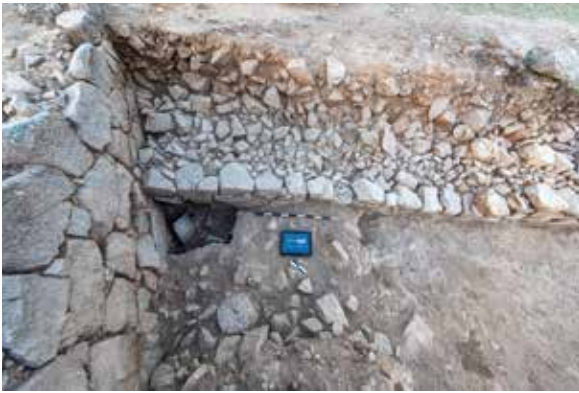
Figure 7. The Urban Block 8 wall abutting against the city wall and demonstrating the absence of a complete ring road within the city.

The final area of TR45 that we excavated during 2019 was a 29.5 m x 3.5 m long area across the top of and just inside the eastern urban block wall. The circa 1 m wide urban block wall runs for 31 m north to south from TR41 to the city wall. With the rubble removed from the top of its northern extent, we discovered that the urban block wall abuts against the city wall, leaving no room for a

ring road to run inside the city wall. This changes our understanding of the city plan as a whole in significant ways. This stretch of urban block wall also abuts against the stretch of urban block wall along the north of TR41, perhaps indicating that this urban block wall was constructed in segments. From south to north the wall is in an increasingly collapsed state, spilling down into the area of the urban block. At a point just beyond the northern wall of the southernmost freestanding building, we found a significant area of smashed in situ pots along this collapsed wall, representing several vessels. Soil samples that we collected from this area may give us a better idea of what these vessels contained. In addition, we found several ivory and antler inlays in this general area at the midpoint
