NINEVEH SHAMASH GATE PROJECT

TIMOTHY P. HARRISON AND KHALED ABU JAYYAB

2023 FIELD SEASON

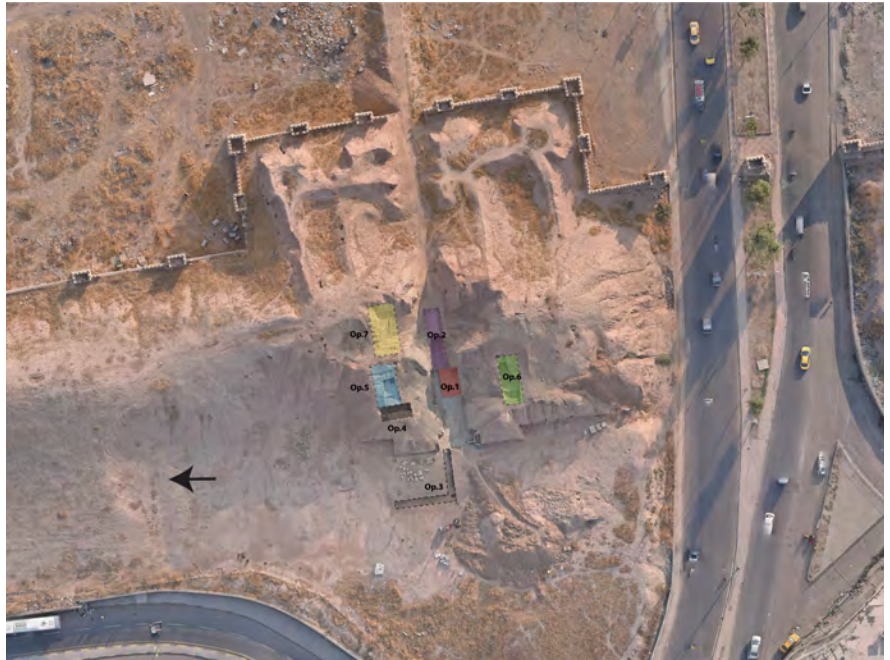
Figure 2. Aerial photo of the Shamash Gate, with the seven operations undertaken in 2023 indicated.

After a high density of debris—likely from the 612 BCE destruction of Nineveh—was identified at the west end of the gate, the main objective for the field season was to excavate these remains in a systematic manner. Since the erosional buildup, which contains the destruction debris, reaches 4 m above the final pebbled pavement, a second objective was to clear a stretch of the gate passage from the later deposition in preparation for future excavations. Finally, a third objective was to clarify the outlines of the tower chambers in the western portion of the gate. Accordingly, we opened seven operations (fig. 2)—operation 1, continuing a preliminary investigation of the destruction debris; operation 2 along the passageway of the gate; operation 3, a sounding in the space west of the gate; operations 4, 5, and 7 within the northwest and north-central towers; and operation 6 in the southwest tower (see fig. 3 for a composite plan of the gate structures excavated to date).

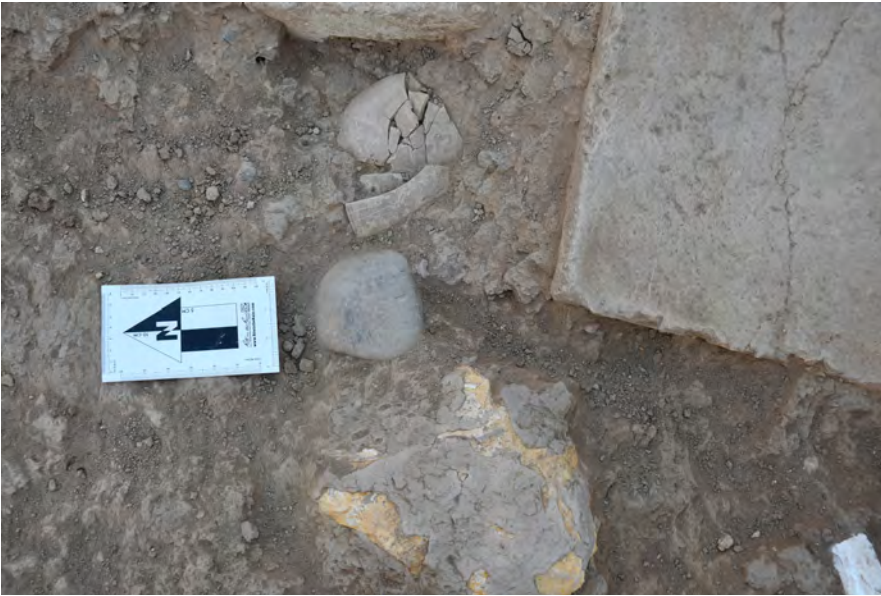
Figure 4. Close-up of the second pavement in operation 1, with objects in situ.

Operation 1 was a continuation of the 2022 soundings A and B in the western portion of the passageway within the gate system. This context proved to be fairly secure (fig. 4), producing a wide range of artifacts that included the fragments of a stela (fig. 5), bronze and iron arrowheads, ceramics, and a decorated bone button. The 2023 excavations also recovered the articulated remains of four human individuals: a child approximately 2.5–3.0 years old; an adolescent male with a bone-growth age of 18–20 years; an adult female aged 20–30 years (to judge from the degree of dental wear); and an adult of undetermined sex and an estimated age of 35–45 years (to judge from the degree of dental wear).

layer seems to have been composed of compact clay with interspersed pebbles and fragments of broken baked bricks. Immediately above and embedded within it were fragments of the stela, partially articulated human remains, and other artifacts. The floor of the second pavement, or third layer, was composed of baked bricks. Although we have yet to encounter baked bricks in situ in operation 1, their presence is not an unreasonable assumption given their clear use as pavement tiles in the north courtyard (visible in the section; fig. 6), as well as the large amount of complete or near-complete bricks that formed the debris attested in operation 1. The absence of a clear baked-brick floor in this area could be the result of bricks having become dislodged by the collapse of parts of the gate system superstructure. Evidence of a conflagration was manifested by pockets of ash and charcoal in the vicinity of the densely intermingled artifacts.

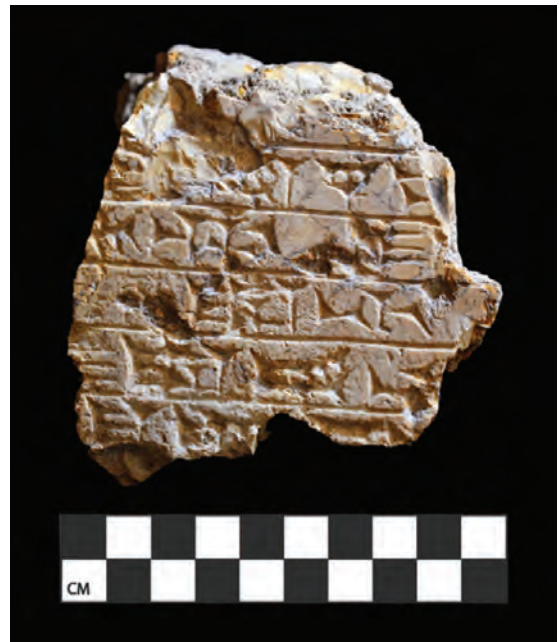
Figure 5. Stela fragment recovered in operation 1.

Some of the stone's surfaces are severely corroded, and it is easily scratched, although some parts of the stone matrix are more compact. Traces of fire and burned organic remains (straw?) are evident on the surface of some of the fragments. The stone may also have become calcified during burning. Conservation and treatment of the stela fragments were complicated considerably by the presence of densely layered clay. The softer clay was removed by moistening it with a contact sponge. The more compact layers required the use of a low-ultrasonic scaler, finished with scalpel and probes (fig. 7). A third layer of clay formed a thin “skin” that had congealed over time directly onto the surfaces of some of the fragments, rendering the clay impossible to remove during this initial phase of treatment.

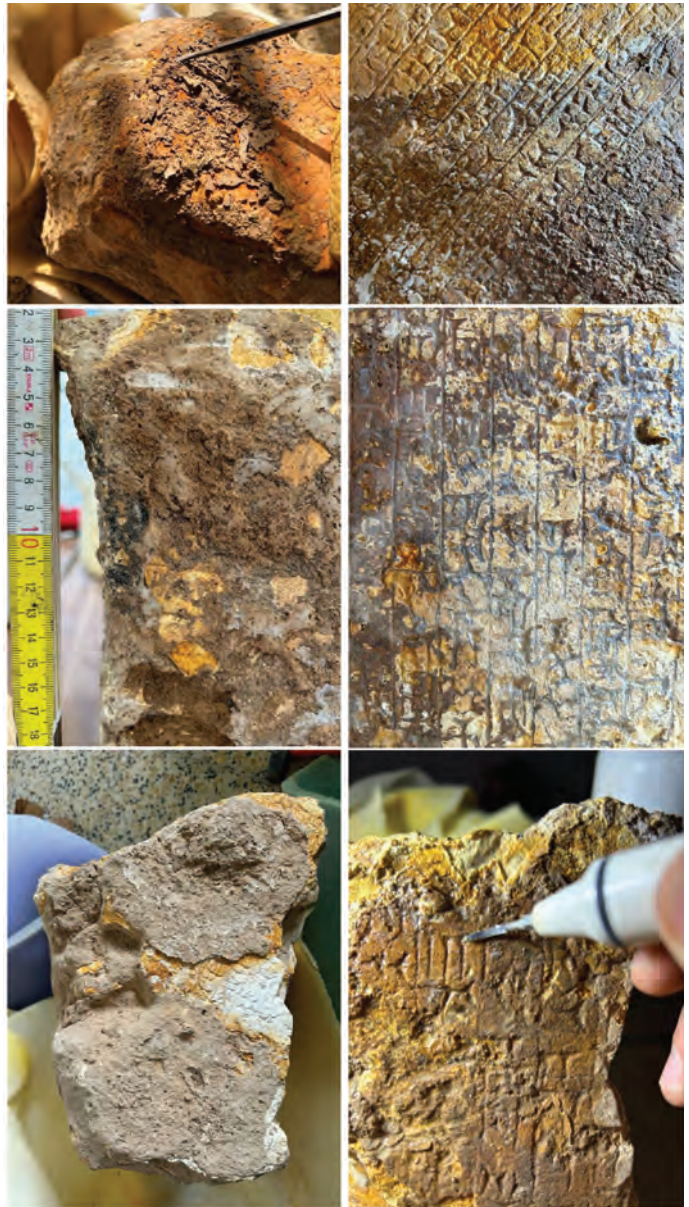
Figure 7. Conservation and treatment of the stela fragments.

To date, more than 100 fragments of a stela dating to the reign of Ashurbanipal have been recovered, although the stela's precise date remains uncertain. The stela was carved from a soft stone—probably a limestone with many inclusions, like breccia—and it had two carved faces, both inscribed in cuneiform. One of the two faces preserves a carved figure, most likely a representation of Ashurbanipal; an elbow, a decorated dress, and a mace or scepter have been discerned thus far. The stela's original size is unknown. Based on the evidence recovered so far, the stela likely stood at least 2 m in height, was 80–100 cm in width, and was 26 cm in depth. It appears to have been destroyed during the fall of Nineveh in 612 BCE.

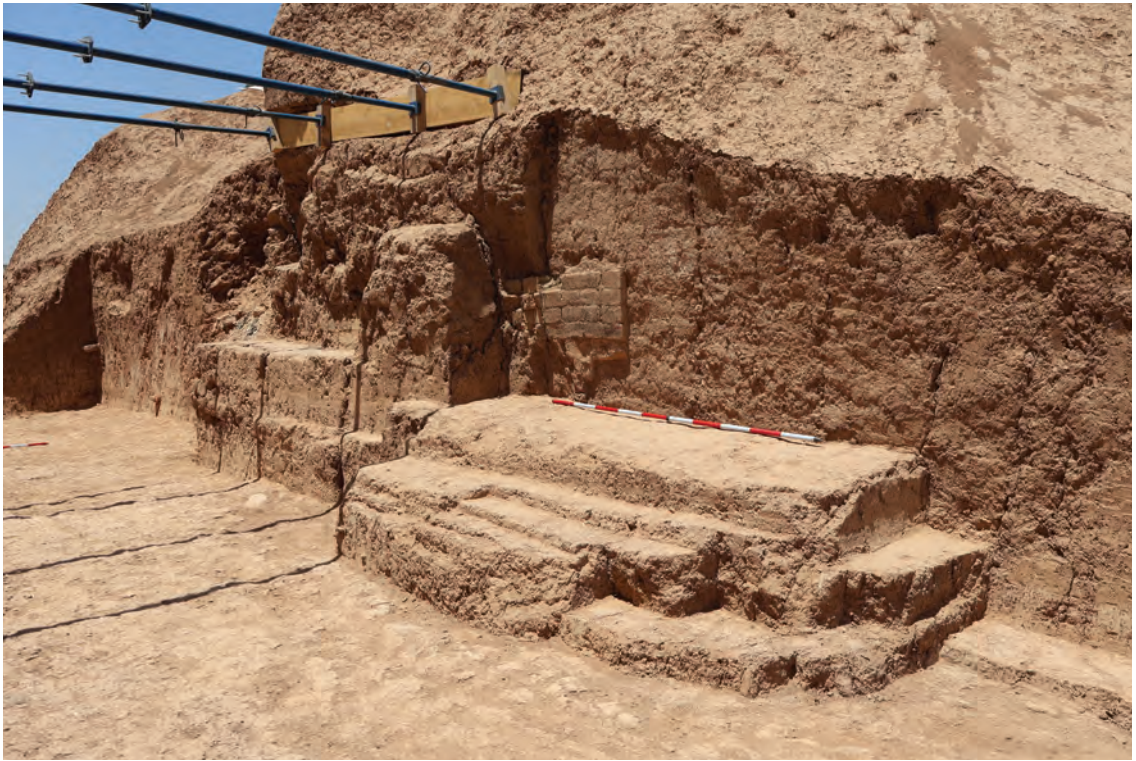
Figure 8. Baked bricks protruding from the north wall, and secondary wall constructed to narrow the passageway.

The spring intervention was successful in removing a substantial amount of the mudbrick collapse that seals the intact remains of the gate complex. More specifically, these excavations succeeded in delineating intact portions of the west and central piers of the north half of the Shamash Gate complex, including the framing orthostats of the central pier and part of an arch and springer anchored to this pier. The excavations also revealed a block of baked bricks inserted into the north wall, just to the east of the base of the arch, and in front of it, at a lower height, a poorly constructed and poorly preserved secondary wall, apparently inserted to narrow the passageway of the gate complex in its final phase of use (fig. 8).
