NINEVEH EAST ARCHAEOLOGICAL PROJECT

TIMOTHY P. HARRISON AND KHALED ABU JAYYAB

This report summarizes the inaugural seasons of excavation carried out at Nineveh by the Nineveh East Archaeological Project (NEAP) in fall 2024 and spring 2025. These seasons involved excavations in three areas—Areas C, V, and L, the latter being the Shamash Gate (fig. 1)—and preservation and restoration work at both the Shamash Gate and the Adad Gate. The Area C and Area V excavations, together with the restoration work at the Adad Gate, were conducted under the auspices of the University of Bologna, a NEAP consortium partner.

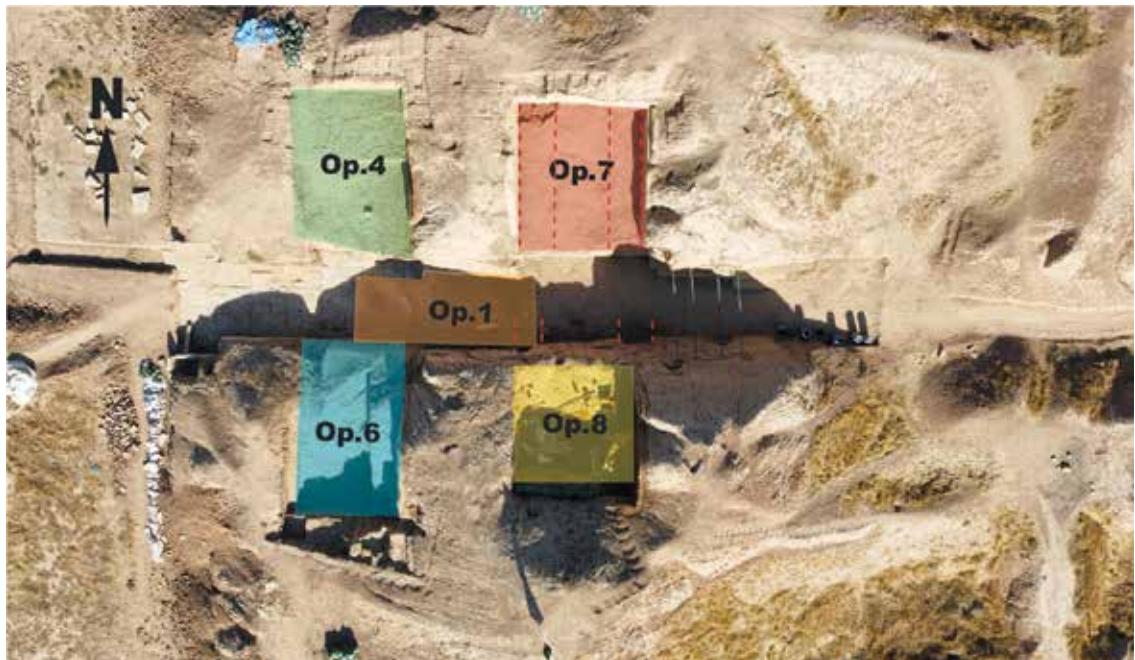
Figure 2. Aerial view of the Shamash Gate with excavation units. The dotted red lines indicate the location of tunnels in operations 7 and 8. Photo by S. Batiuk and K. Abu Jayyab.

remains. After we identified a high density of debris (which likely resulted from the 612 BCE destruction of Nineveh) at the western end of the gate, our main effort involved exposing the gate's central passageway (operation 1 in fig. 2). In 2024, this effort was accompanied by excavations in the chambers that we had begun exposing in 2023 (operations 4, 6, and 7) to clarify their outlines, and it expanded to include the south-central chamber (operation 8). In 2025, we further expanded our operations to include excavations in the eastern portion of the gate, specifically operations 11, 12, and 13 (fig. 3). Two additional operations initiated in 2025, operations 9 and 10 (fig. 3), were later abandoned because of the risk posed by the presence of previously undetected tunnels, possibly dug by the Islamic State of Iraq and Syria (ISIS).

Operation 8 corresponds to the south-central chamber of the tower gate system (see fig. 2). This operation was the only new one we opened during the fall 2024 and spring 2025 seasons. It was deemed prudent to carry out excavations in this area before lowering the passageway further, since doing so would render this area more difficult to access. The fact that the south-central chamber is bounded to the south by the highest-preserved towers of the gate has caused severe erosion in the fill of the chamber, requiring that this area also be leveled to prevent continuous erosion and deposition into the central passageway of the gate.

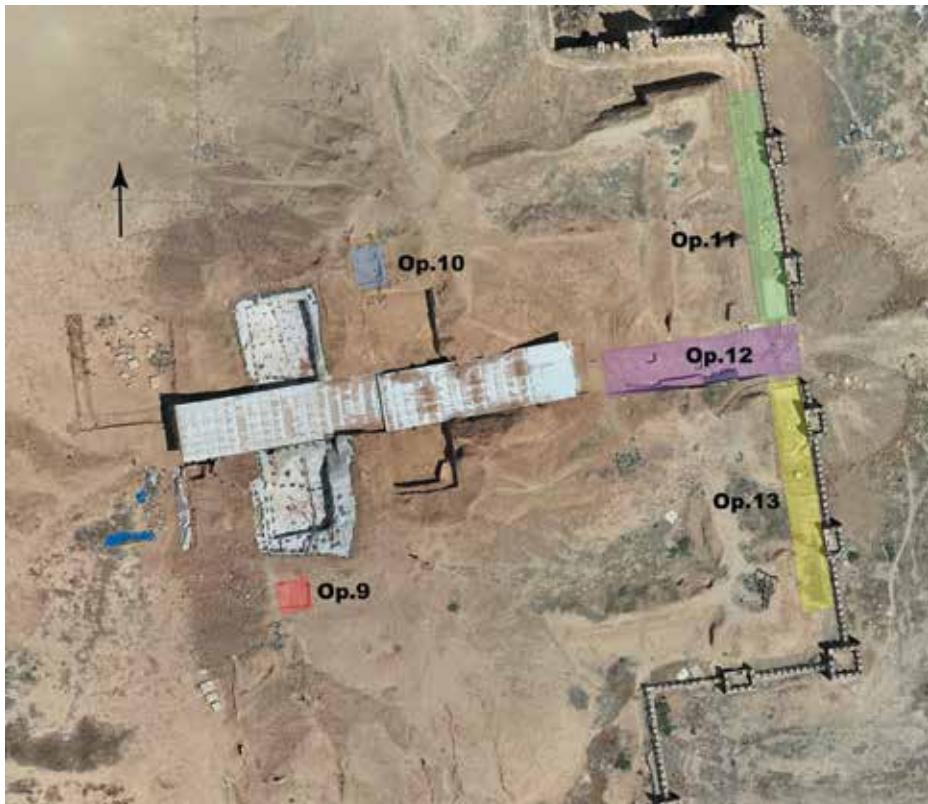
Figure 3. Orthophoto of the Shamash Gate showing operations 9 and 10. Photo by S. Batiuk and K. Abu Jayyab.

The Shamash Gate excavations during the spring 2025 season (fig. 3) focused on the gate's eastern area, with the aim of detailing the main features of the eastern approach to the gate, in preparation for the restoration of the area's mudbrick towers (first restored by Tariq Madhloum in the 1960s) scheduled to commence during the fall 2025 season. The area was divided into three operations (fig. 11): the northern alleyway between the stone and mudbrick fortification walls (operation 11), the eastern portion of the central passageway (operation 12), and the southern alley between the stone and mudbrick fortification walls (operation 13).

Several steps were taken during the fall 2024 season to preserve and maintain the Shamash Gate's integrity. We plastered the exposed faces of the towers' mudbrick walls, including the preserved portion of one of the gate's central archways (fig. 12a). All exposed excavation areas were covered with heavy-duty tarps secured by sandbags and dirt (fig. 12b). A temporary roof shelter was then erected over the central passageway (figs. 3, 12c–d).

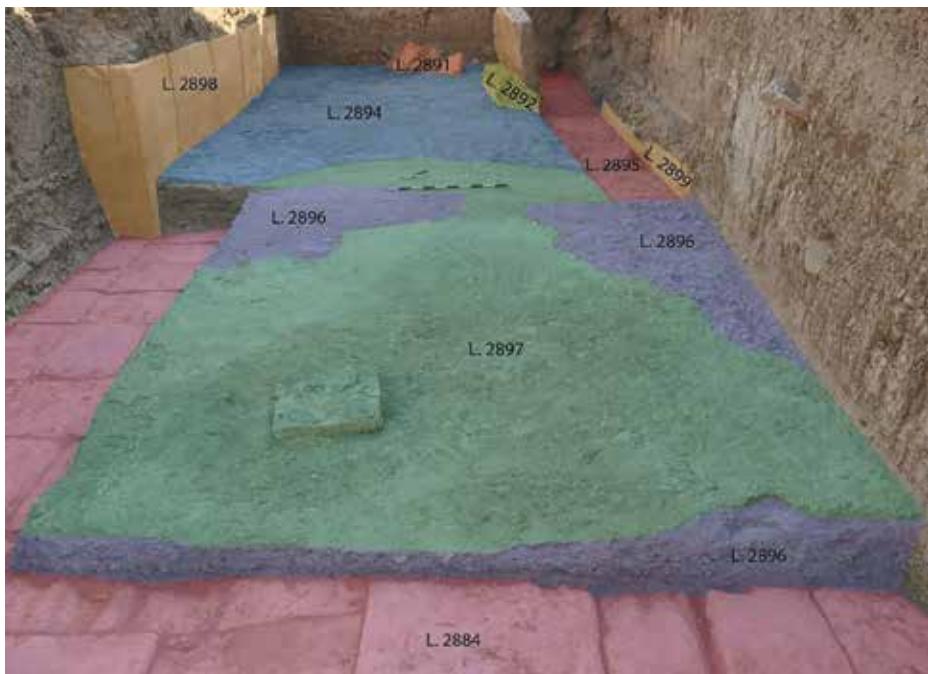
Figure 4. Loci designation in operation 1. Photo by S. Mooney.

Operation 1 is the central passageway of the Shamash Gate. The fall 2024 excavations continued a multiyear project to uncover the entire passageway. Previously, the team had reached the monumental paving stones (flagstones) at the western end of operation 1, the interior portion of the gate (fig. 4). The work carried out during previous seasons had also included a probe of substantial size along the northern balk of the trench in an attempt to clarify the stratigraphic situation. This probe was largely successful, since it allowed us to understand the repaving episodes that occurred after the monumental pavement's original construction, likely during the reign of Sennacherib.

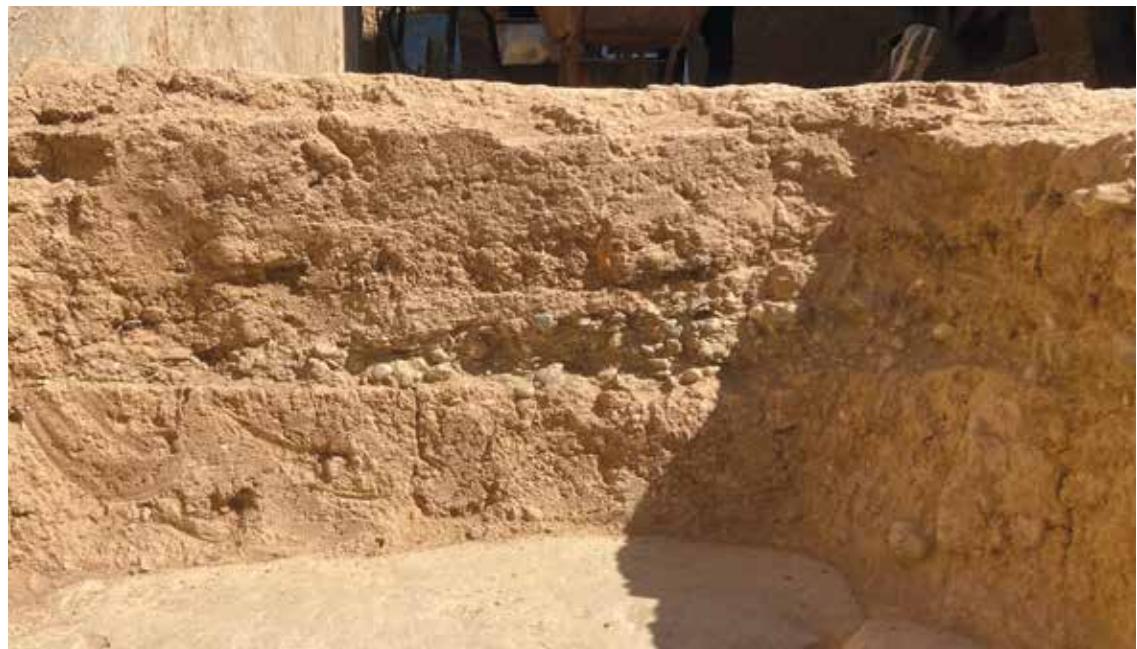
Figure 5. Layers of the second pavement. Photo by N. Hnetka.

During the fall 2024 season, the team uncovered one definite, and very likely two, repaving events that took place after the original flagstone construction (fig. 5). Mixed within the rubble and destruction layer of the later surface was a nearly intact human skeleton (fig. 6). In addition to the usual ceramic and bone

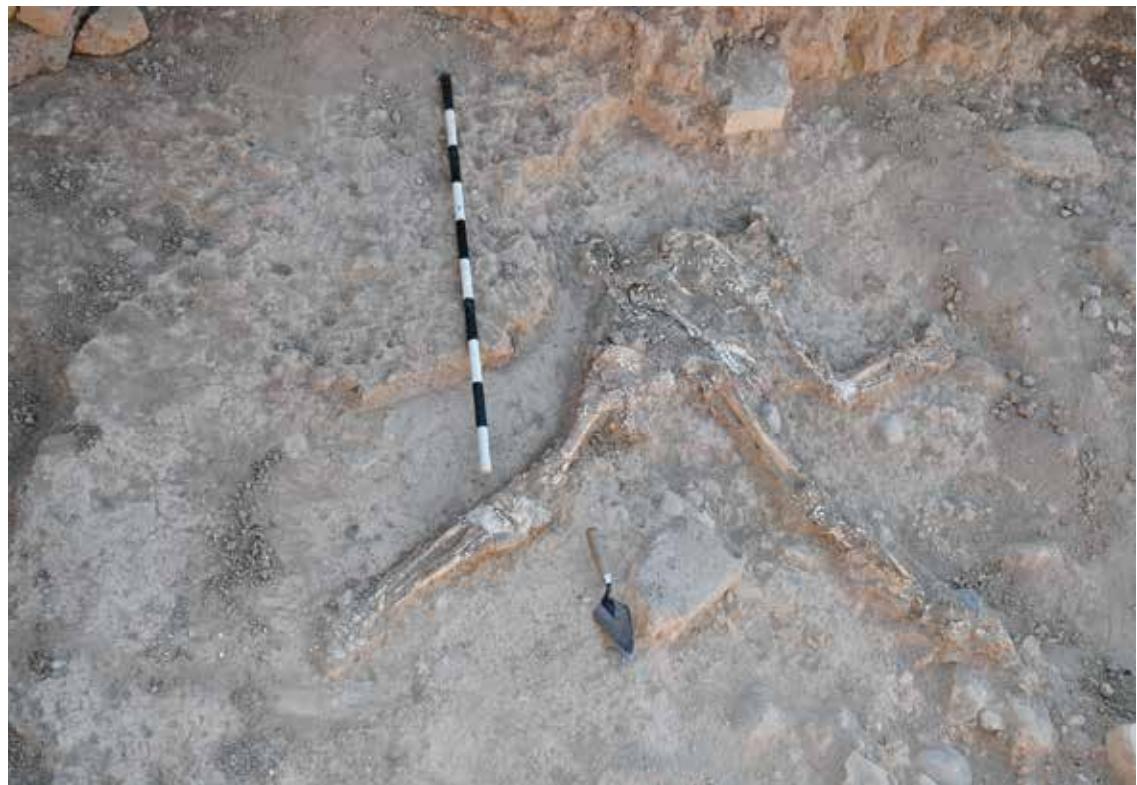
Figure 6. Human remains in operation 1. Photo by N. Hnetka.

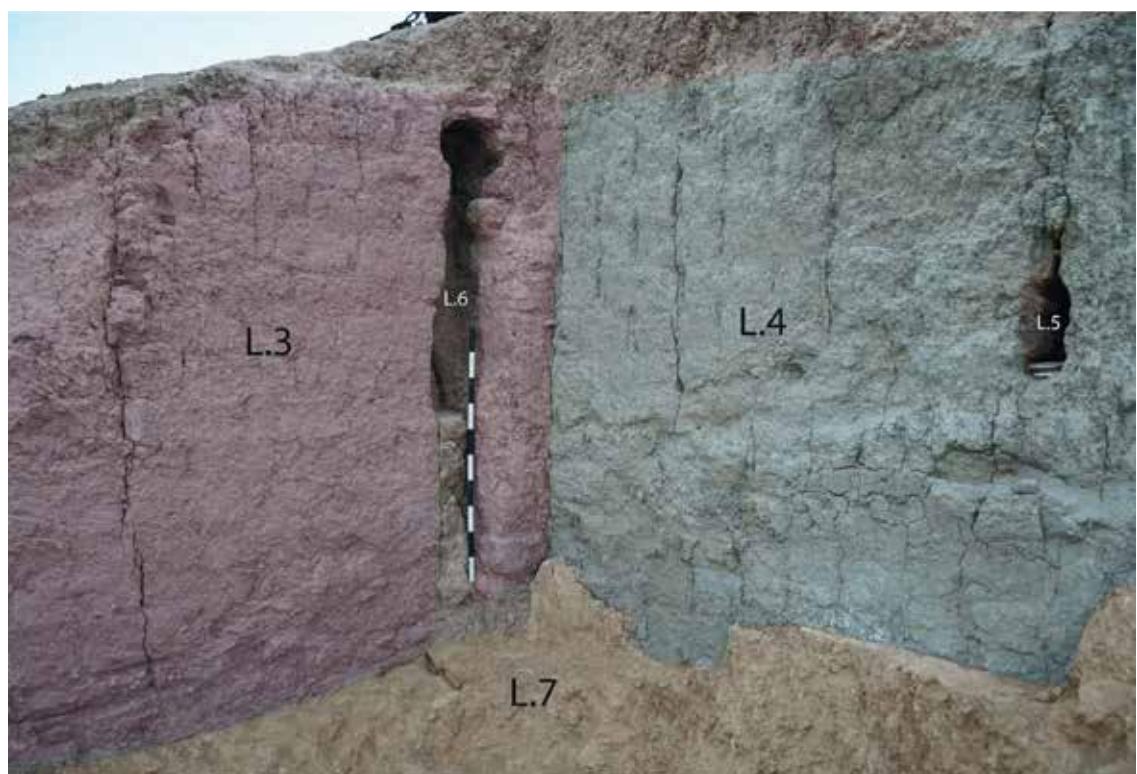
Figure 7. Northeastern corner of operation 4. Some of the original plastering on the eastern wall is still intact. Photo by N. Hnetka.

Operation 4 represents the fill of the northwestern chamber, an 8×6 m area. Since the boundaries of this chamber had been exposed in 2023, the fall 2024 season's goal was to lower the level inside the chamber as much as possible (fig. 7). The fill in this area consisted of hard, mudbrick collapse with occasional baked bricks and random air pockets.

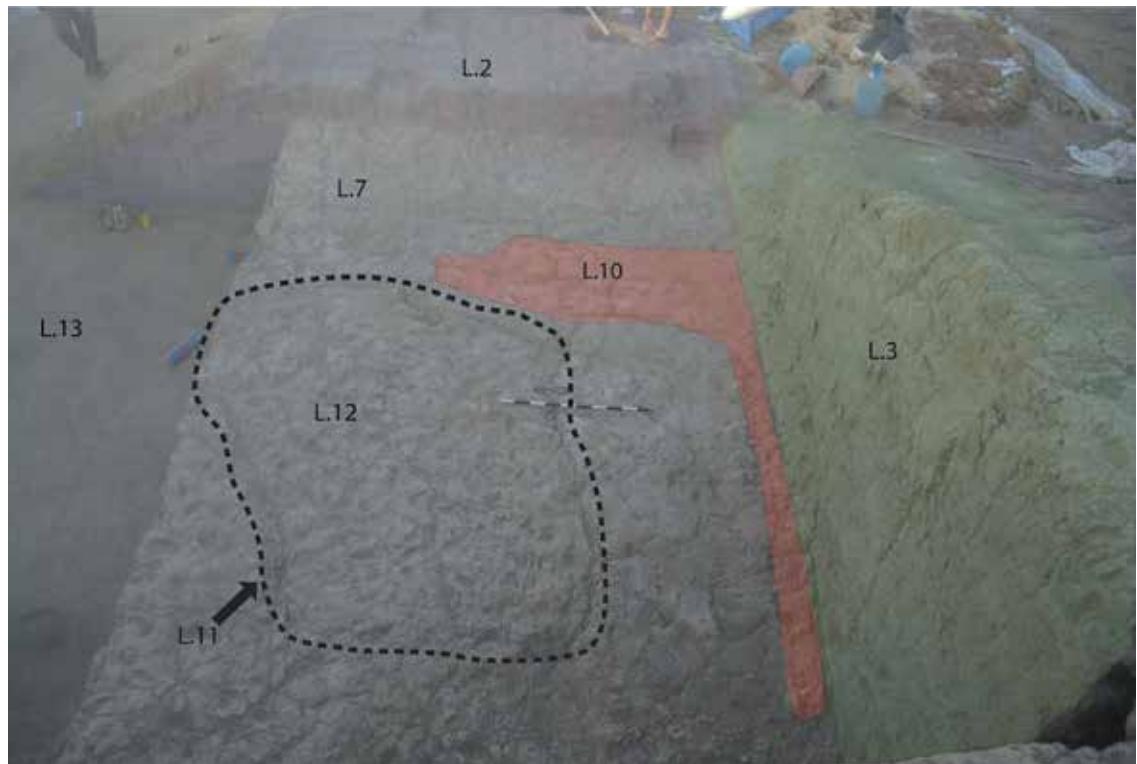
Figure 8. Operation 4 on October 24, 2024, facing west. Photo by N. Hnetka.

As Locus 7 was exposed to the elements over the course of the year, two features became apparent. First, a mudbrick formation running parallel to the eastern and western walls, about 1.5 m to the east of the western wall, was designated as Locus 10 (fig. 8). This mudbrick formation could be part of a staircase or a supporting buttress. We were able to follow the bricks running north-south for about 2 m. The formation may run farther south than is indicated in the photo, but it is increasingly disturbed.

The second feature may play a role in the disturbance of Locus 10. A large pit, which emerged in the middle of the square, overlapped to some extent the location where we would expect Locus 10 to continue south. The pit was designated as Locus 11 and the fill as Locus 12. These features were not completely excavated this season (fig. 8).

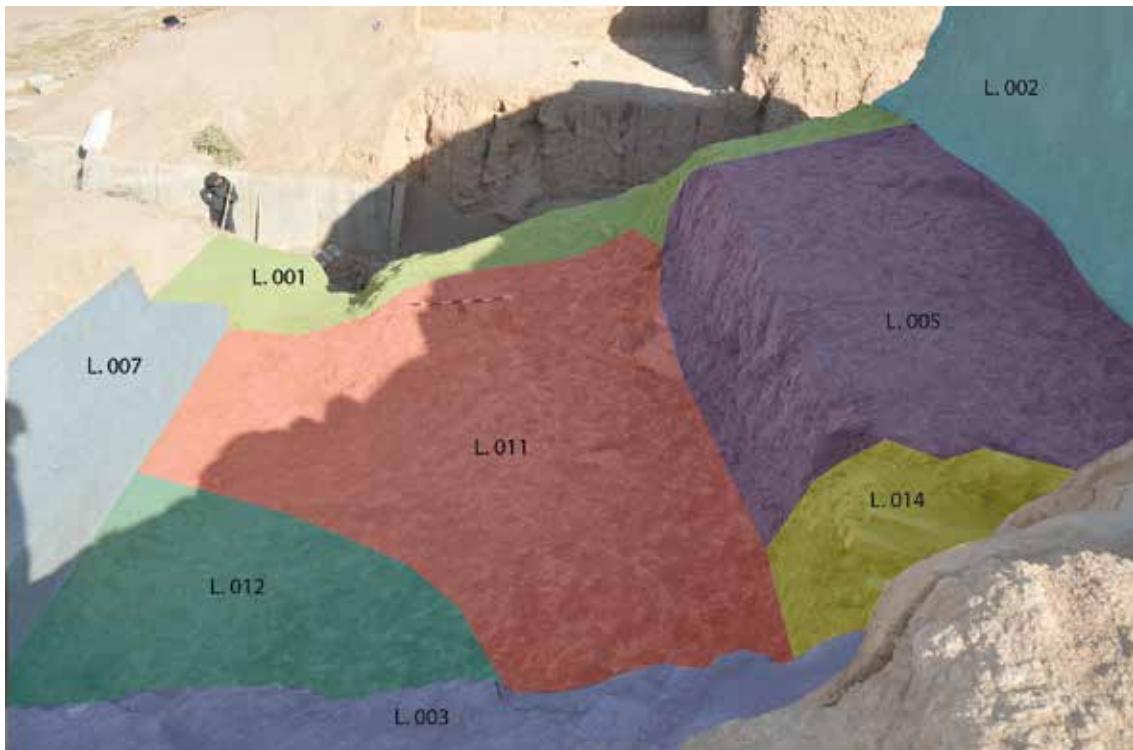
Figure 9. Loci of operation 6, viewed from the south. Photo by S. Mooney.

Operation 6 represents the excavation of the room fill of the southwestern tower. Its dimensions roughly matched those of the northwestern chamber (8×6 m). The objective for the fall 2024 season was to continue the work of the previous (2023) season to find the full boundary of the Shamash Gate's southwestern chamber (fig. 9). Previously, we were able to find conclusively the southern and eastern walls of the room (Loci 3 and 2, respectively), but the face of the western wall, though known and declared a locus, remained elusive. The eroded topography and significant disturbance from the battle to liberate Mosul made this task difficult. The fall 2024 and spring 2025 excavations also successfully defined most of the eastern and southern walls, and an exploratory trench was opened to find the face of the western wall (Locus 7), which was articulated despite the difficult conditions of the soil. Additionally, tunneling disturbance (Locus 14), uncovered the prior year, was fully excavated and defined. However, further excavation in this area will be challenging because of the existence of tunnels that pass through the entire square at a deeper level.

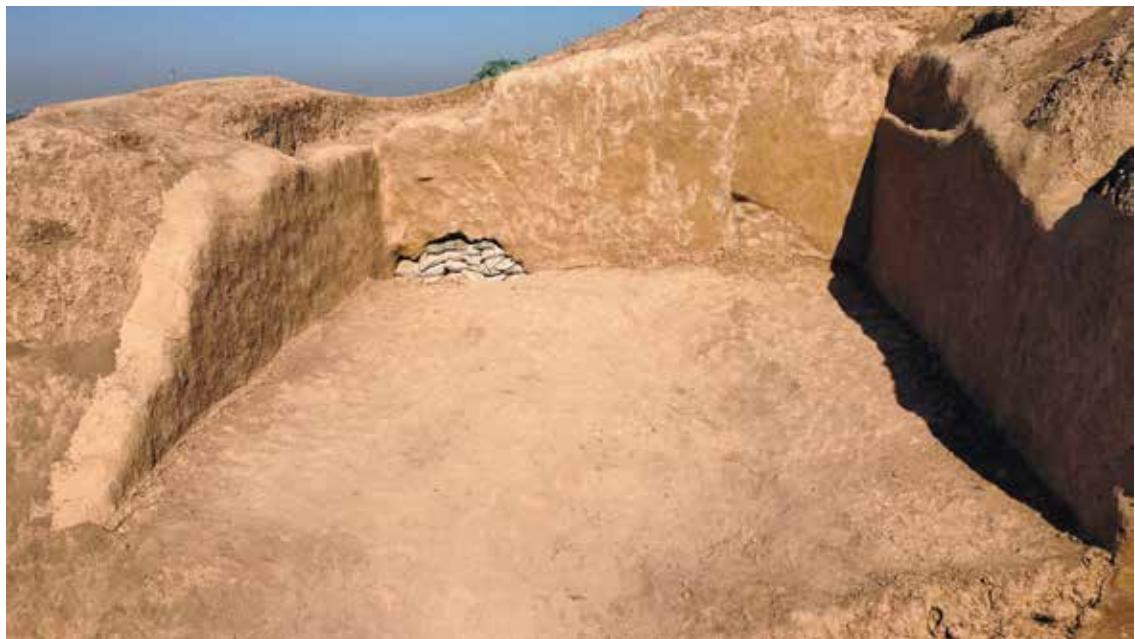
Figure 10. Potential ISIS tunnels or ancient passageways running through the northern wall of the north-central chamber (operation 7), viewed from the south. Photo by S. Batiuk.

At a depth of roughly 2 m from the tops of the walls, we came across two tunnels that ran north–south under the northern wall of the chamber and continued partially beneath its fill (fig. 10). The nature and extent of these tunnels was difficult to determine; a first impression suggested they were either tunnels dug by ISIS, similar to others found across the site, or part of Austen Henry Layard’s tunneling along the face of the orthostats in the 1840s. Alternatively, the tunnels could be ancient passageways through arches that held up a second floor in the chamber. These passageways could have run under the northern wall of the chamber to connect this hall to a second, adjacent room to the north (the abandoned operation 10).

The first possibility may be supported by the fact that the eastern tunnel appears to connect to an apparent ISIS tunnel seen in the cross section of the room visible in the passageway. Moreover, both tunnels align with tunnels on the other side of the passageway. Potentially ruling out the ISIS-tunnel hypothesis is the lack of a connection between the tunnels north and south of the passageway; that is, the tunneling seems to stop abruptly at the edges of the north-central and south-central chambers, respectively. This lack of connection leads us to think that these features were either tunnels dug by Layard, who followed the orthostats along the interiors of the chambers, or passageways through arches supporting a second floor of the chamber and providing access to other chambers in the central towers. The presence of bricks laid at an angle following an arch that corresponds to the angle of the bricks forming the top of the tunnel/arch in the hollow under the northern wall of operation 7 may support this ancient-passageway hypothesis.

We decided to halt excavations in this area because of the risk of collapse. As a final action, we packed the western tunnel with sandbags (the eastern tunnel already had a collapsed dirt fill) and shifted operations to the south-central chamber. In future seasons, we will aim to explore the hypotheses pertaining to the tunnels through excavations in the room to the north and clarification of the sections of the room along the passageway.

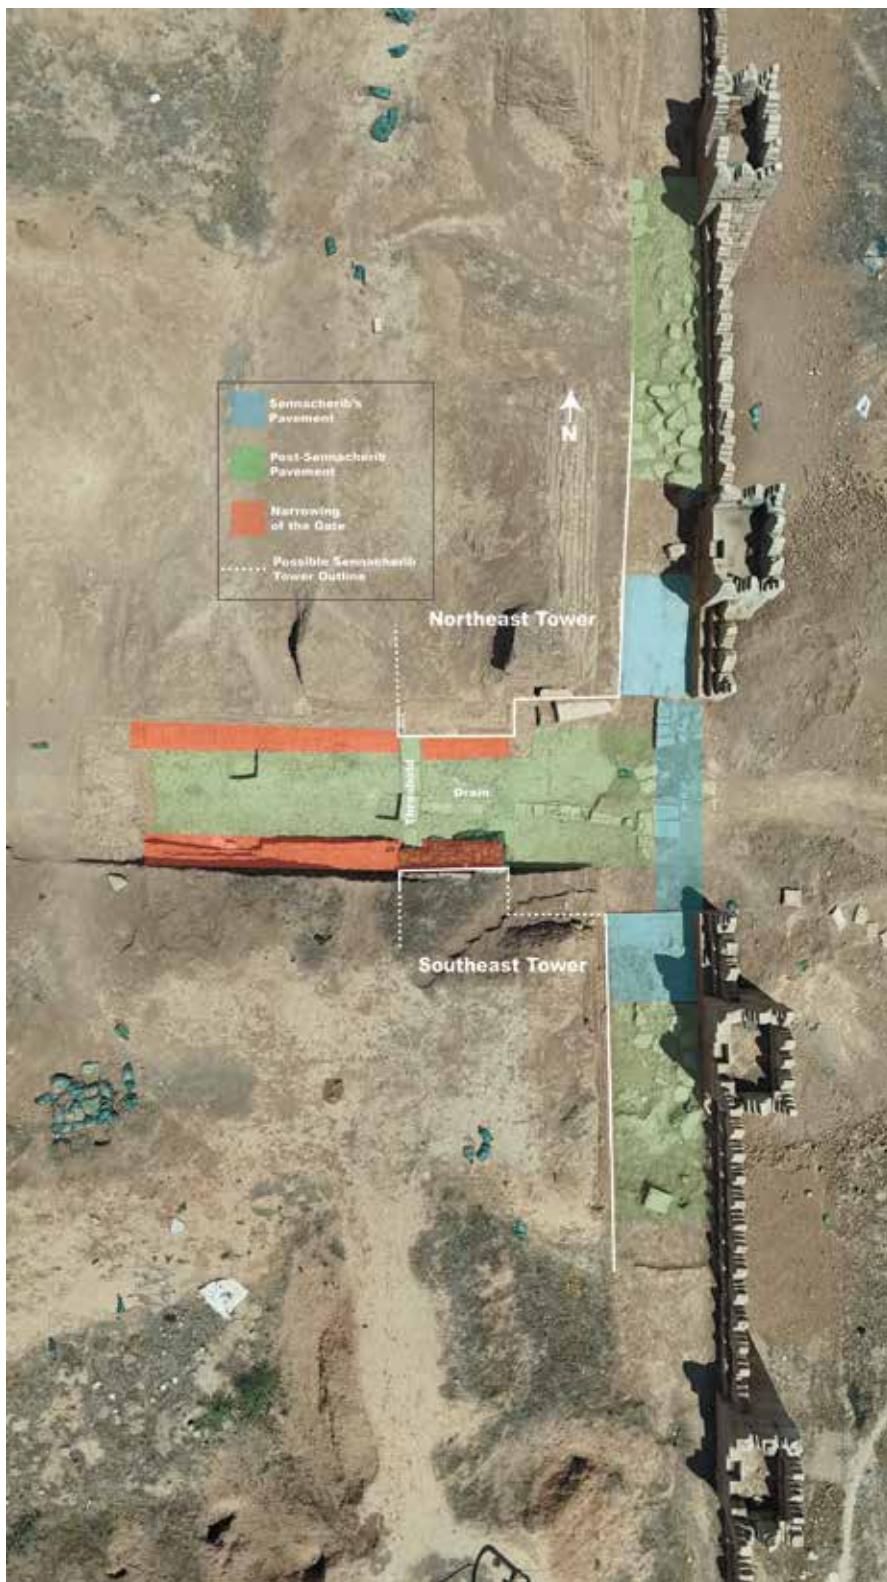
Figure 11. Excavations in the eastern portion of the Shamash Gate. Photo by K. Abu Jayyab.

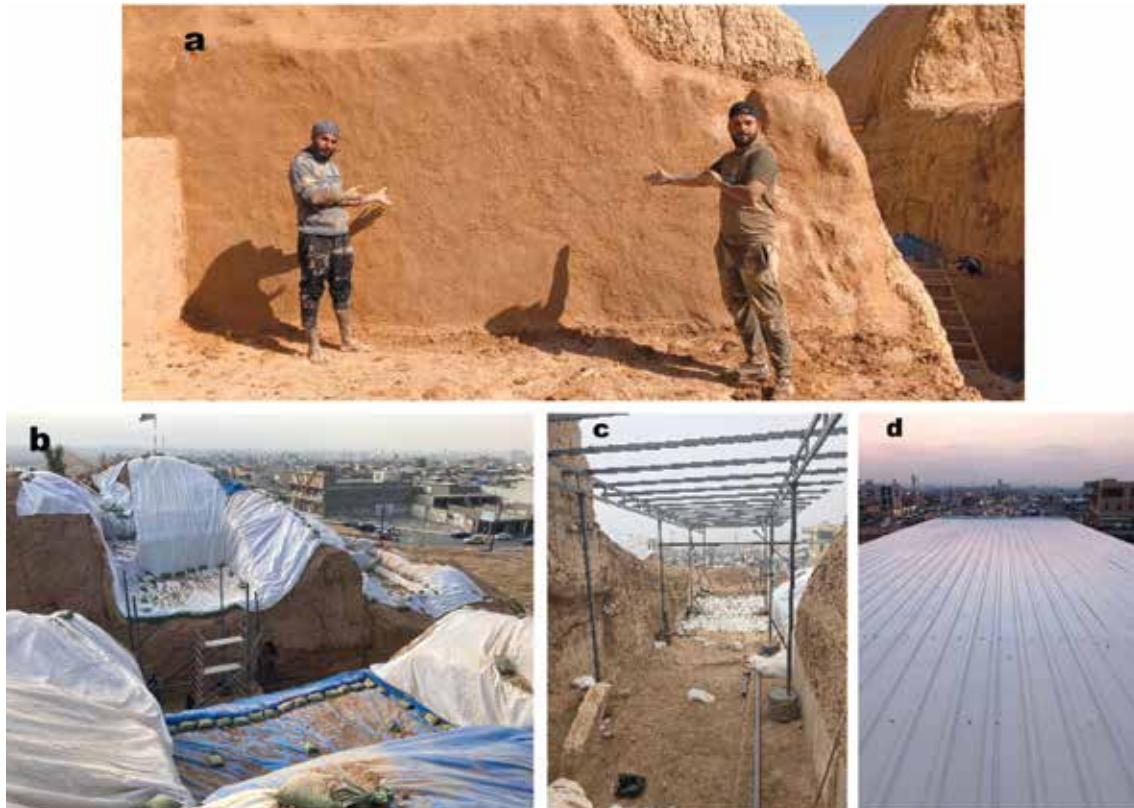
Figure 12. Plastering, covering, and roofing the Shamash Gate. Photos by K. Abu Jayyab.

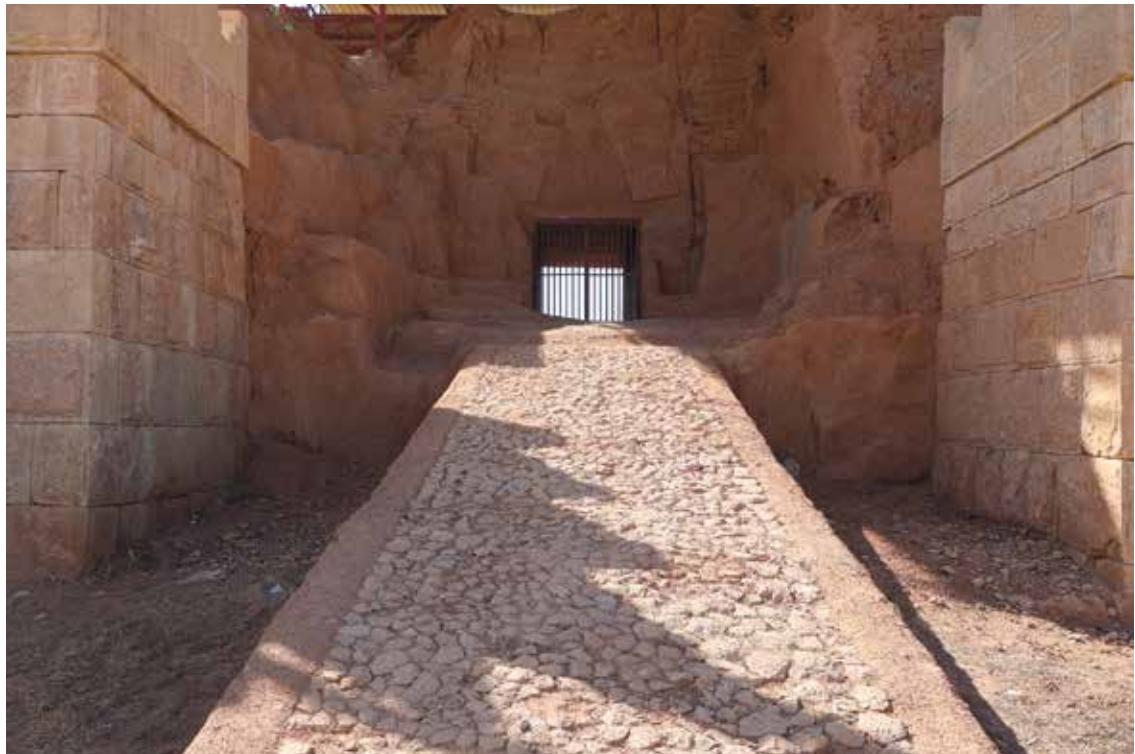
Figure 13. The restored entrance ramp to the Adad Gate. Photo by S. Rosso.

Further conservation and restoration was conducted at the Adad Gate (Area D; see fig. 1) under the supervision of Serafino Rosso. Numerous exposed sections of the ancient wall were replastered; the entrance ramp was repaired (fig. 13); and a new, more durable information panel was installed at the gate's entrance.

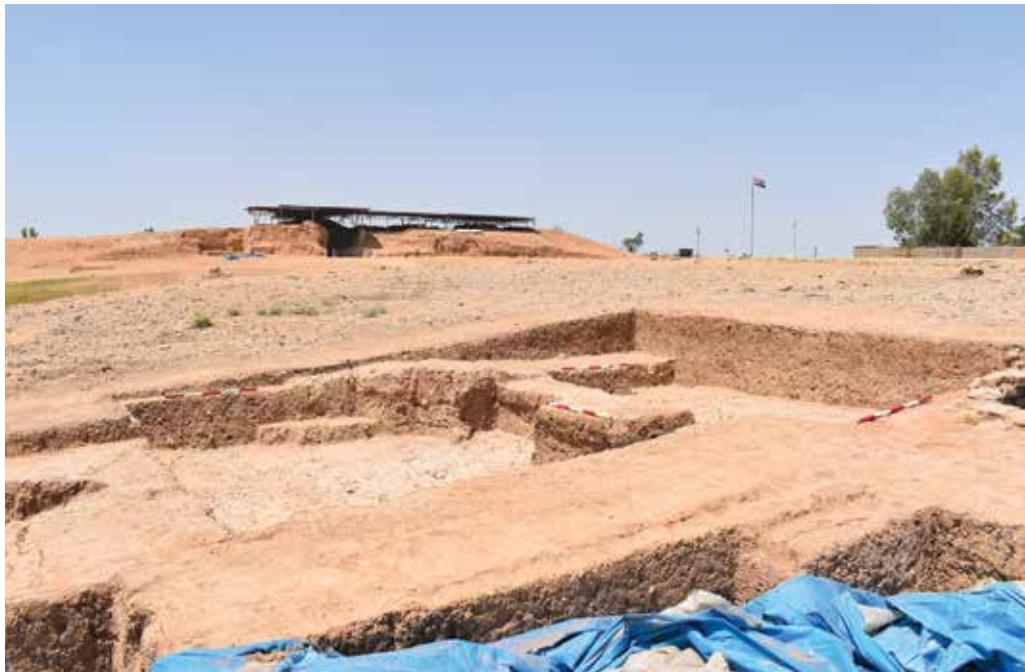
Figure 14. General view of the Area C excavations, from the southwest looking northeast. Photo by E. Mariani.

Area C (see fig. 1) lies between ISIS-dug Trenches 2 and 3, placed along the northern side of Trench 2. During the spring 2025 season, excavations in this area under the supervision of Eleonora Mariani were expanded northward and westward to clarify the extent and architectural plan of the structure, already partially exposed in the 2019–23 campaigns (fig. 14). The excavations focused on the building's northern rooms, which proved to be poorly preserved as a result of heavy modern disturbance.

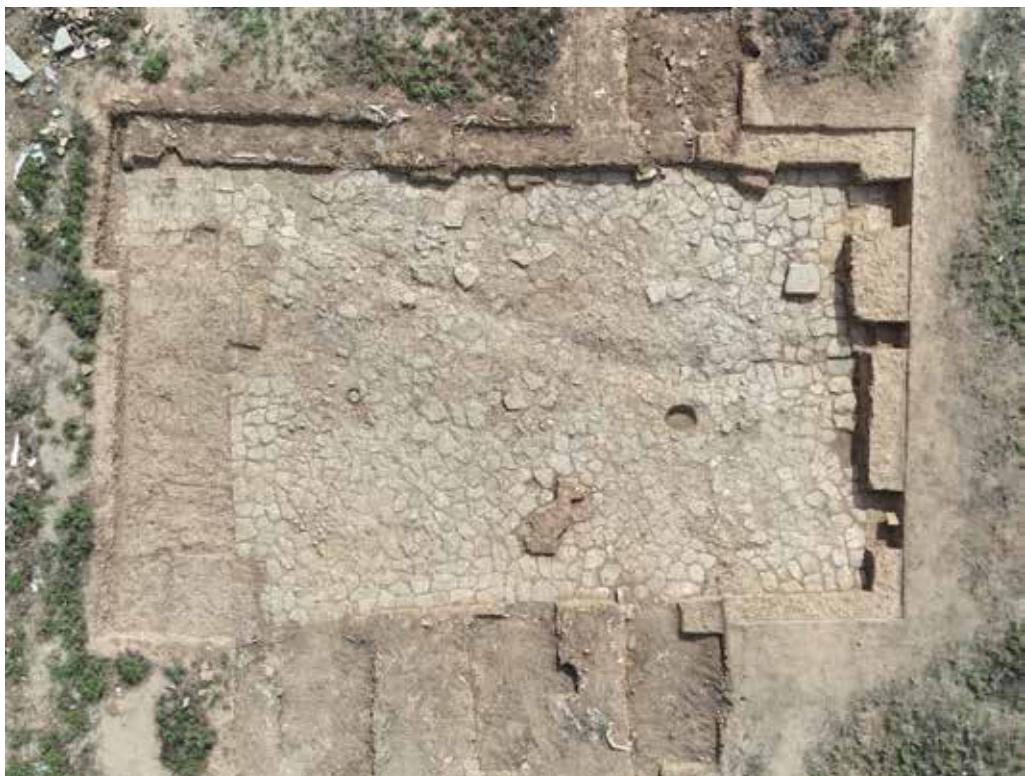
Figure 15. General view of Area V at the end of the spring 2025 season; the three doorways are visible to the right (north). Photo by F. Cavaliere.

remainder of the courtyard was exposed (fig. 15), along with thousands of pottery sherds, part of a destruction layer that sealed the courtyard.

Three doorways were uncovered along the courtyard's north side. The western and central doors were paved with baked bricks, while the eastern doorway had a beaten-earth threshold. The spring 2025 excavations also further delineated a drainage channel that continued northward out of the excavated area.

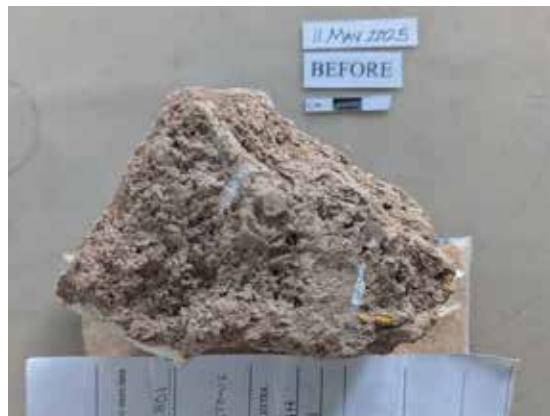
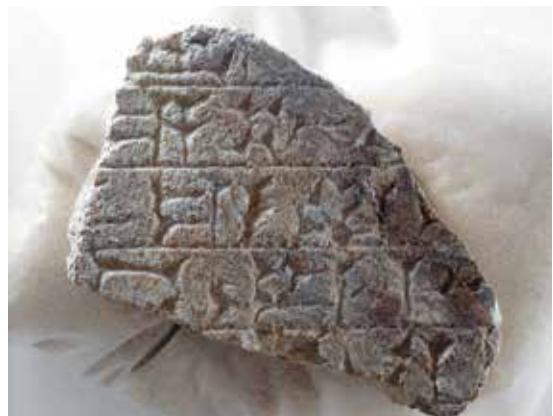
Figure 16. Stela fragment no. 801 before and after cleaning. Photo by J. Unruh.

Conservation work was performed on eleven of the stela fragments found at the Shamash Gate (fig. 16). The fragments were cleaned using the same procedure established in previous seasons. Thick, mud accretions were reduced with a scalpel, after which detailed cleaning was performed with a dental scaler and wooden skewers. As needed, the stone was consolidated during cleaning with Conservare HCT, an aqueous hydroxylating nanolime consolidant. Photos of the cleaned text were sent to epigrapher Gianni Marchesi, who confirmed their legibility.
