KERKENES DAĞ PROJECT

The 2009 season at Kerkenes Dağ laid the foundation for an extensive multi-year program of restoration within one of the key gates of this ancient Iron Age city. The Cappadocia Gate, so named by the project because the important region of Cappadocia lies fairly near in the southwesterly direction it leads, has been an area of intensive research since the beginning of the project (figs. 1–2). Its importance is inferred not only from the direction it leads to outside the walls, but also because of its size and its close proximity to the Palatial Complex within the city. Mapping of the gate from aerial photographs was undertaken as early as the second season of the project, in 1994. More detailed total station mapping was undertaken to recover the full plan of its walls, chamber, and towers starting in 1996.

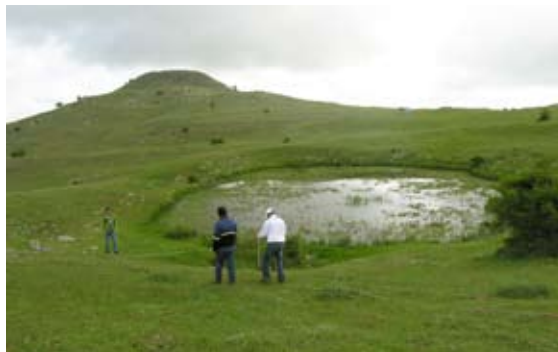
Figure 3. Workers collecting resistivity data during the May season

Building upon the successful test area within the city next to the Cappadocia Gate in 2008 (see *2008–2009 Annual Report*, p. 89), a much larger area was surveyed adjacent to the gate in May of 2009 (fig. 3). A 56,800 sq. m area (5.5 ha) was covered by the resistivity survey successfully connecting this area with those surveyed in and around the Palatial Complex in 2006–2008 (fig. 4). Magnetometry survey conducted in this area in the mid-1990s revealed open areas delineated by freestanding walls, long narrow structures immediately opposite the gate that have been interpreted as stables, the second-largest water storage pond in the city, and additional urban blocks up around the Palatial Complex. The resistivity survey in these areas confirmed this basic arrangement while providing additional details on secondary pools within the water storage system and more detailed information on the buildings within the additional urban blocks. Next year's resistivity survey is planned to continue working south and west of the area of the Cappadocia Gate and Palatial Complex back along the top of the ridge toward the Gözbaba Gate.

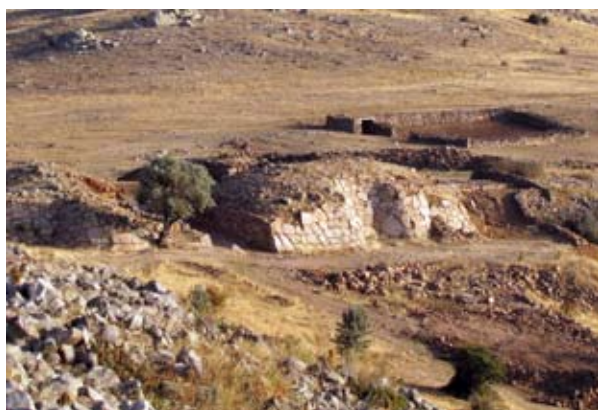
Figure 6. A view of the outside of the Cappadocia Gate showing the preserved sloping stone glacis that once stood at the base of the external walls and towers. The new walkway created to the east of the gate to divert animal traffic around the gate passage can be seen on the right of the photograph

In preparation for reconstruction work within the Cappadocia Gate, excavations were conducted both inside and outside the gate (fig. 5). Outside of the gate, along its northeast side, the external wall was further exposed, and a pathway was constructed over the main city wall just to the east of the gate (fig. 6). The pathway provides a way for sheep, goats, and cows that graze the site to be rerouted around the main gate passage that they have been using to enter and leave the city. This was critical both for issues of safety as well as for the long-term sustainability of reconstructive work inside the gate.

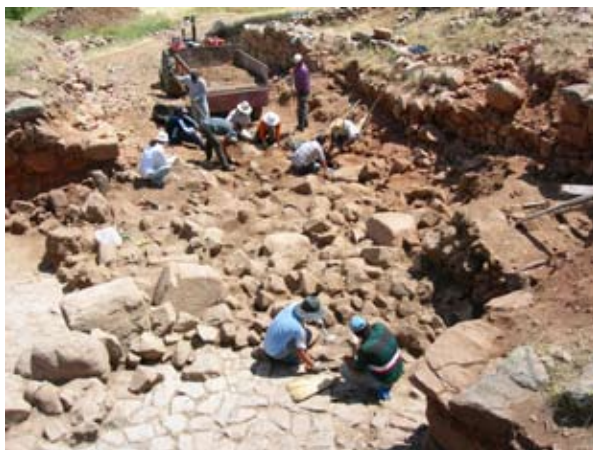
Figure 7. Excavations in the passage of the Cappadocia Gate undertaken to remove the fallen stone and debris before restoration work can begin

Within the gate passage and gate chamber, excavation proceeded down through the last thick layers of collapsed stone and burnt debris (figs. 7–8). Stone paving was found underneath the debris throughout the gate passage and in the excavated portions of the gate chamber. This stone paving, like that in the entranceway to the Palatial Complex, shows some signs of wear from the people and animals that once used this gate to get into and out of the city. The pavement also incorporates a stone-lined drain, curving around the West Tower of the gate and then down into the lower passage, that would have helped direct the flow of water from rain or runoff down through the gate.

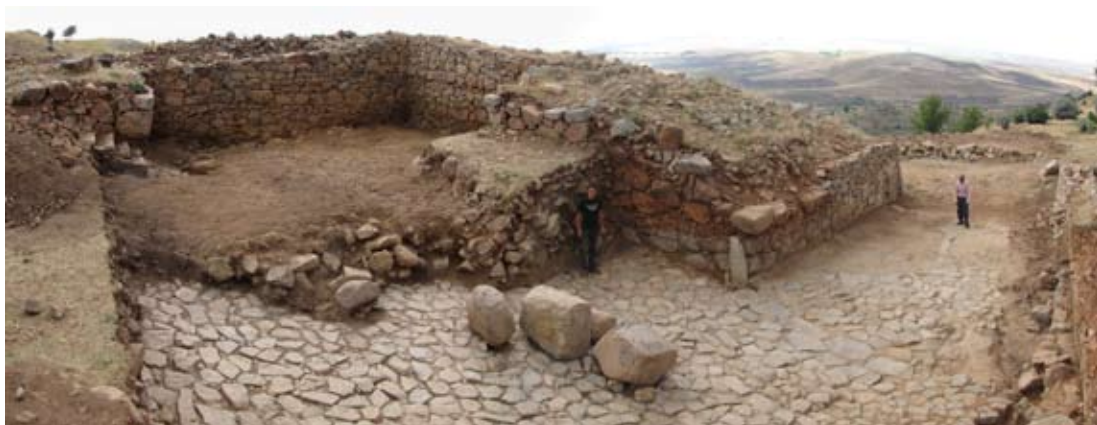
Figure 8. Photograph of the inside of the gate passage and chamber showing the extent of this year's excavation. Excavation will continue next year with the removal of the remaining portion of collapse in the gate chamber

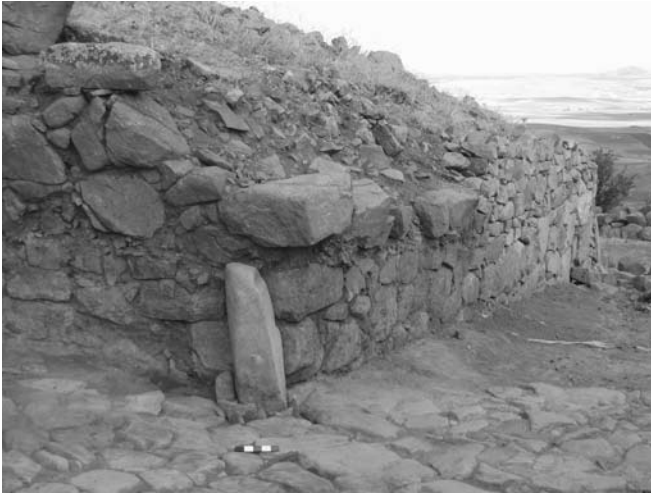
Figure 9. The new aniconic stela discovered adjacent to the western corner of the Middle Tower

An impressive semi-aniconic stela had been uncovered within the gate passage adjacent to the North Tower of the gate in 2003 (see *2006–2007 Annual Report*, fig. 8). The high stepped platform upon which it had been placed was completely excavated this year down to the stone paving at its base. In addition, a second aniconic stela was uncovered set into the paving stones at the northwestern face of the western corner of the Middle Tower (fig. 9). Quite different in character and composition from the first stela, this second stela would have faced up the gate passage, past the downward-looking first stela, and on into the city.
