## **THE MEGIDDO WATER SYSTEM**

# THE MEGIDDO WATER SYSTEM

*By*  
ROBERT S. LAMON

**COPYRIGHT 1935 BY THE UNIVERSITY OF CHICAGO  
ALL RIGHTS RESERVED. PUBLISHED JUNE 1935**

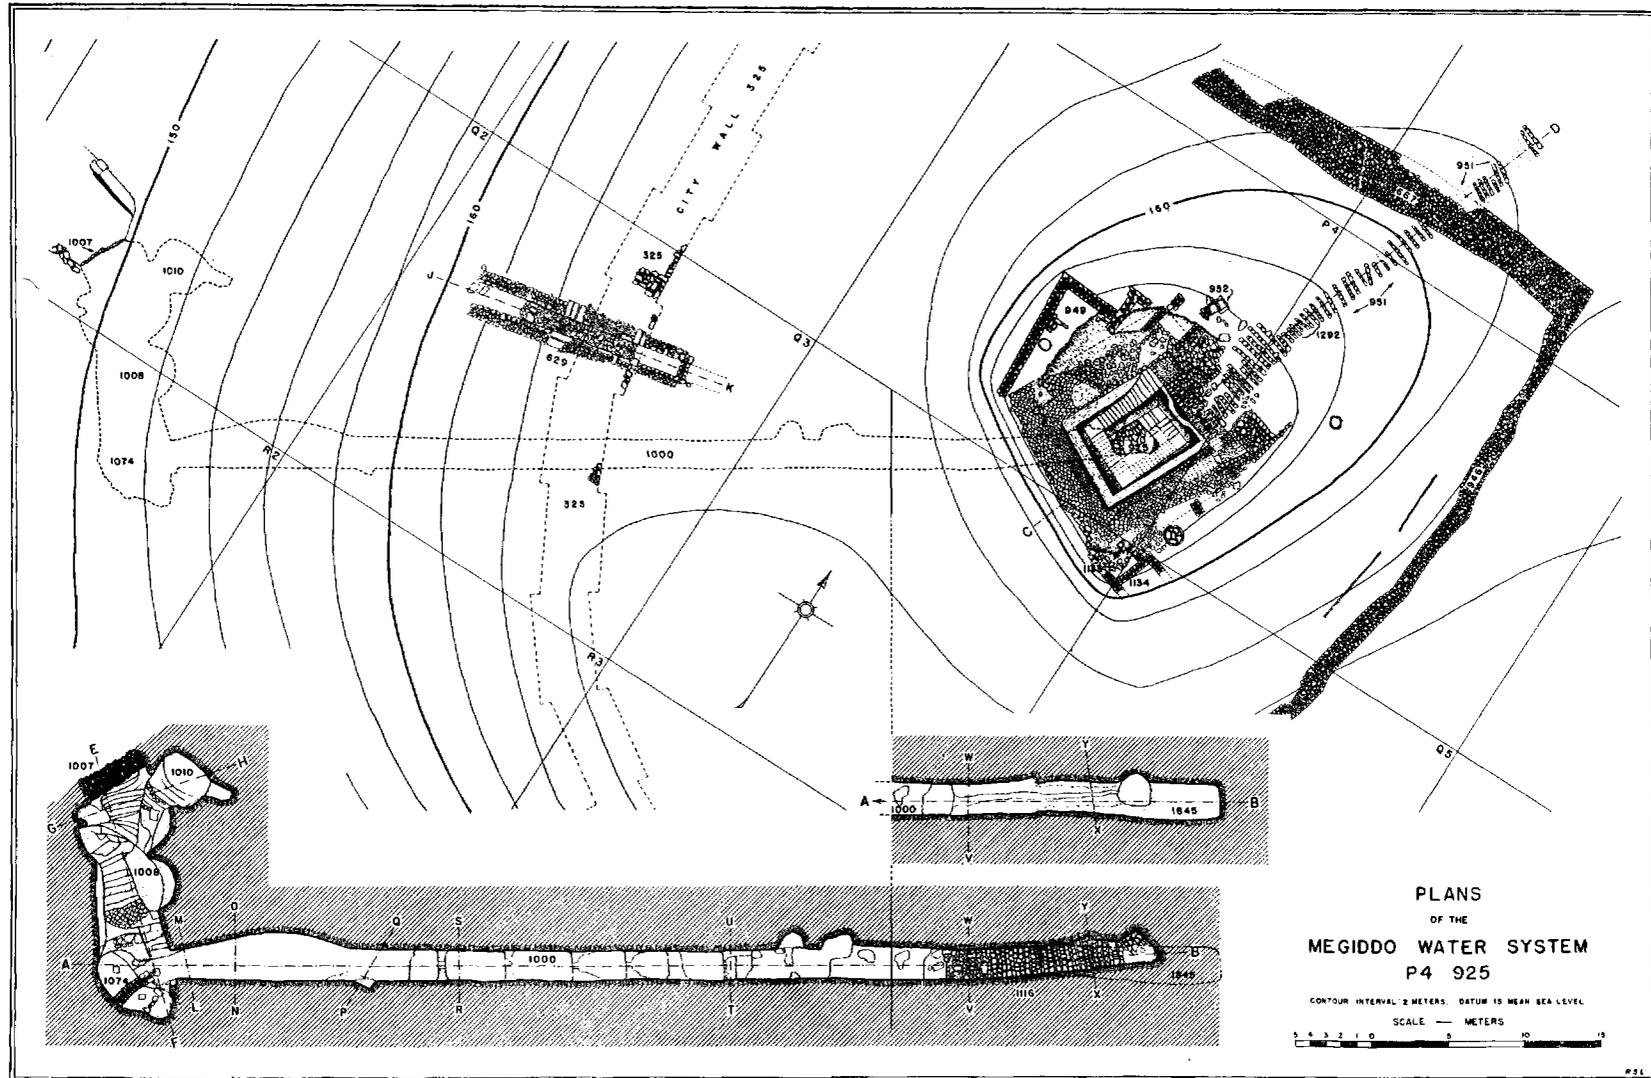
FIG. 2.—PLANS OF THE WATER SYSTEM. SCALE, 1:500

The bottom plan shows the underground part of the system as it would appear were the rock above it removed. The outline of this underground part is shown in broken line in the top plan. The small plan shows the eastern end of the water system, with the masonry stairs in the inclined passage removed. The lines marked A-B to X-Y indicate the locations of the cross-sections in Fig. 3.

A small passageway (locus 629 in Q 3; see Figs. 2 and 3), originating well within the city, leads part way down the slope of the hill toward the entrance to the cave. It is substantially built of part ashlar and part rubble masonry and is floored with large, fairly well squared flagstones (Fig. 8). In all probability it was originally roofed over and buried, forming a tunnel or gallery some 2 meters high and slightly more than a meter wide. The west, or down-slope, end of the gallery is broken away and comes to no definite terminus. There is every indication that it once extended farther, and it may very possibly have connected directly with the mouth of the cave. If this is the case, it is likely that some remains of the lower end of the gallery are preserved under the as yet unexcavated area outside the blocking wall 1007.

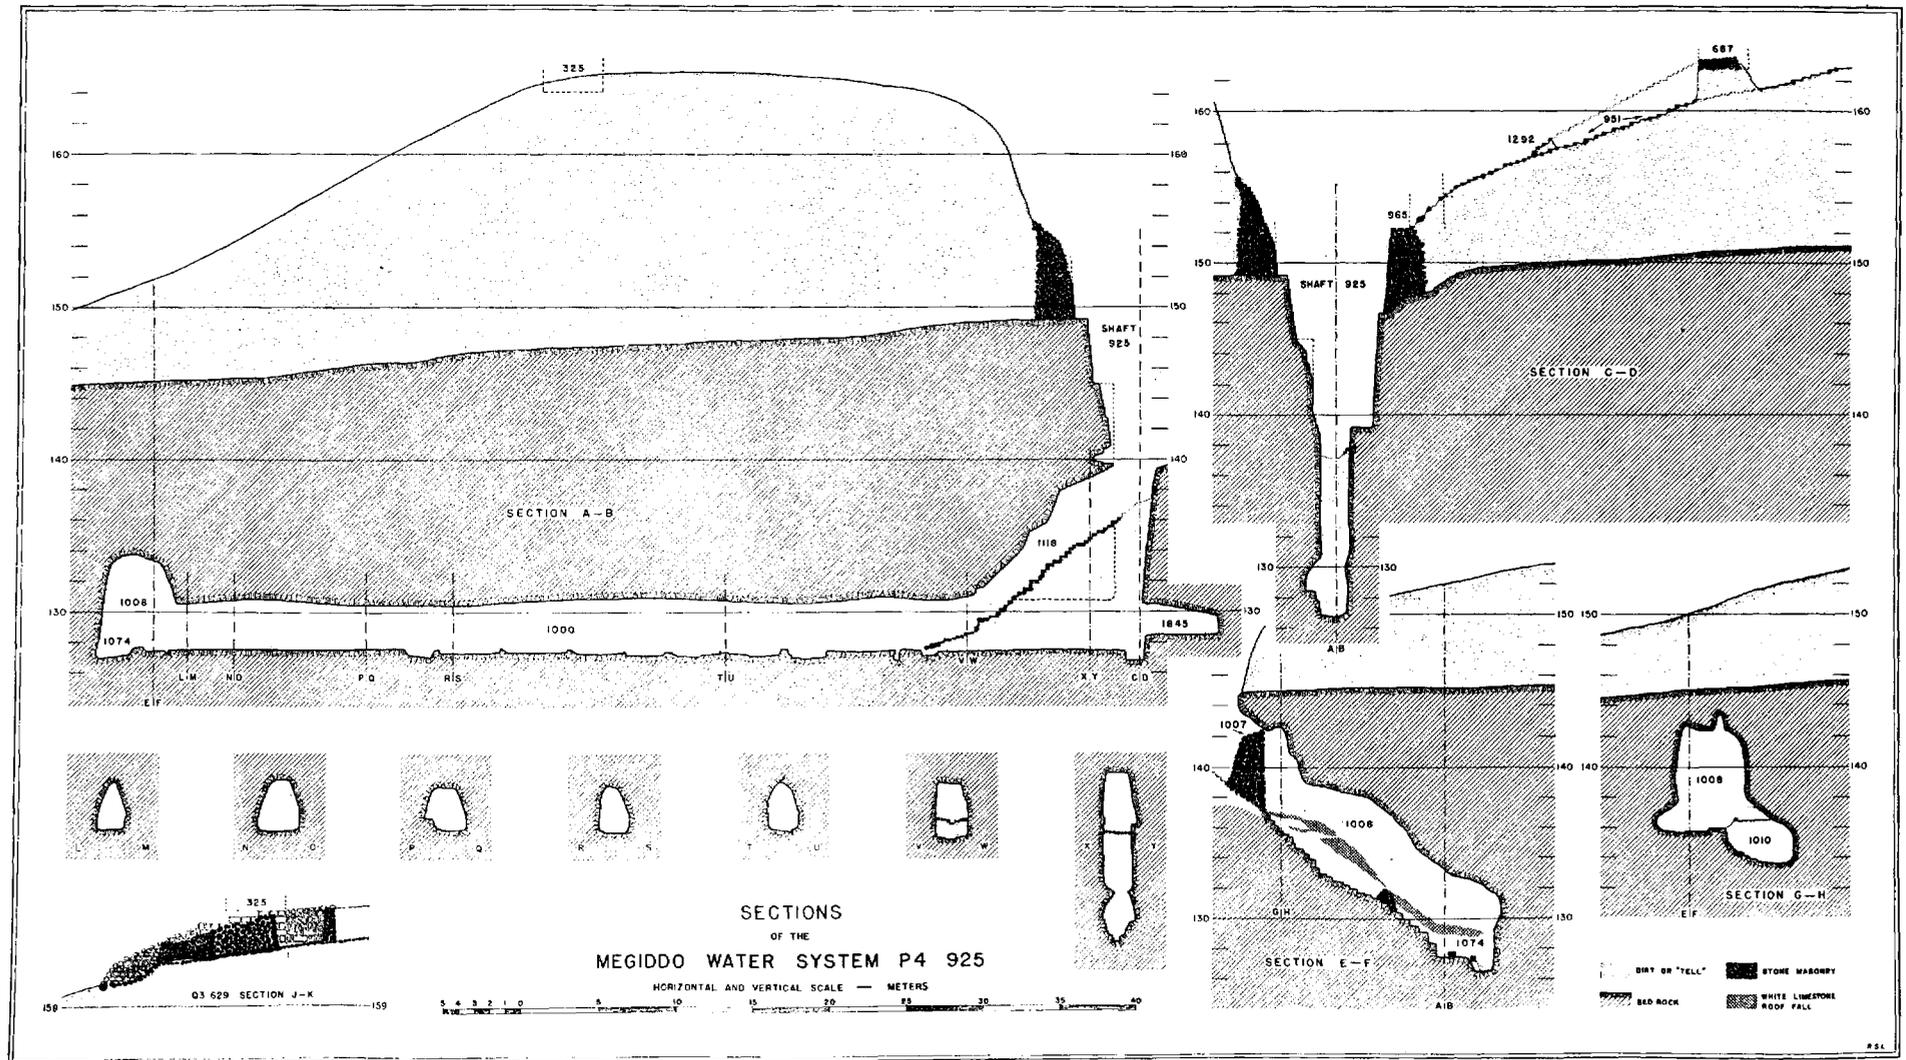
FIG. 3.- CROSS-SECTIONS OF THE WATER SYSTEM. SCALE, 1:500  
For locations of these sections see Fig. 2.

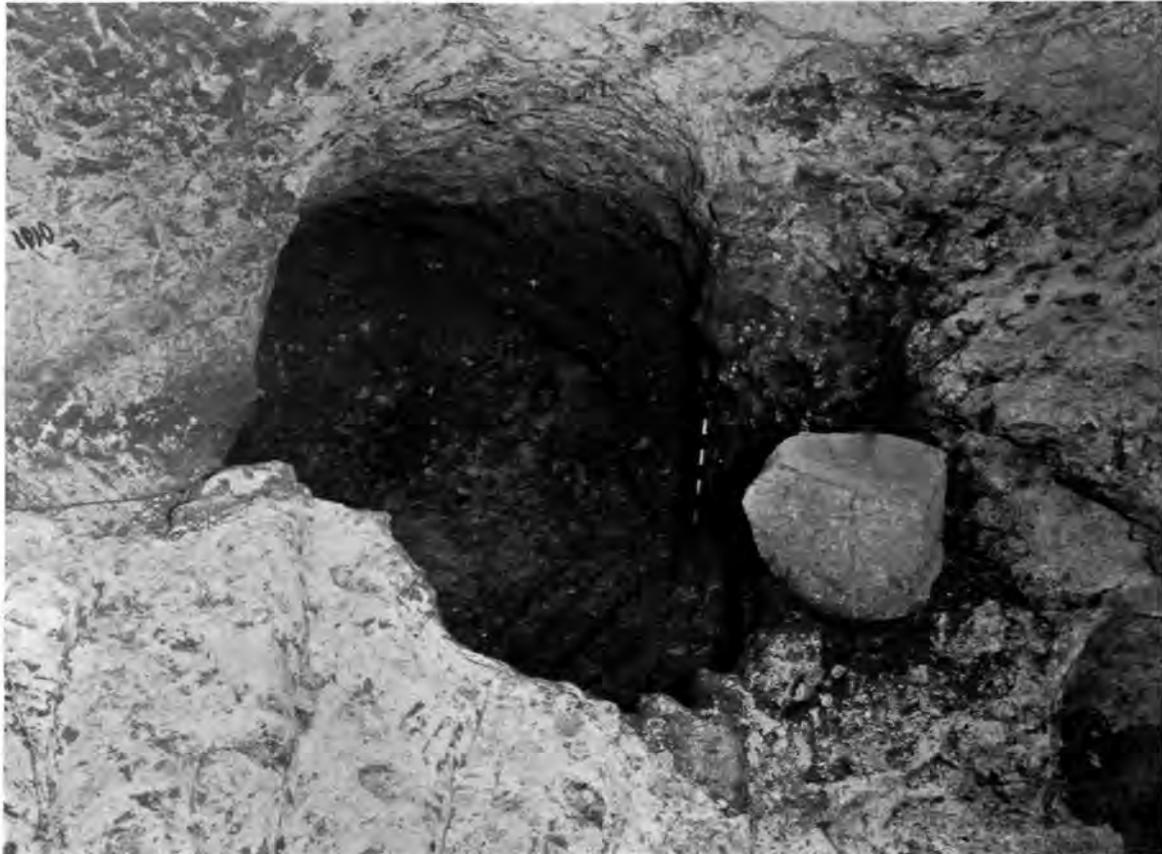
FIG. 4.—CAVE 1010 WITH THE FILLING REMOVED. CF. FIG. 6

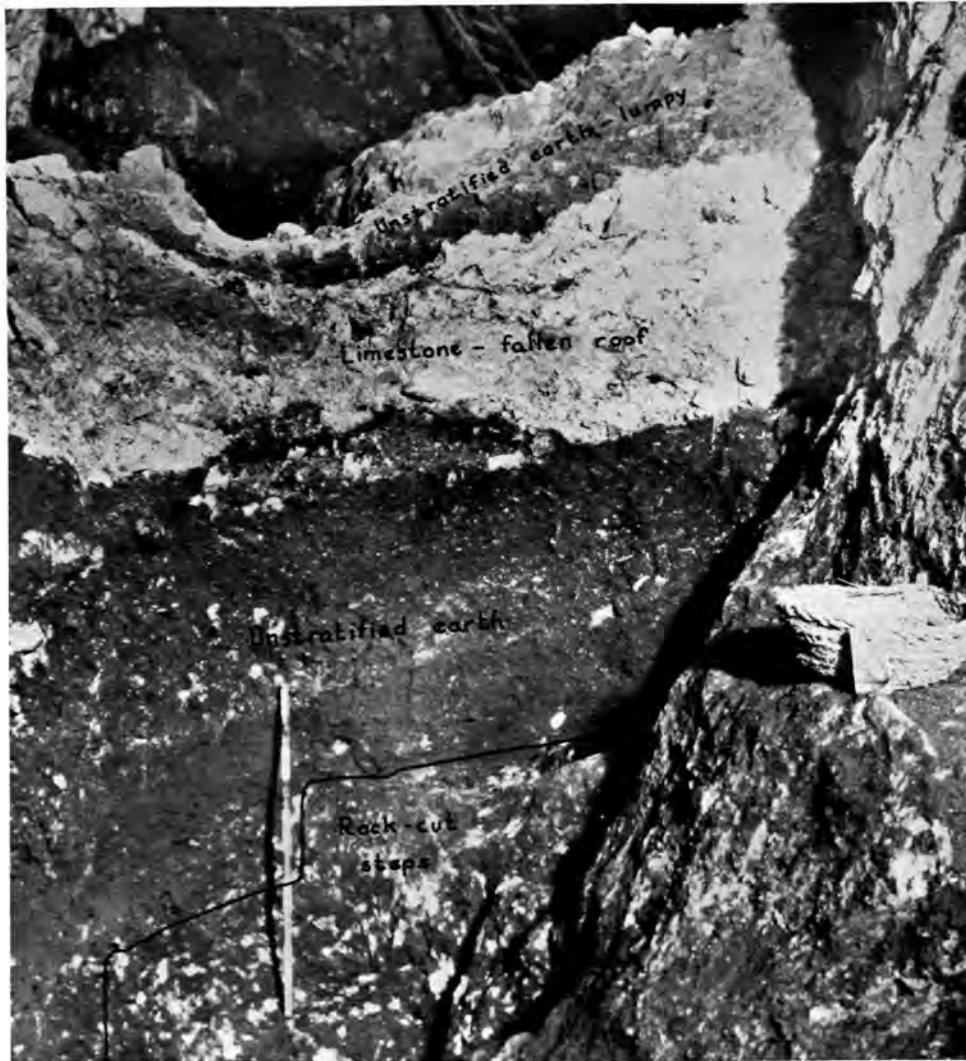
FIG. 5.—CROSS-SECTION OF FILLING IN THE MAIN CAVE (1008)

After the blocking of the outside entrance the upper part of the cave, being useless for any other purpose, was used as a dumping place for the silt periodically cleared out of the well. A rough retaining wall (8 in Fig. 13) was thrown across the lower part of the cave to prevent the dumped material from slumping back into the well. The débris found in the cave was dirt interstratified with crushed limestone. The upper part of the deposit consisted of lumps of laminated, waterlaid silt; the lower part—below the limestone—was of similar character, but the lumpy appearance had been obliterated by the weight of the overlying deposit (see Fig. 5).

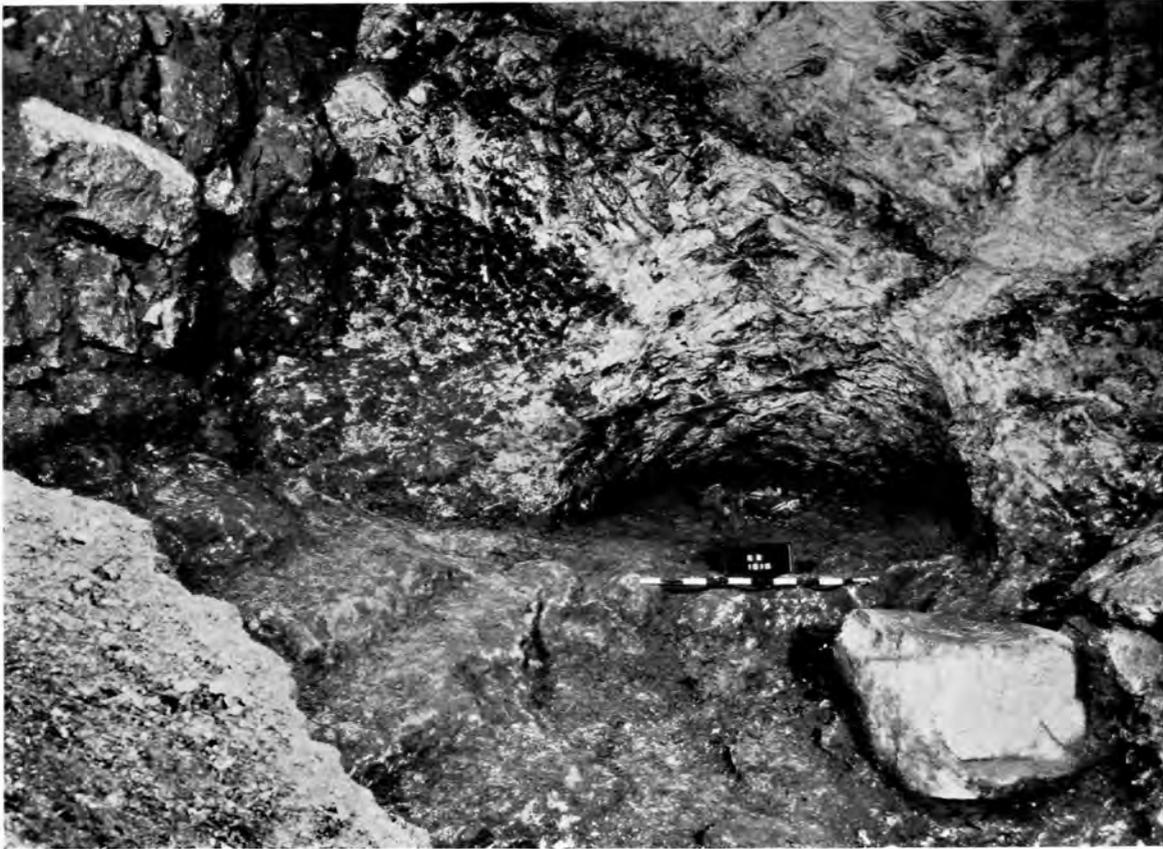
FIG. 6.—THE GUARD'S POST (1010) BEFORE THE FILLING WAS REMOVED

A part of the blocking wall (1007) appears in the upper left-hand corner, and steps of the main cave (1008) are seen in the foreground.

The small upper part of cave 1010 which remained unfilled was used as a guard's post or sentry box (Fig. 6). In the sloping roof, toward the front, were drilled several holes into which pegs had apparently been driven to support a lamp platform. Signs of burning still remain on the rock just above the holes. A rough rubble floor was thrown over the dump material, and

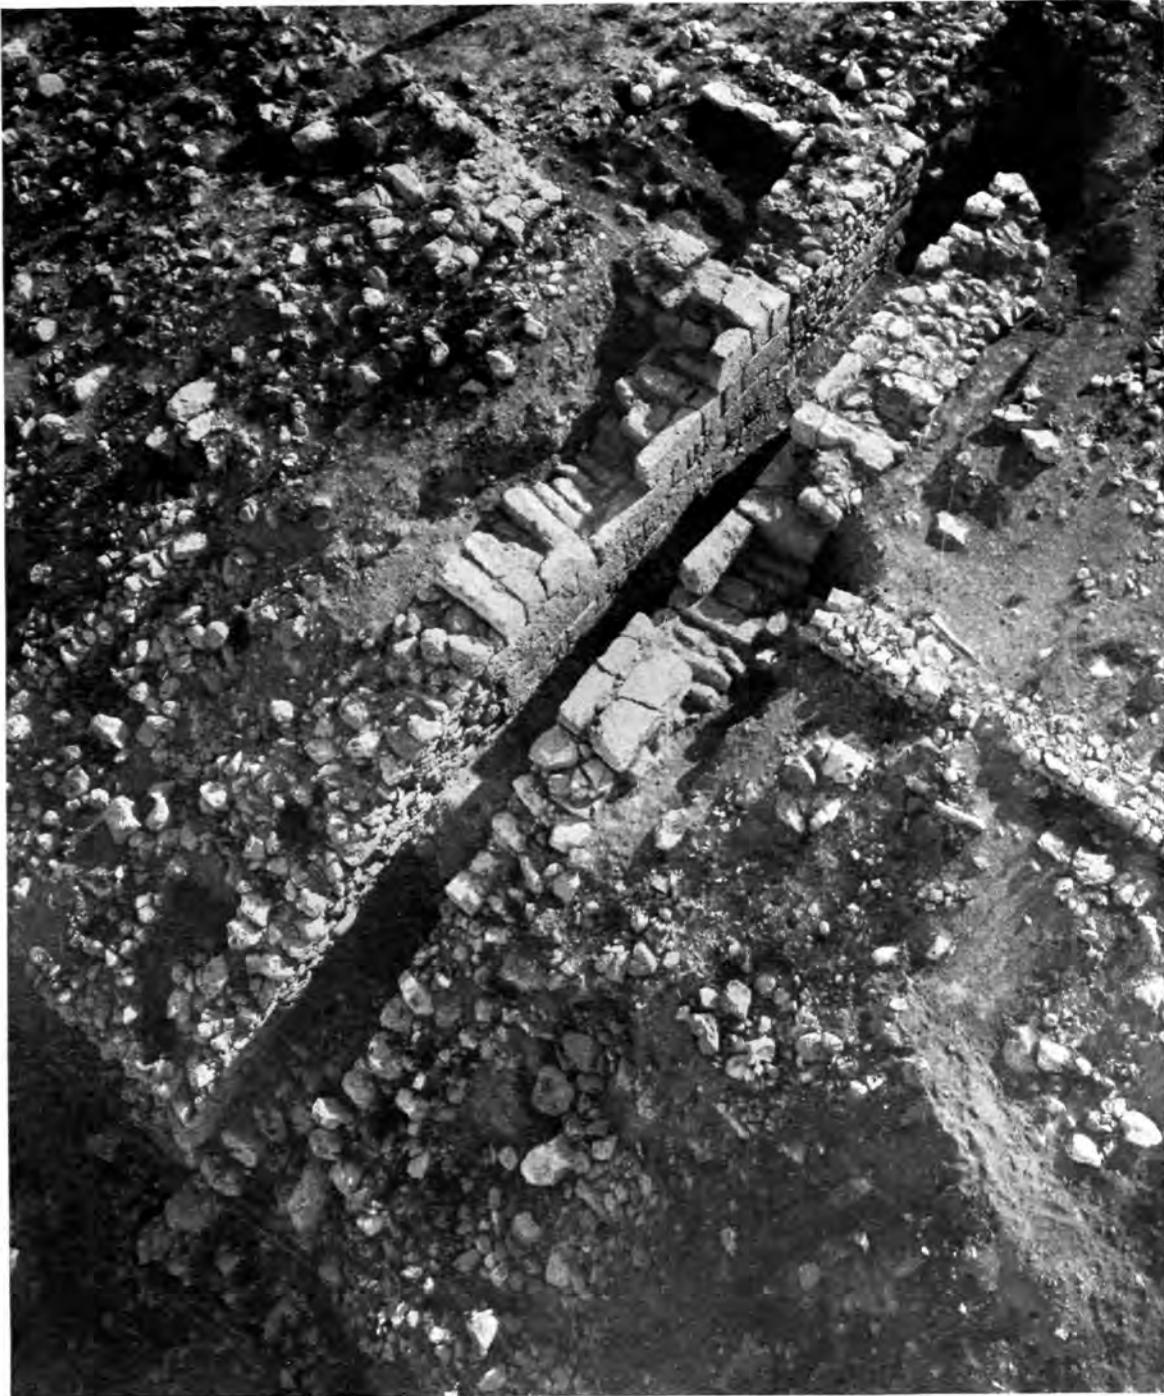
FIG. 8.—UPPER PART OF GALLERY 629, FROM THE SOUTHWEST

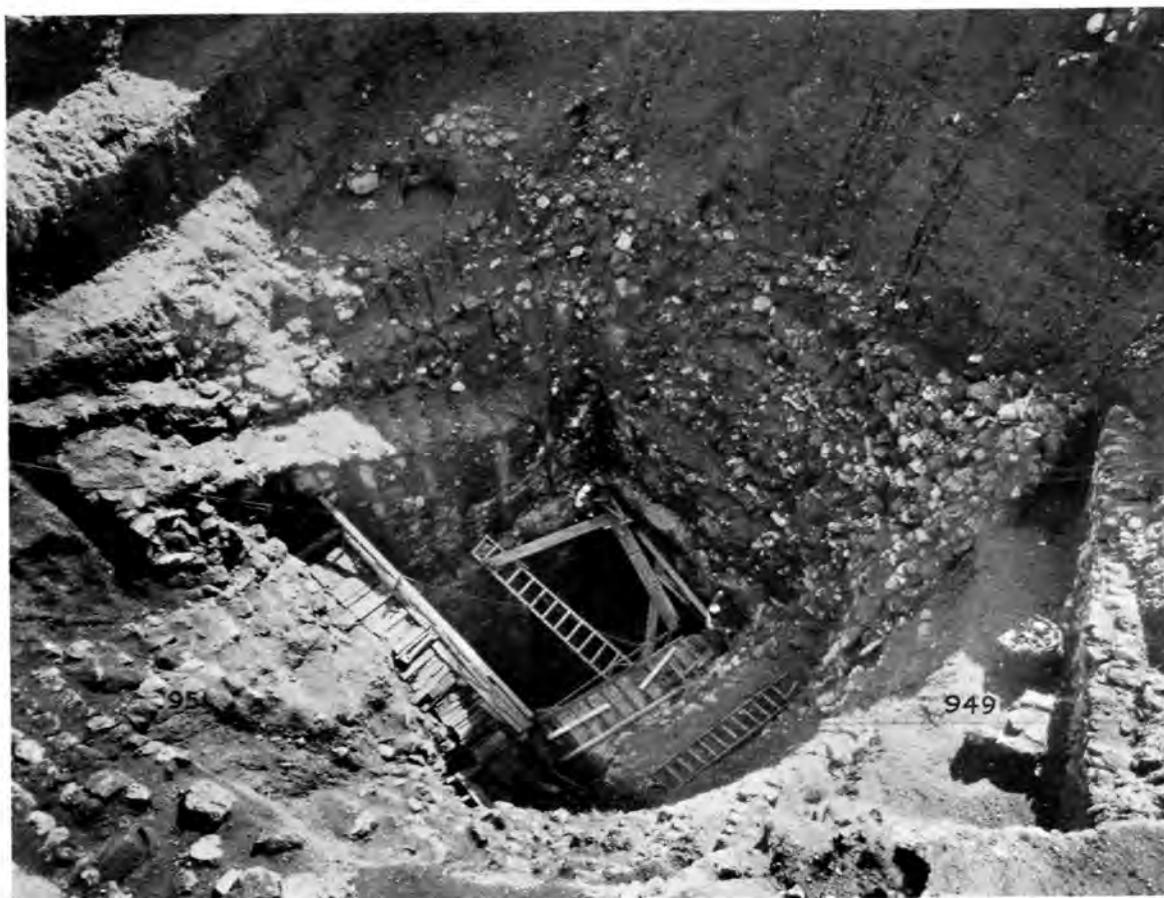
FIG. 9.—VIEW DOWN THE SHAFT FROM THE NORTH  
Bed rock begins where the two figures stand.

When the irregular funnel-shaped hole had penetrated through the tell and reached bed rock (see Fig. 9), the work of building thick retaining walls was begun. A staircase (965) was built along the inner sides of the walls. Dirt was packed behind the four walls as they rose toward the surface, thus filling in the irregularities and leaving a roughly square masonry

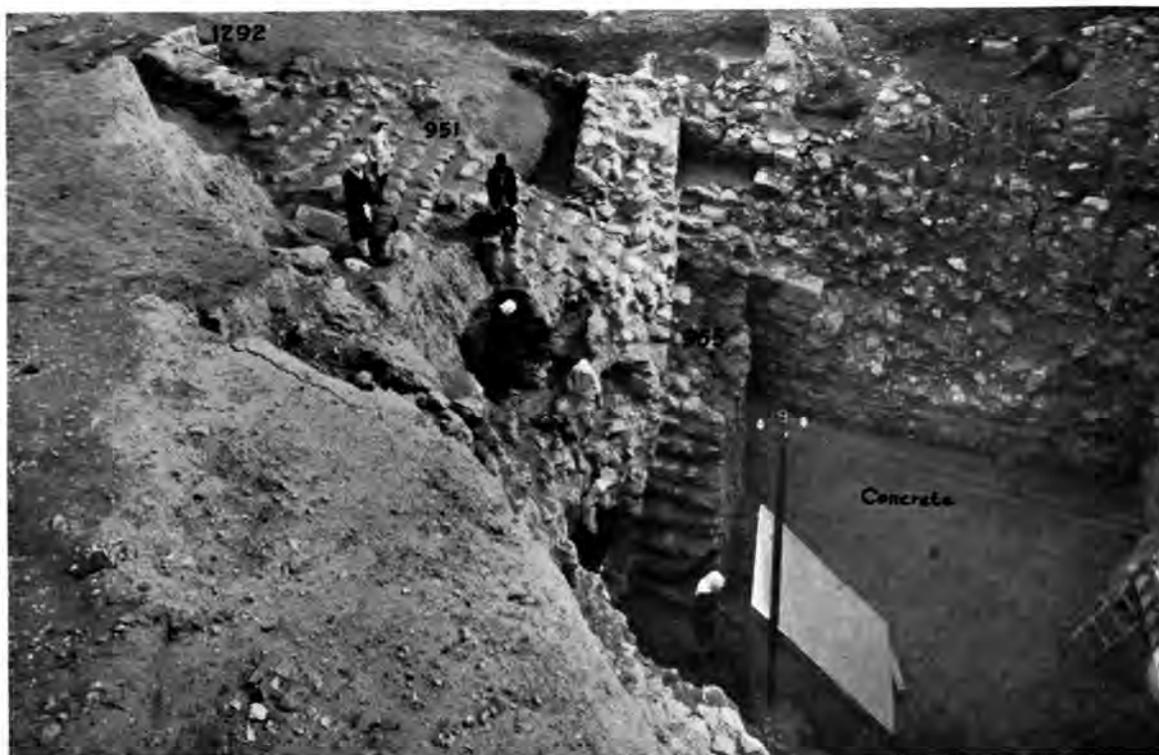
FIG. 11.—VIEW FROM THE NORTHWEST SHOWING STAIRCASE 965, INCORPORATED ALONG THE INNER FACES OF THE RETAINING WALLS, AND THE LATER STEPS (951) BUILT THROUGH A BREACH IN THE ORIGINAL WALL

The edge of the concrete slab rests on the top of the bed rock.

shaft. Staircase 951 is a later addition, for it is built through a breach in the original wall (Fig. 11; see p. 31). It is believed that the masonry shaft originally rose to the surface of the mound and that the steps 965 continued around the sides and emerged at the top of the shaft. After the completion of the retaining walls, or perhaps while they were being built, the shaft was extended down into the bed rock, and the stairs were continued along the sides of the rock-cut shaft as the work progressed (Fig. 12).

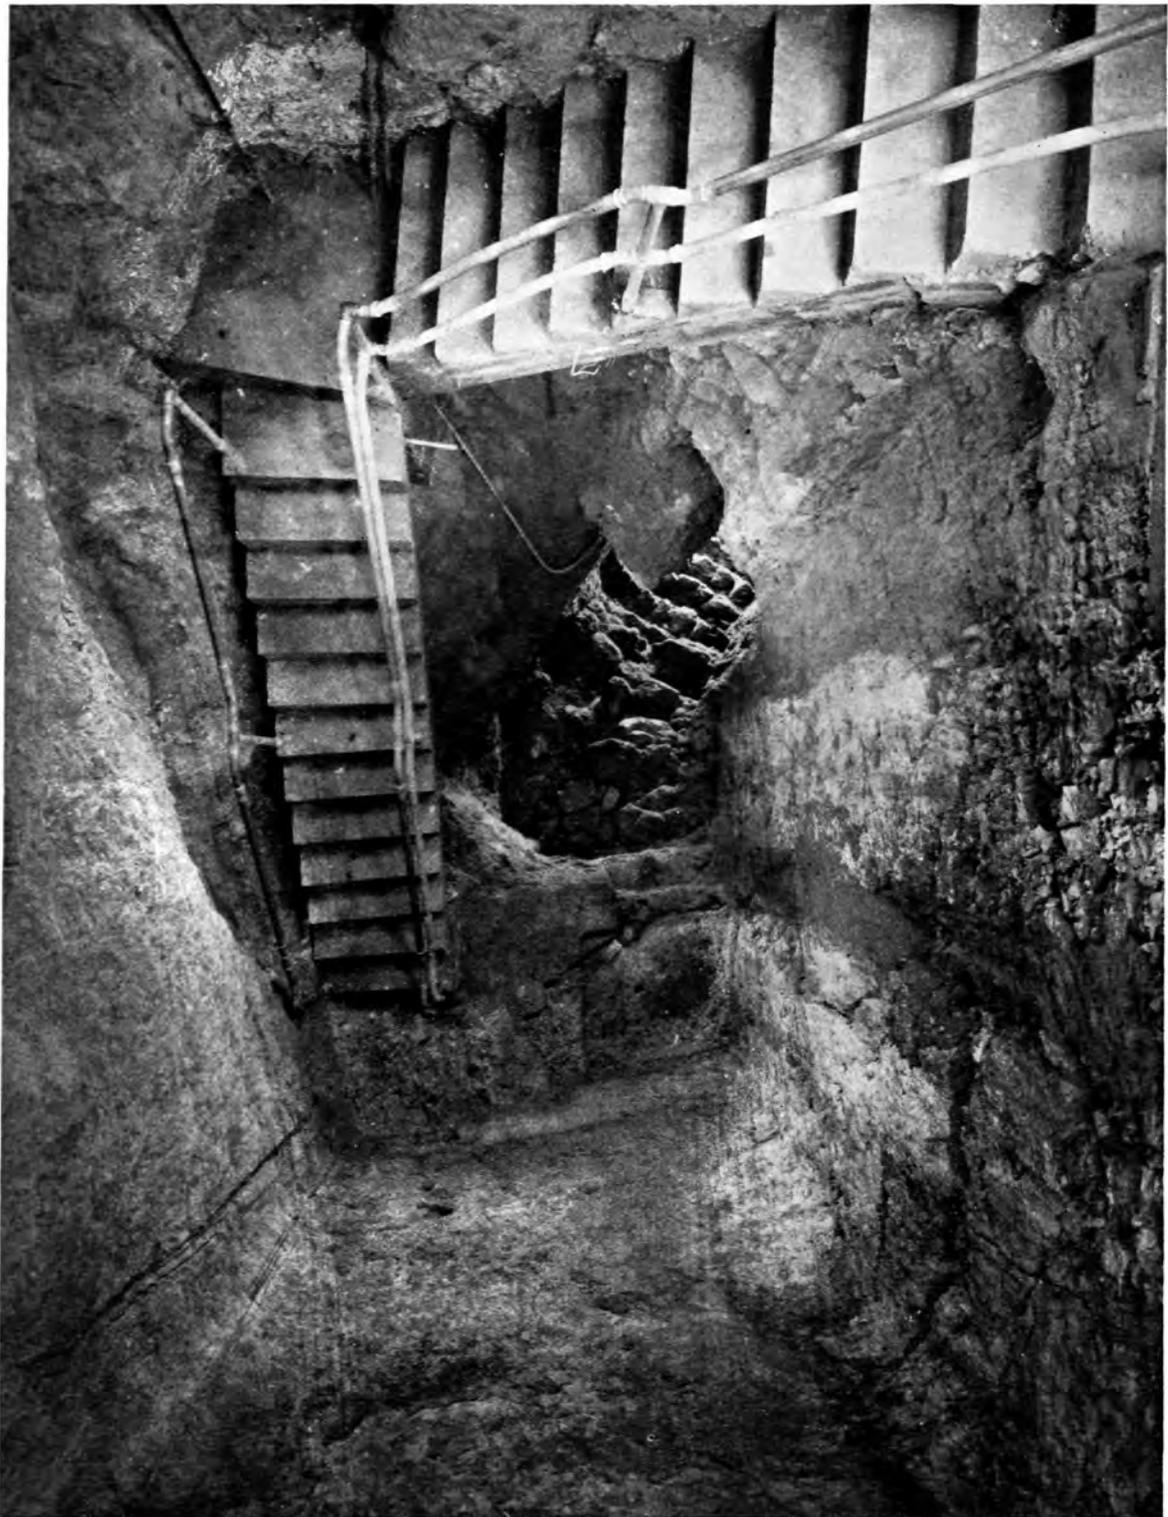
FIG. 12.—VERTICAL VIEW DOWN THE ROCK-CUT SHAFT

The ancient stairs were largely destroyed, but their remains indicate that they followed approximately the line of the modern concrete steps.

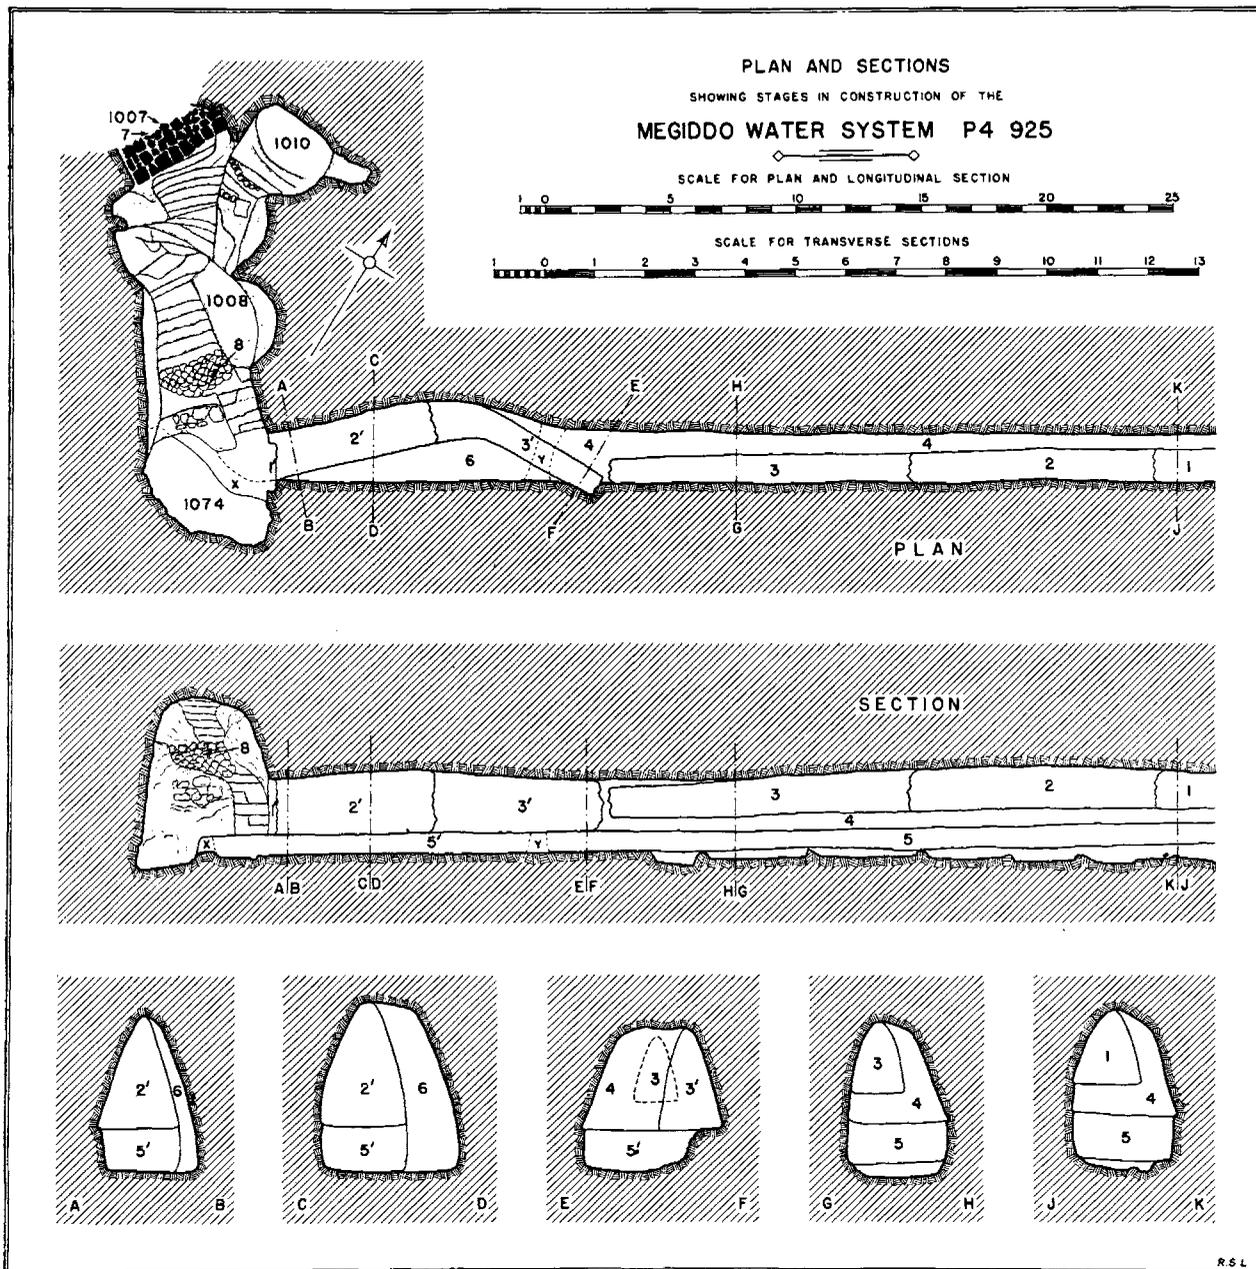
FIG. 13.—PLAN AND SECTIONS ILLUSTRATING THE VARIOUS STAGES IN THE CONSTRUCTION OF THE TUNNEL. SCALE, 1:300 (TRANSVERSE SECTIONS, 1:150)

The numbers 1 and 1', 2 and 2', etc., represent steps carried out simultaneously; and their sequence corresponds to the order in which the steps were executed. Note that sections A-B, C-D, and E-F are drawn facing east, while the other two face west.

The two irregularities in the floor of the western part of the tunnel, one where the two tunnels originally joined (Fig. 26) and the other just south of the mouth of the tunnel near the well, are remnants of dams Y and X respectively (see pp. 22 f. and Fig. 13). When the

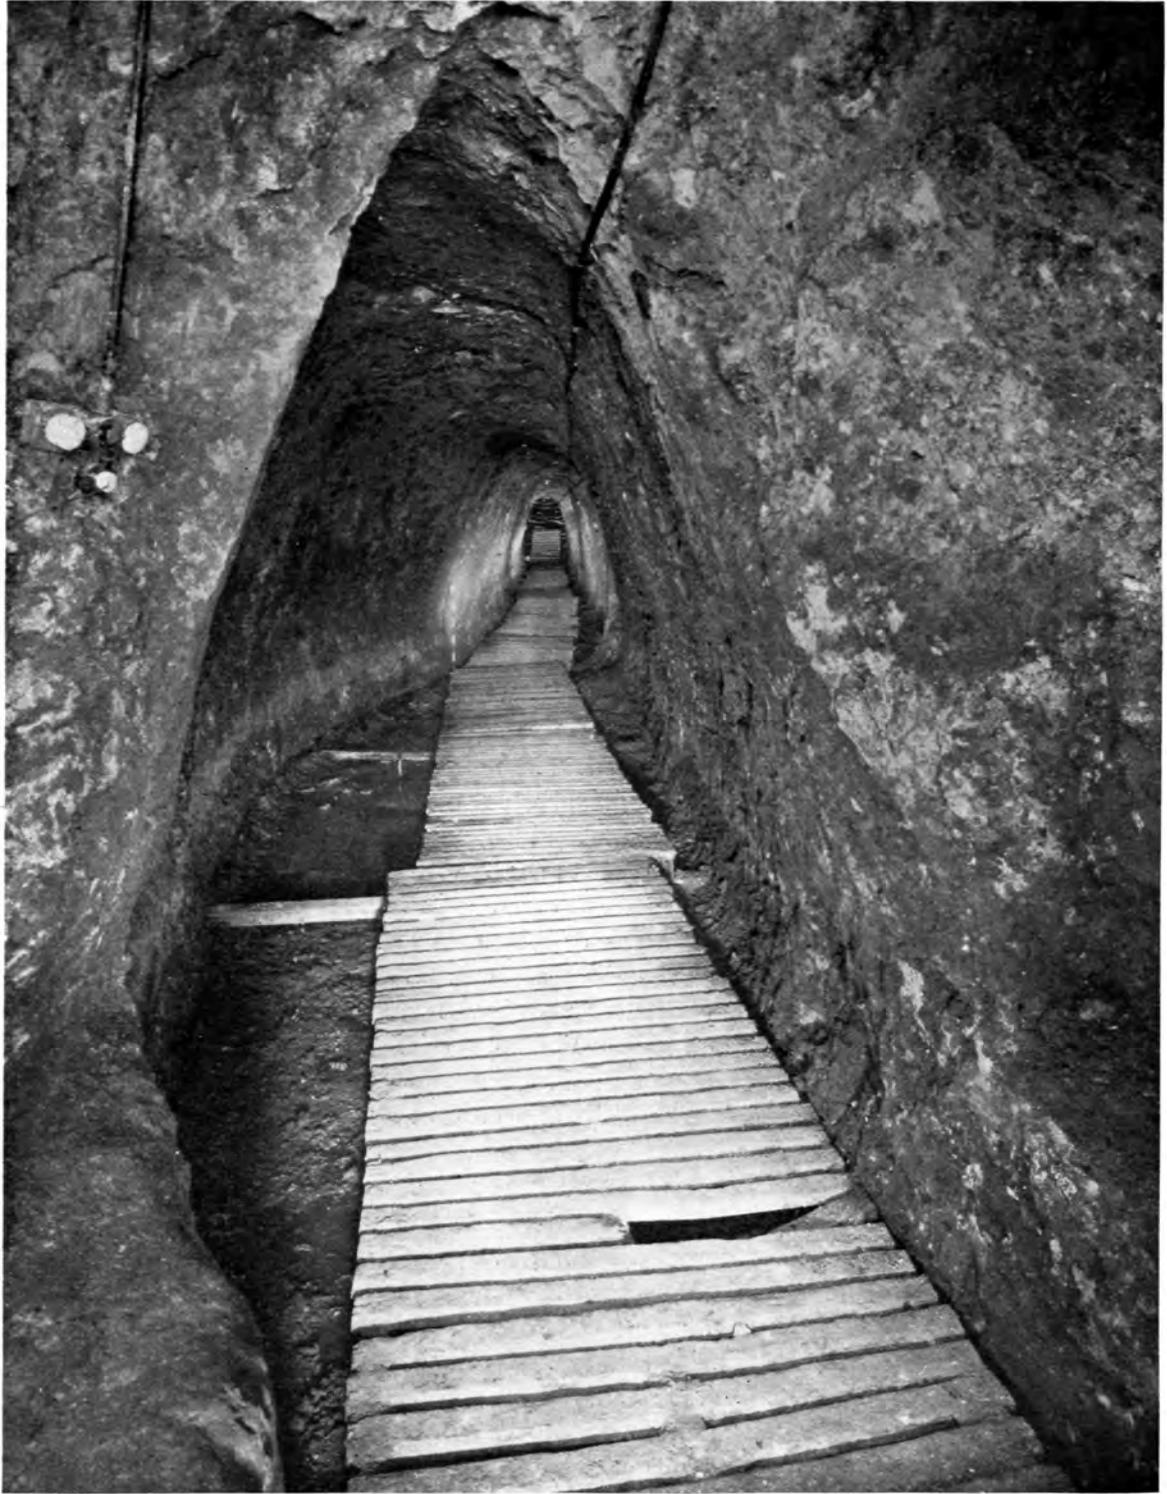
FIG. 14.—TUNNEL 1000, LOOKING EAST FROM THE WELL  
The meter stick indicates the point where the two ends of the tunnel met.

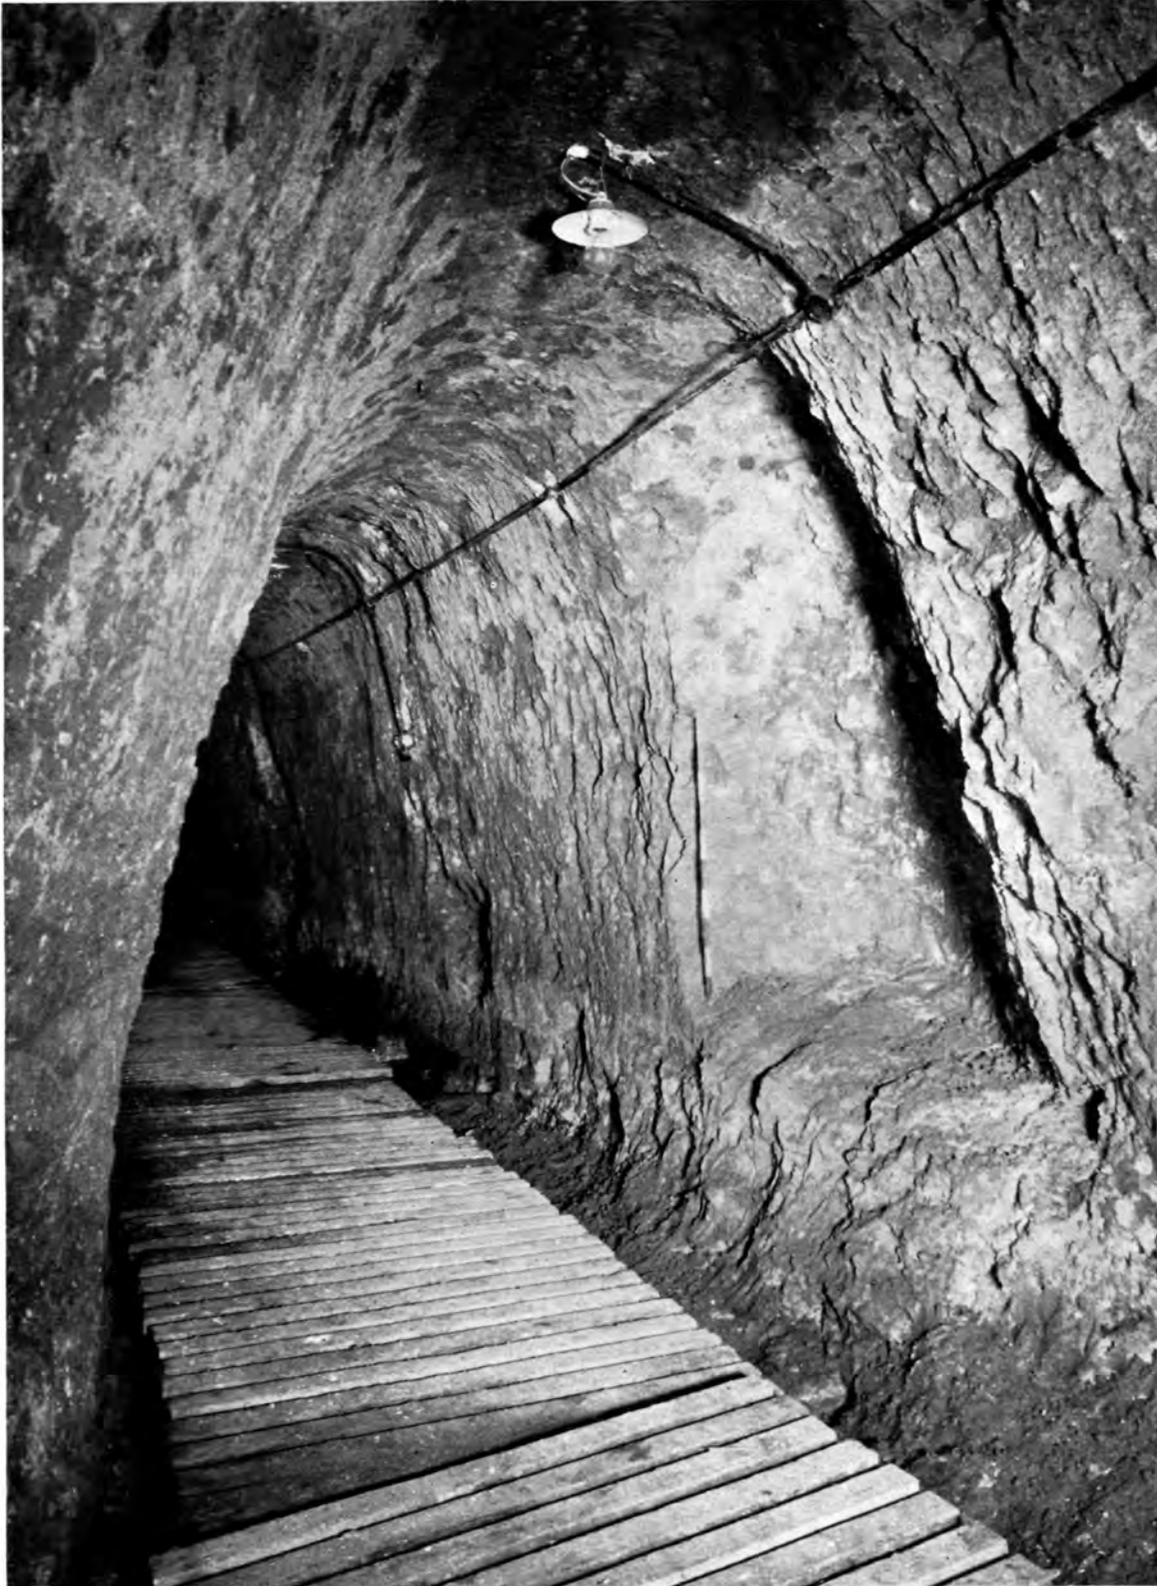
FIG. 15.—INDENTATION IN THE SOUTH FACE OF TUNNEL 1000, MARKING THE END OF THE WESTERN SECTION WHERE IT JOINED THE EASTERN SOUNDING TUNNEL

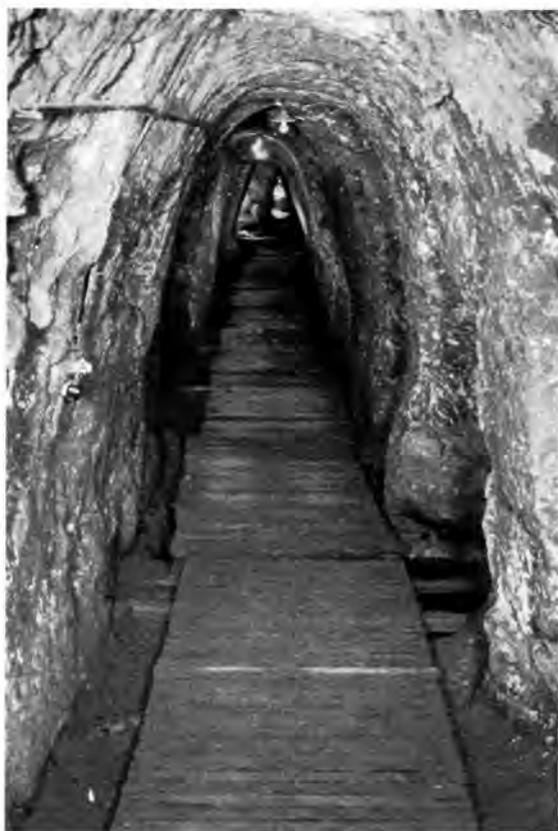
FIG. 16.—VIEW THROUGH TUNNEL 1000 TOWARD THE WELL

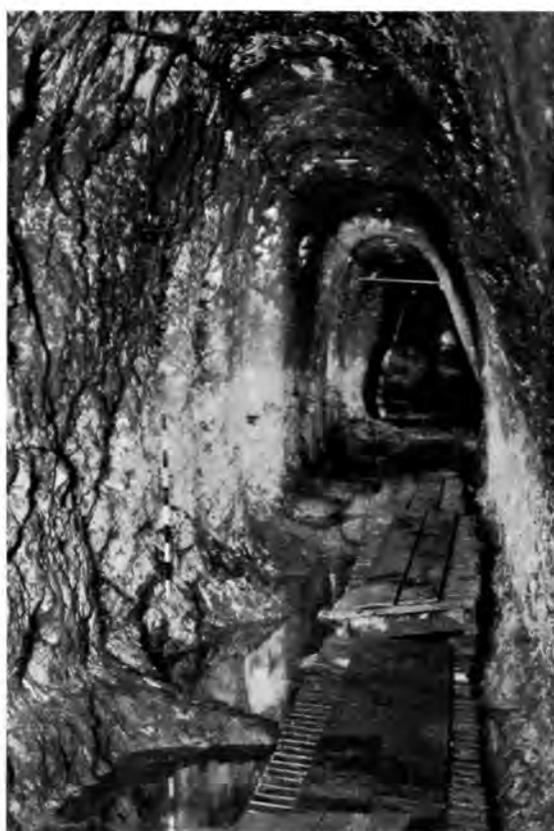
FIG. 17.—VIEW THROUGH TUNNEL 1000 TOWARD THE WELL

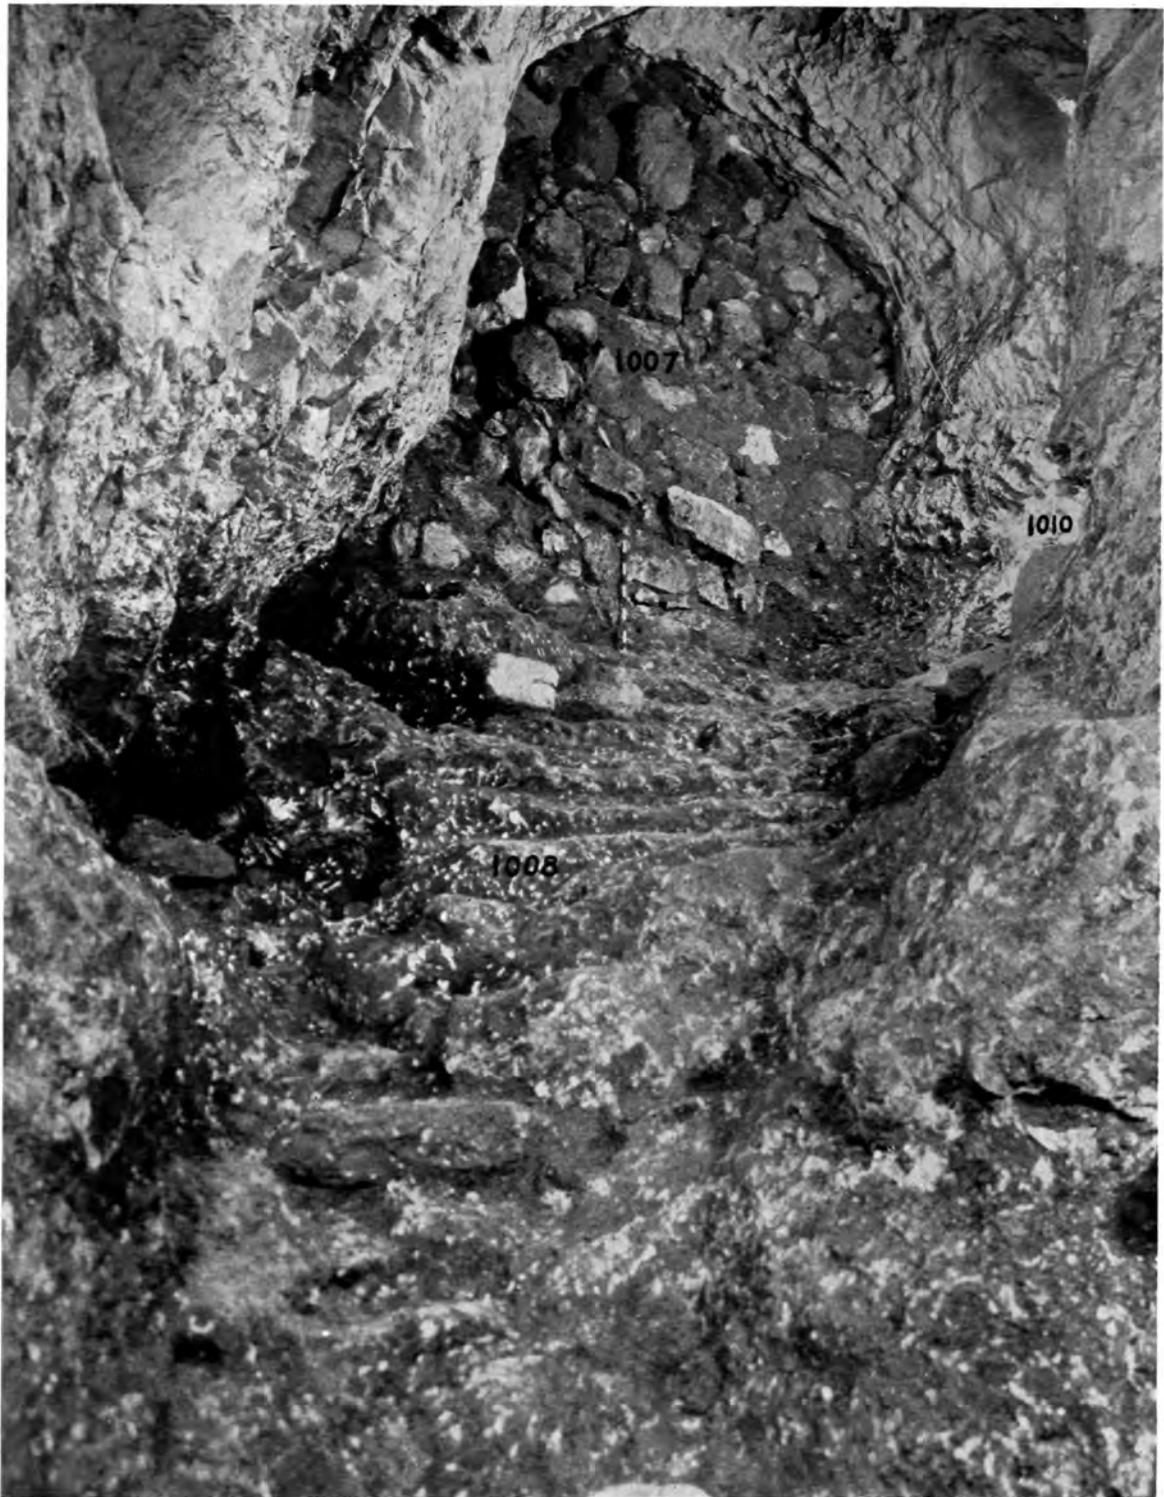
FIG. 18.—LOOKING UP THROUGH THE MAIN CAVE (1008) TOWARD THE BLOCKING WALL (1007)

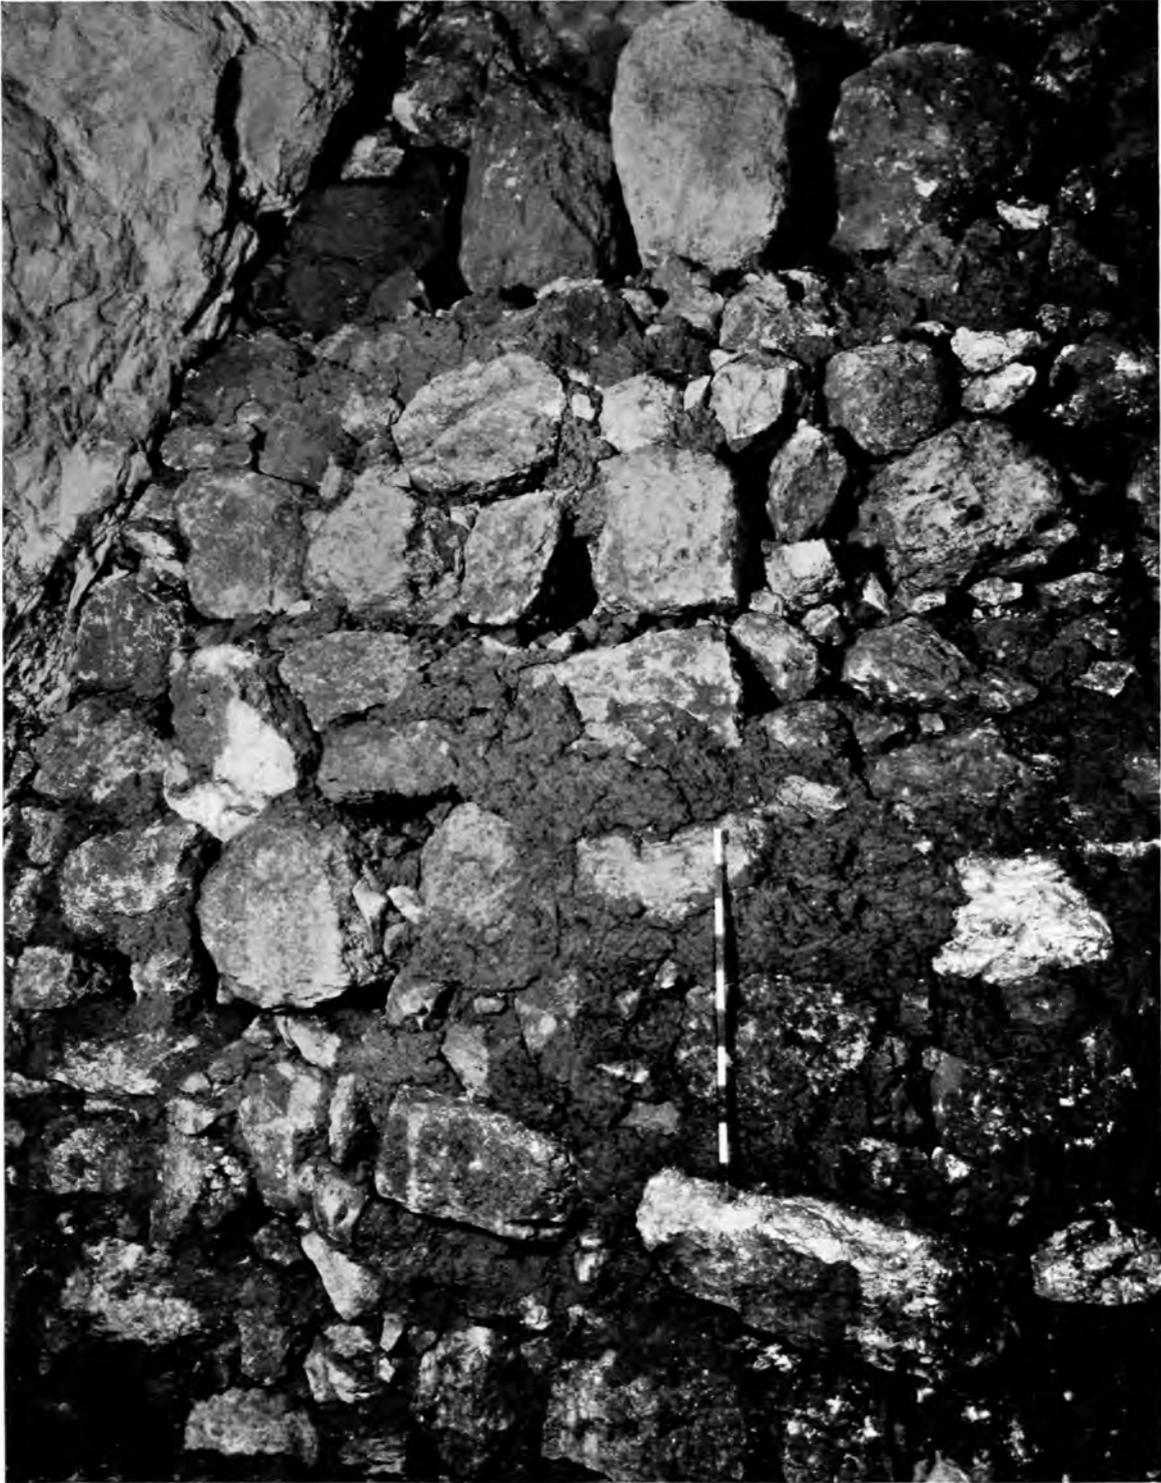
FIG. 19.—THE BLOCKING WALL (1007)  
Note the finger marks on the mud pointing.
