## **THE MEGIDDO WATER SYSTEM**

# THE MEGIDDO WATER SYSTEM

*By*  
ROBERT S. LAMON

**COPYRIGHT 1935 BY THE UNIVERSITY OF CHICAGO  
ALL RIGHTS RESERVED. PUBLISHED JUNE 1935**

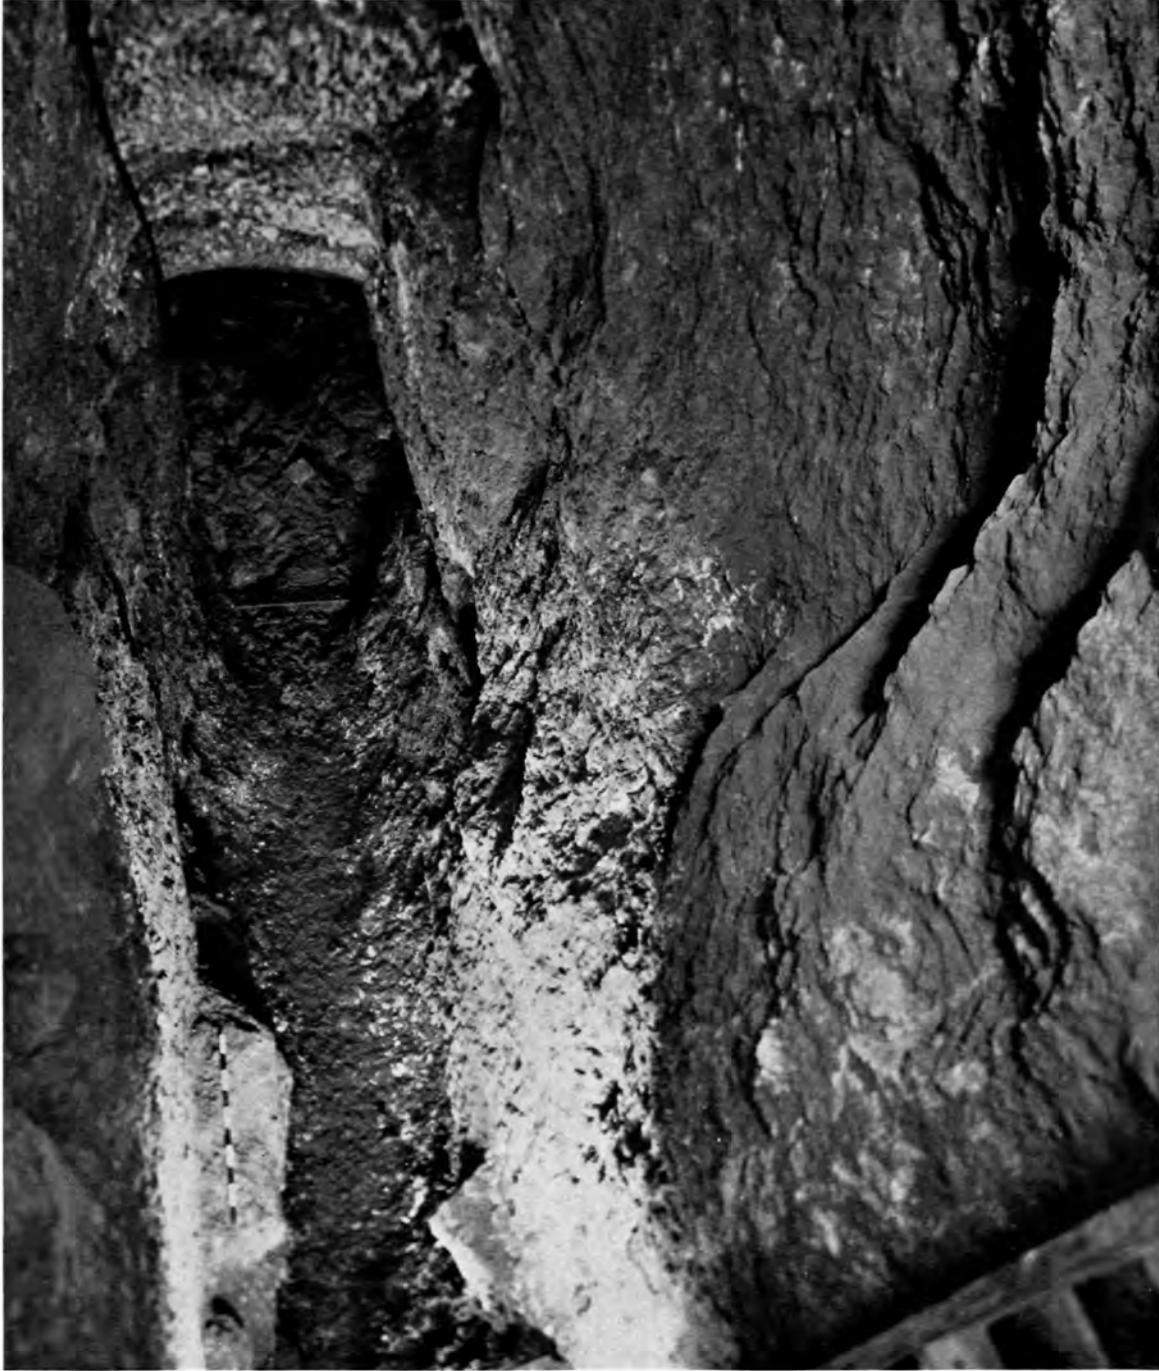
FIG. 20.—THE EASTERN TUNNEL (1845) BELOW THE MASONRY STAIRS OF THE INCLINED PASSAGE (1116), FROM ABOVE  
The meter stick rests on a remnant of the destroyed roof over the tunnel. Remains of four rock-cut steps of the original inclined tunnel are visible at right.

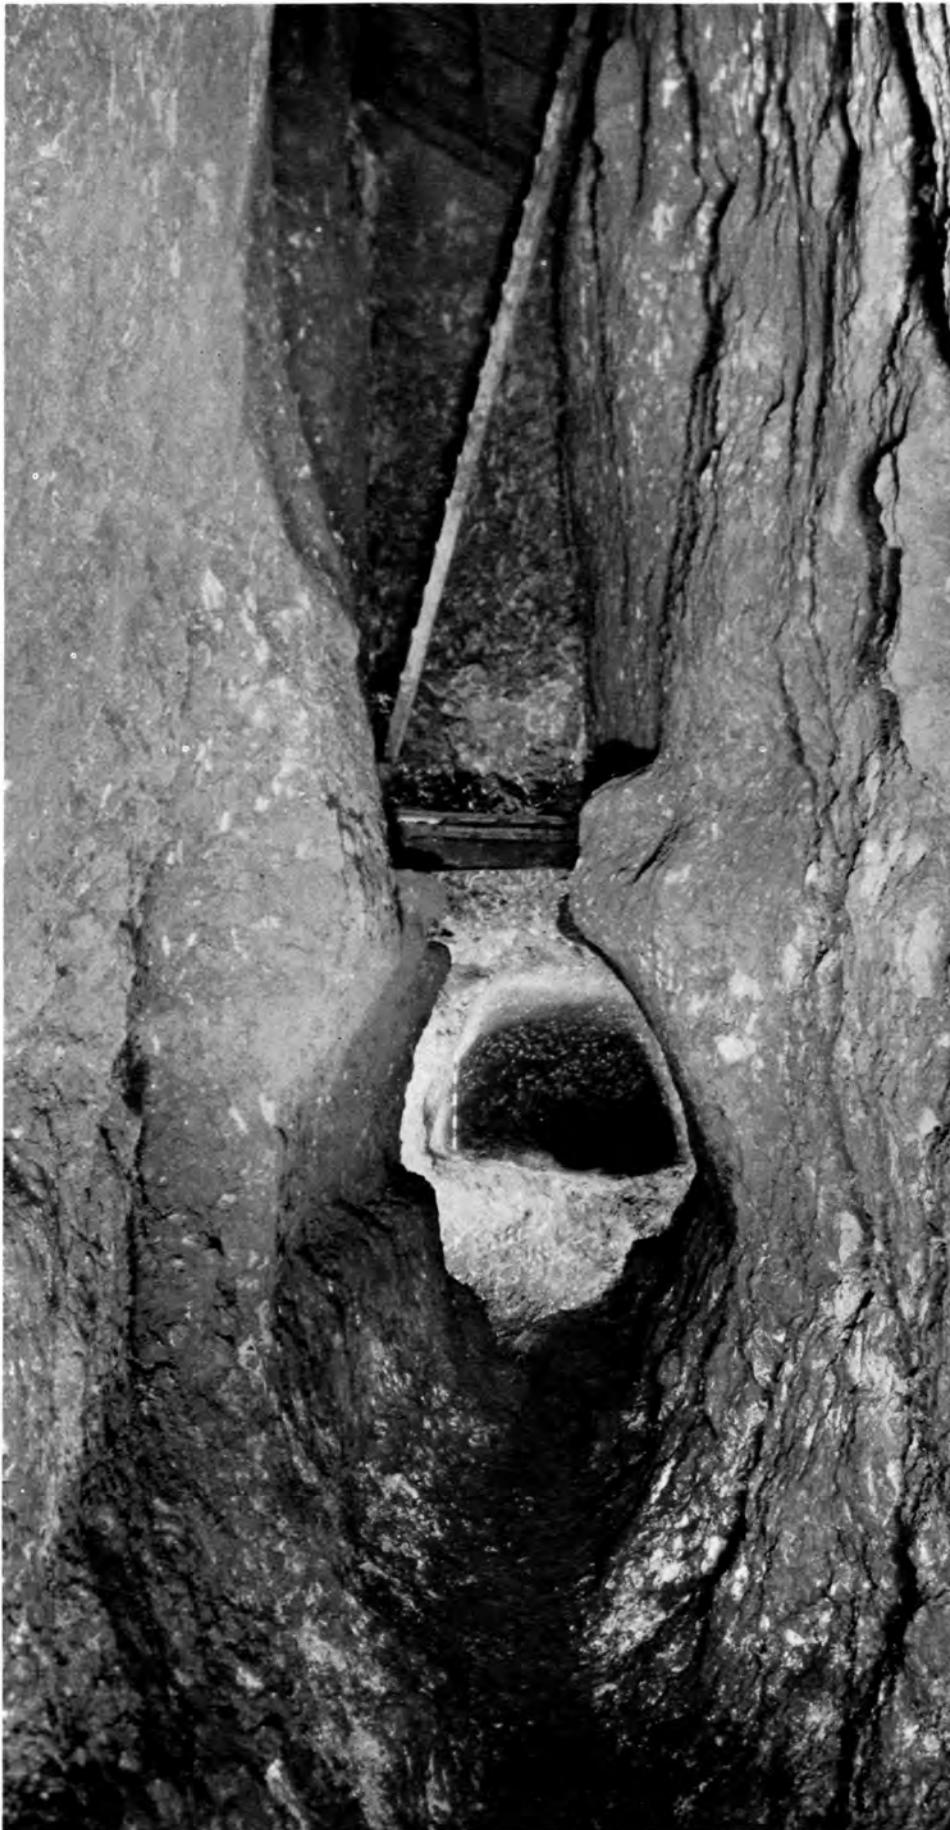
FIG. 21.—THE EASTERN TUNNEL (1845) AND THE LOWER PART OF THE VERTICAL SHAFT, FROM THE WEST

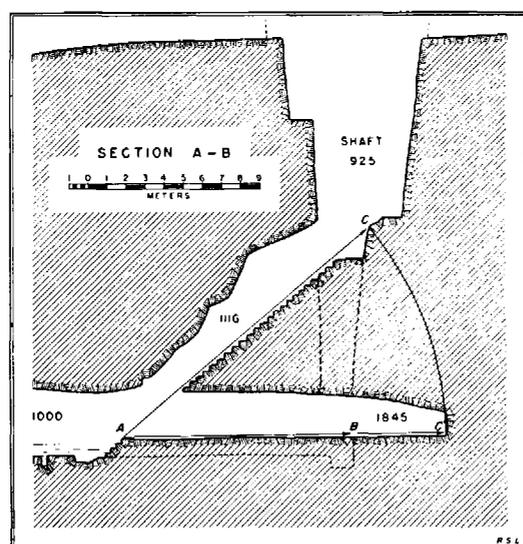
FIG. 22.—SECTION SHOWING EASTERN TUNNEL (1845) AND INCLINED PASSAGE (1116)

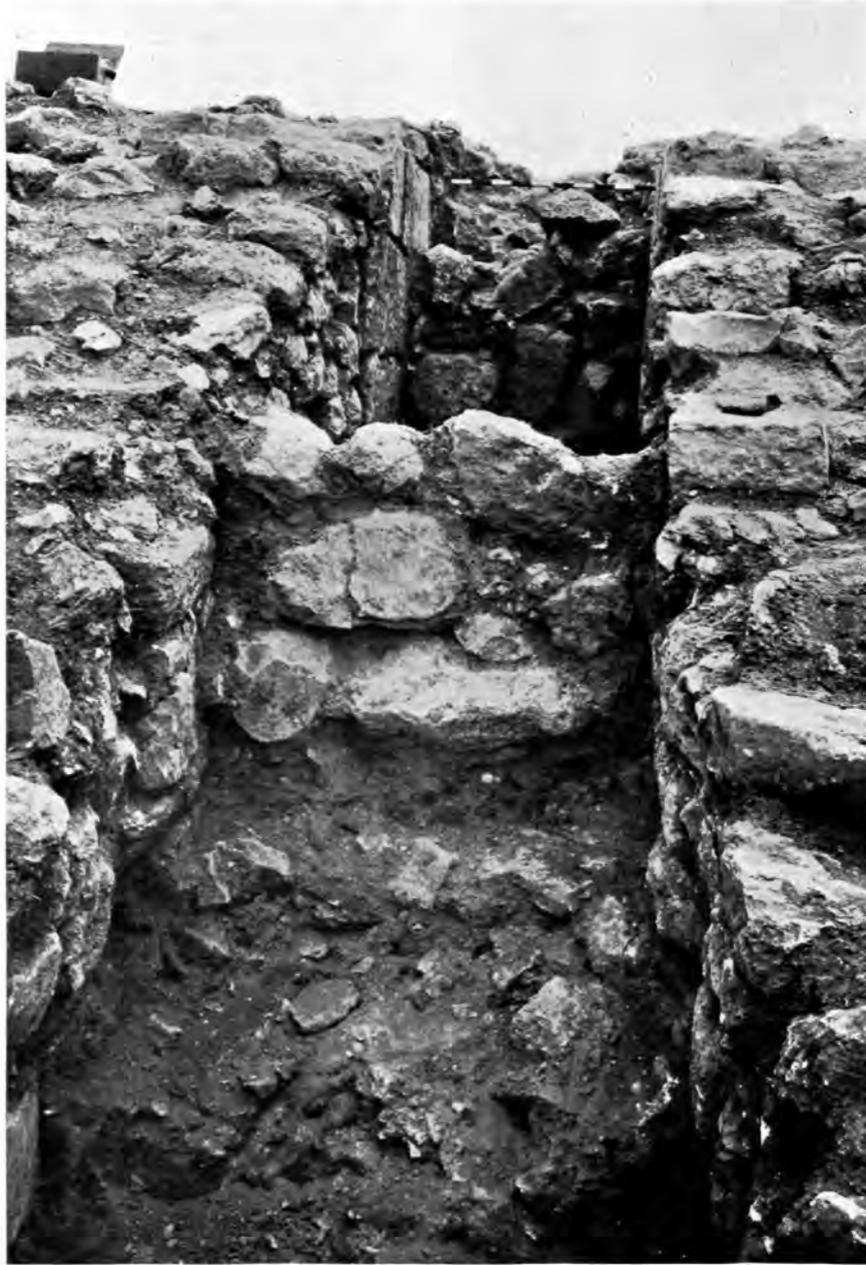
FIG. 23.—GALLERY WITH BLOCKING WALLS IN POSITION. Cf. FIG. 8

The upper part of the gallery (629) which passed under or through the city wall was effectively blocked to prevent its being used for gaining access to the city. City wall 325 (see Fig. 2)

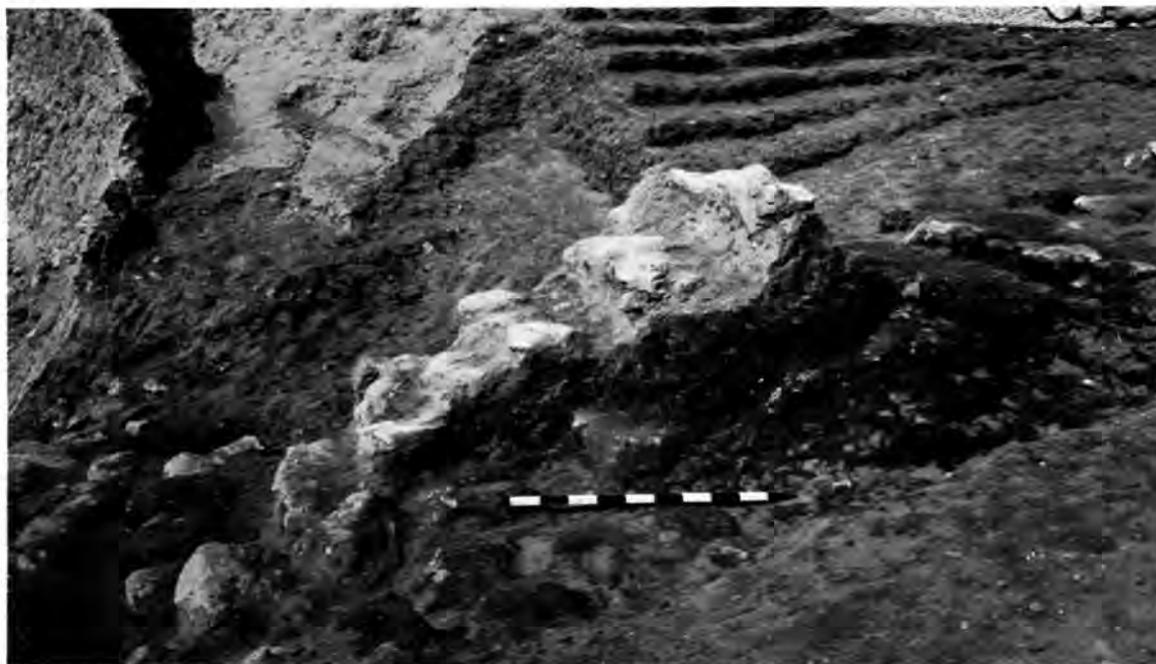
FIG. 24.—STAIRCASE 1292 BUILT OVER STAIRCASE 951. Cf. FIG. 11  
The stairs in the background are modern.

A short flight of steps (1292) built over 951 (Fig. 24), if extended, would reach the top of the retaining wall 667 (see Figs. 2-3), which with its continuation (946) belongs to the Greco-Persian period—the latest occupation of Megiddo. The sherds found in the filling which we cleared from the shaft were of practically every period represented in the mound, but there was a distinct predominance of pottery belonging to the later periods—mostly post-Solomonic. A fragment of Attic ware (Pl. VIII 31) was found in the shaft, 13 meters below the original surface of the mound.

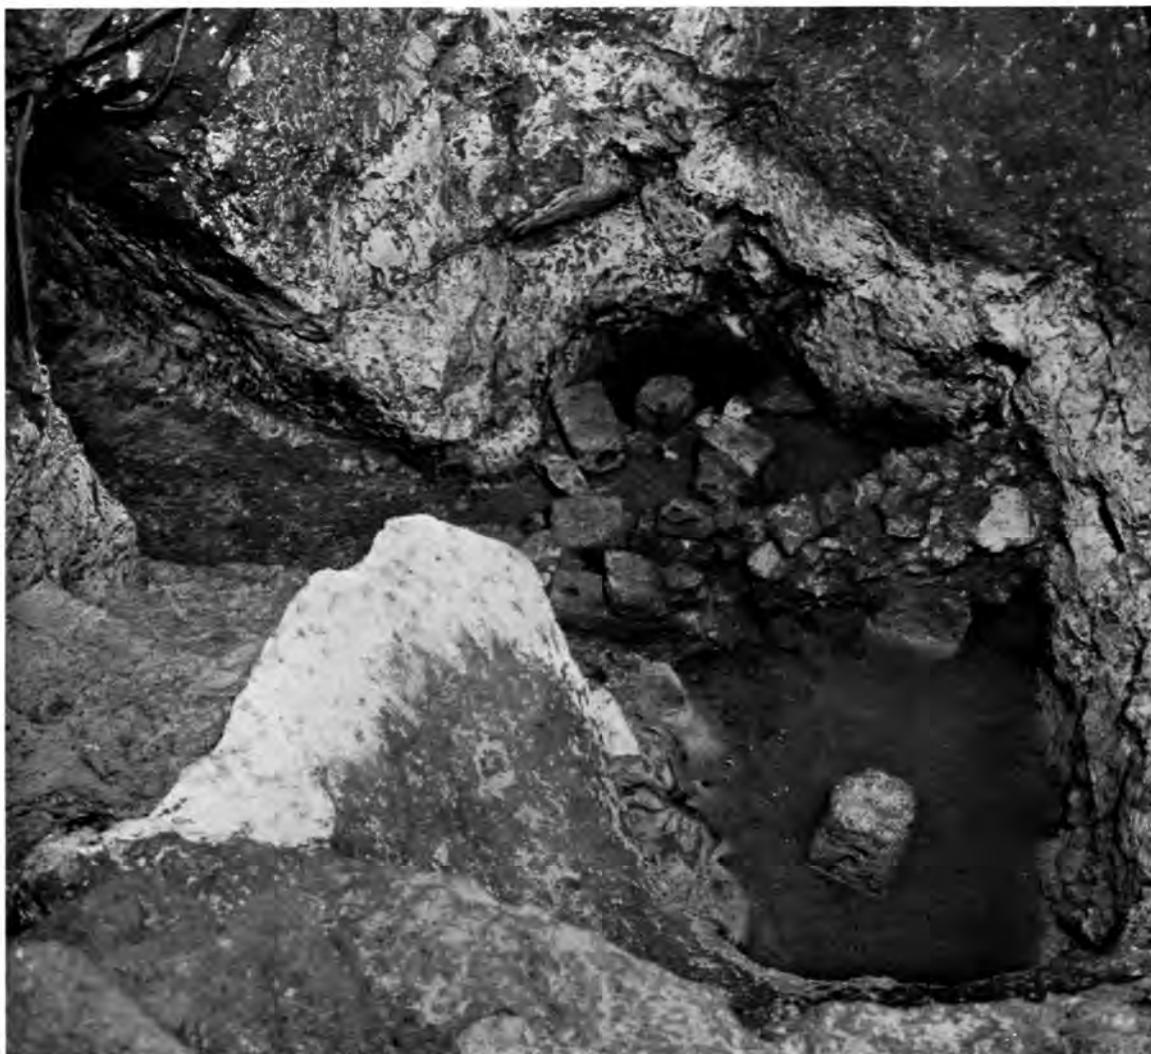
FIG. 25.—WELL 1074 FROM ABOVE

The mouth of the tunnel and the lower part of the steps in the main cave are seen at left.

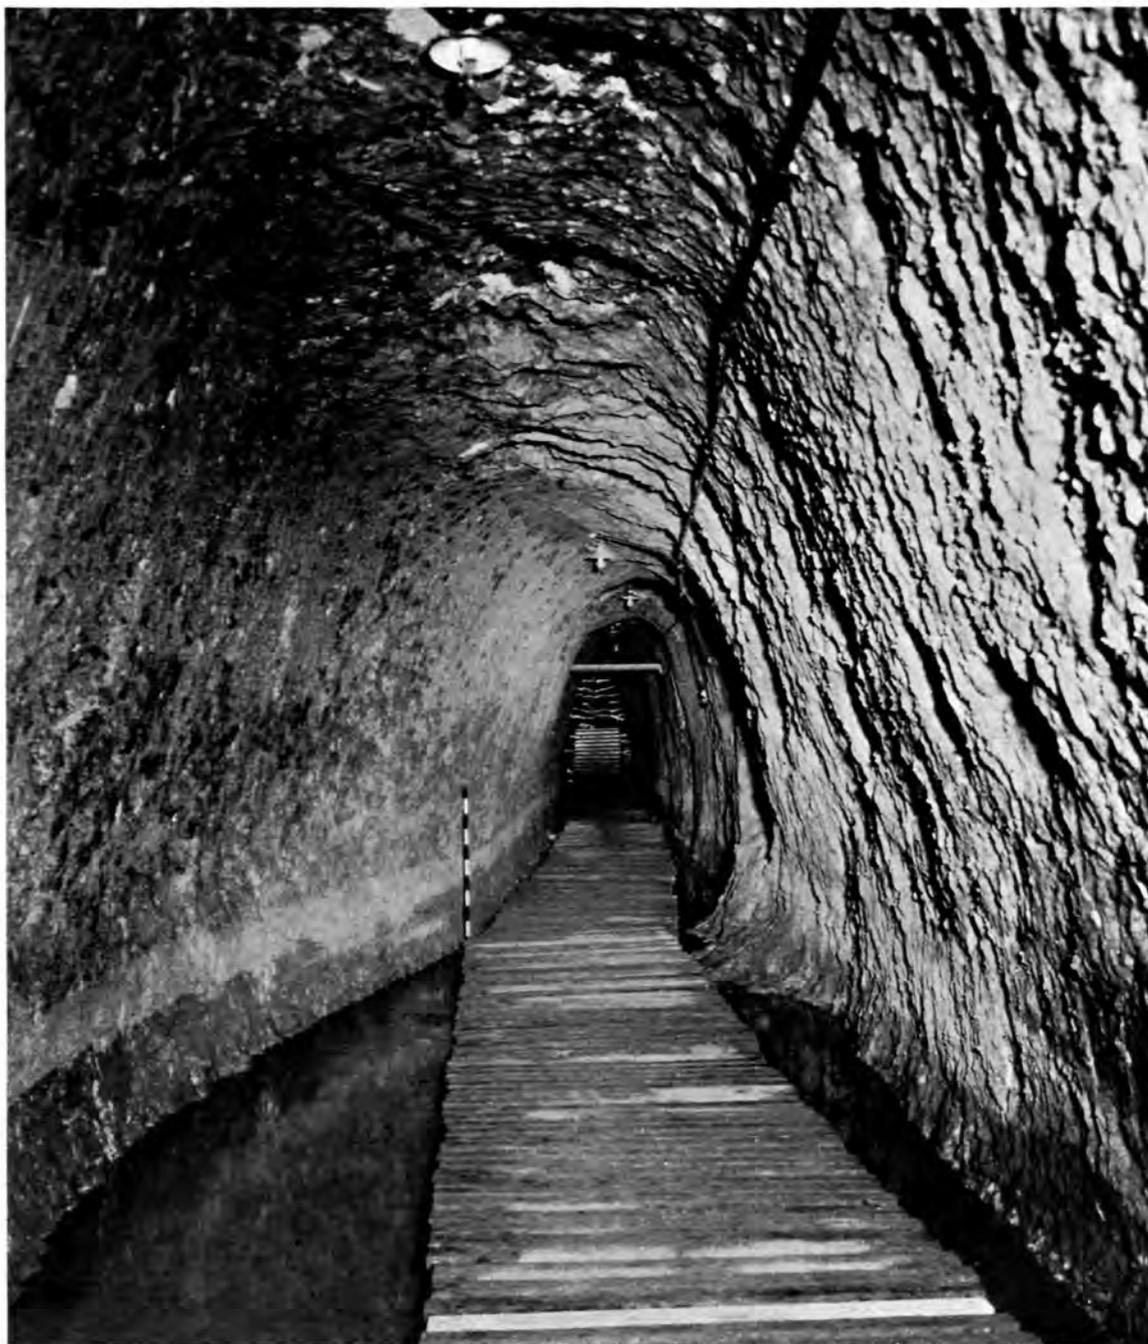
FIG. 26.—TUNNEL 1000, LOOKING EAST TOWARD THE INCLINED PASSAGE  
The irregularity in the floor is a remnant of dam Y.

The two irregularities in the floor of the western part of the tunnel, one where the two tunnels originally joined (Fig. 26) and the other just south of the mouth of the tunnel near the well, are remnants of dams Y and X respectively (see pp. 22 f. and Fig. 13). When the

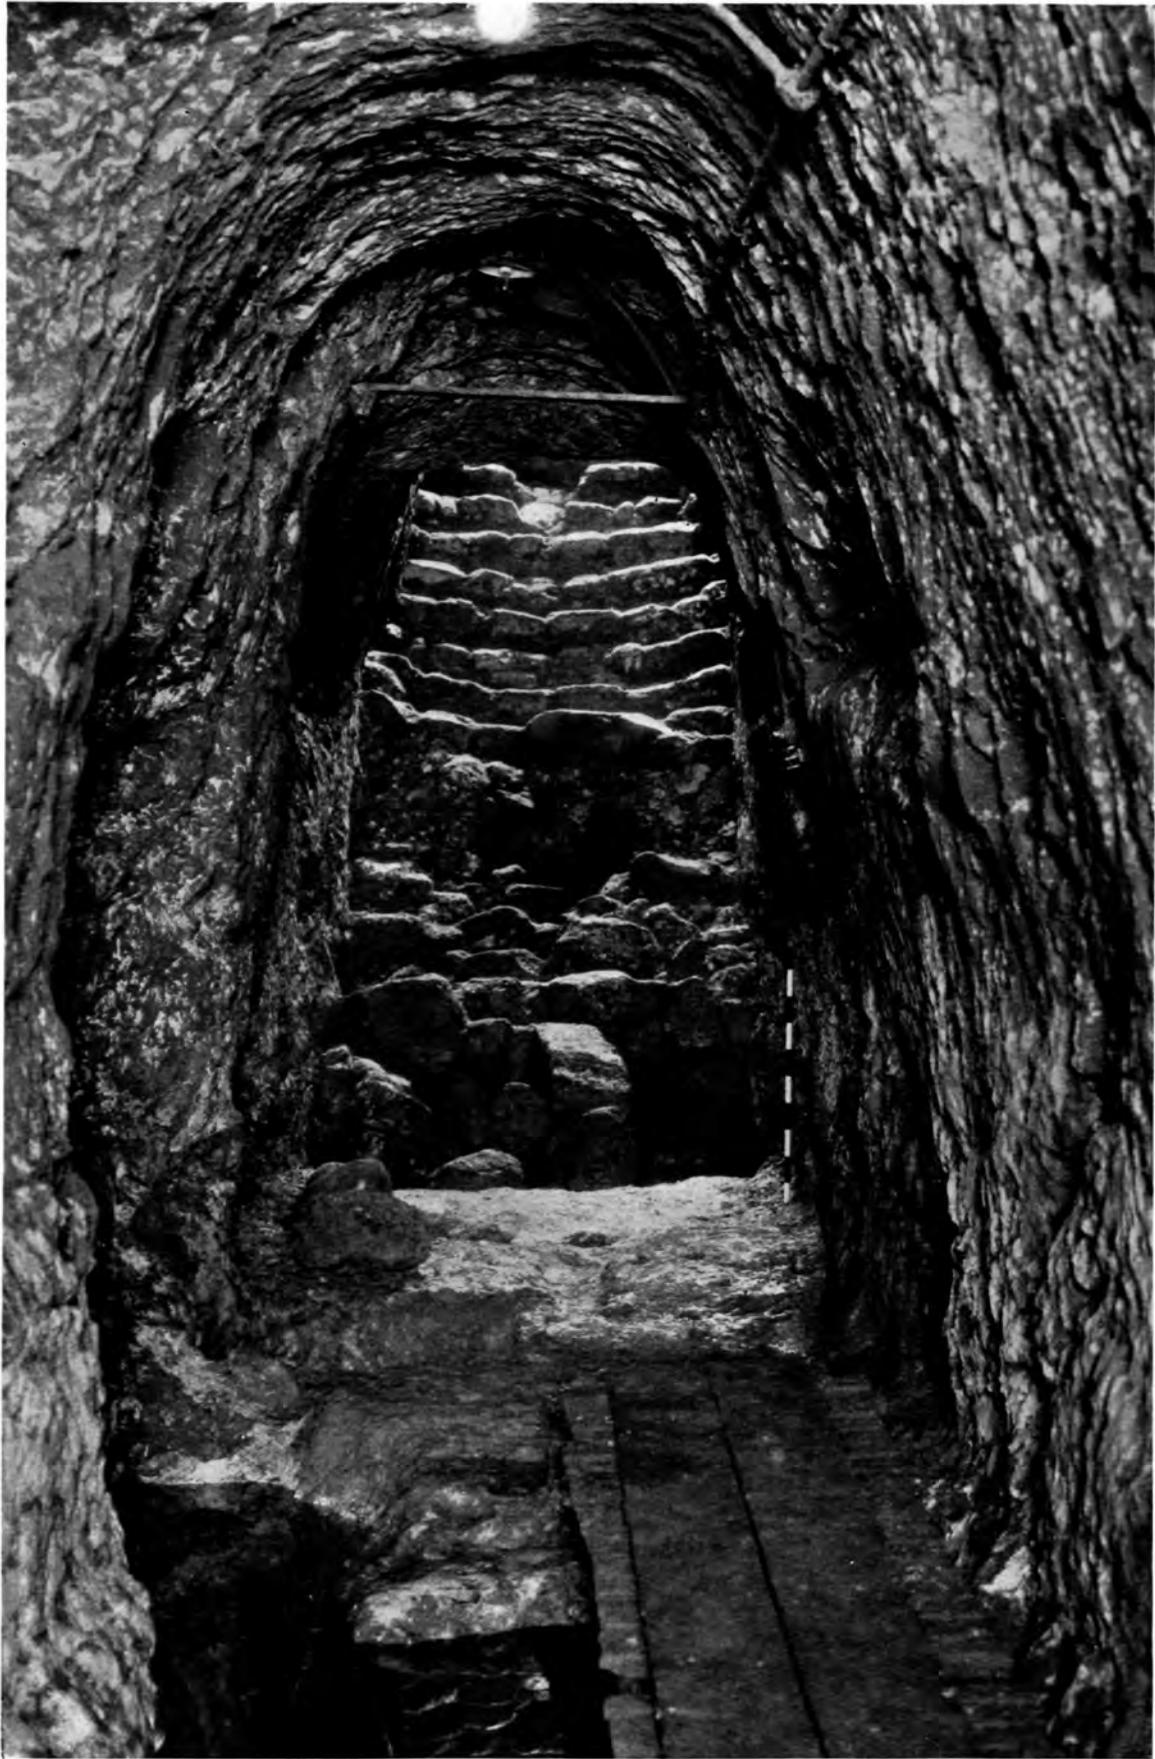
FIG. 27.—THE EASTERN PART OF TUNNEL 1000, SHOWING THE MASONRY STEPS IN THE INCLINED PASSAGE

The masonry stairs in the inclined tunnel (Figs. 27–28) were evidently built during a time of general repair at the beginning of the Solomonic period (cf. p. 17). In the filling below the

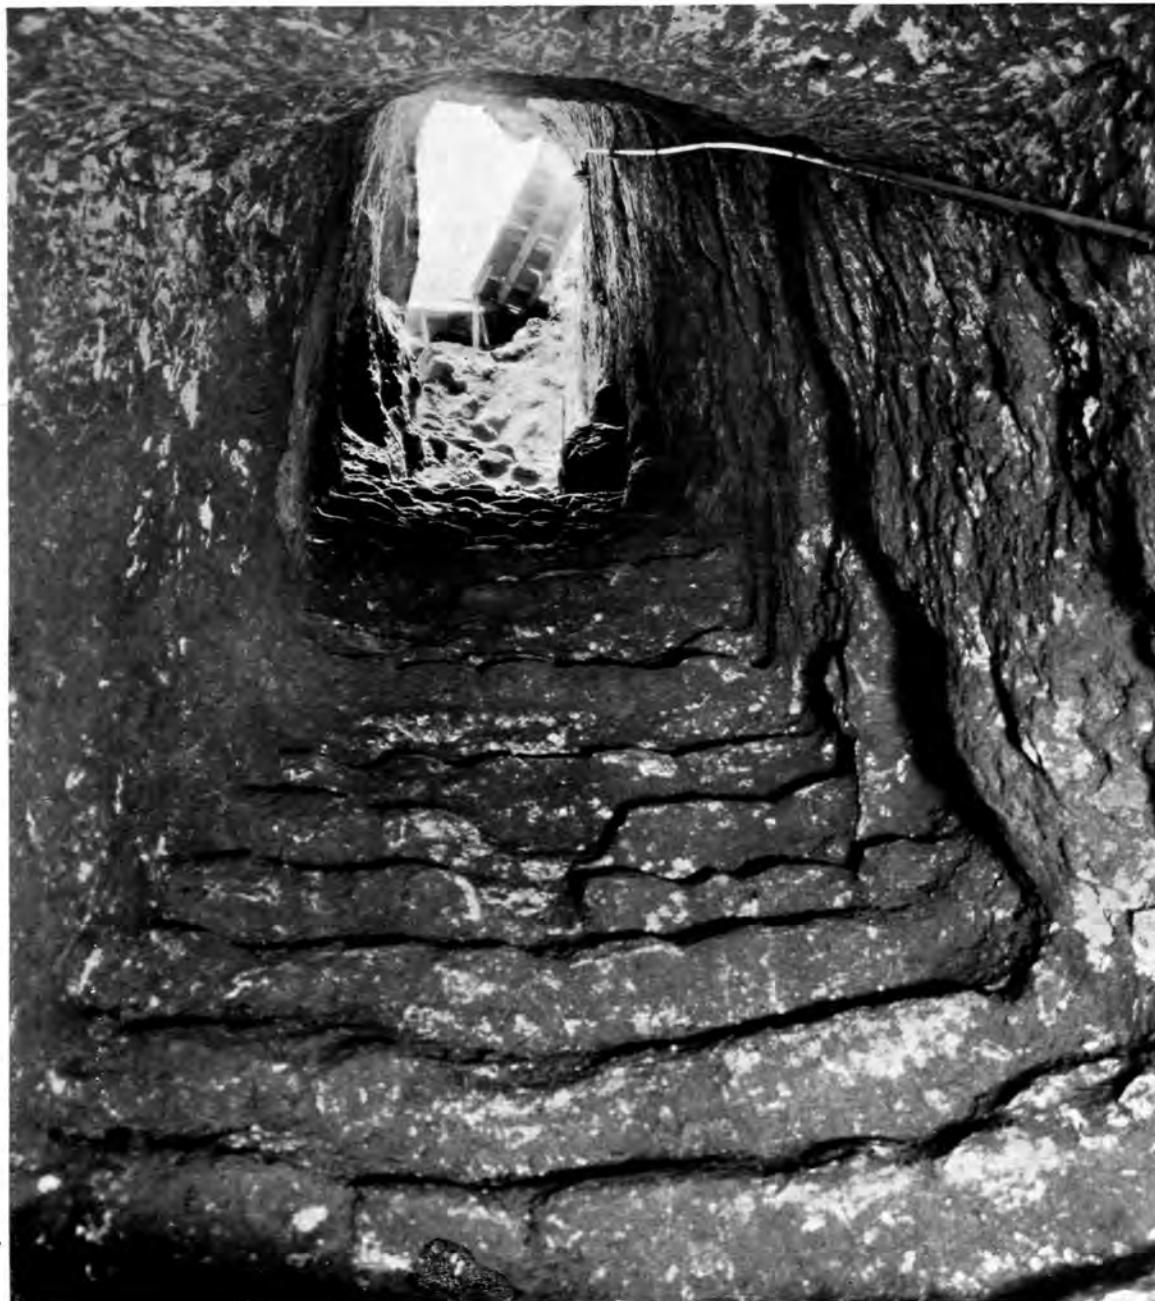
FIG. 28.—THE MASONRY STEPS IN THE INCLINED PASSAGE, FROM BELOW

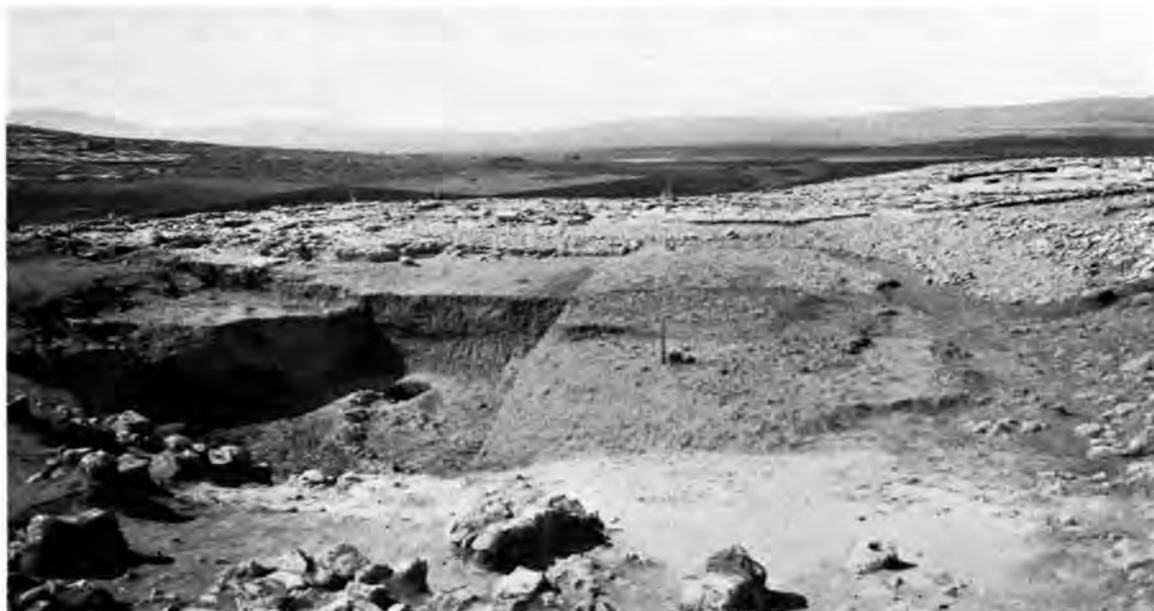
FIG. 29.—DEPRESSION OVER THE SHAFT OF THE SILTED-UP WATER SYSTEM, SHOWING SERIES OF RUBBLE PAVEMENTS THROWN ACROSS IT

The city appears to have been rebuilt and the fortifications repaired to a certain extent during the time of Josiah. To this period is to be attributed the long flight of stairs (951) which led down through a breach in the original masonry shaft of the water system. The history of Megiddo subsequent to this time is hard to define, and all that can be definitely stated is that the site ceased to be occupied at about 350 B.C. During the last stages of sporadic occupation the water system was allowed to silt up again. Eventually it became merely a depression in the top of the mound, which, during the rainy season at least, to judge from the series of rough rubble pavements thrown across it, was merely a mudhole (Fig. 29).
